Sinking of US Cargo Vessel SS *El Faro*
Atlantic Ocean, Northeast of Acklins and Crooked Island,
Bahamas
October 1, 2015

Accident Report

NTSB/MAR-17/01
PB2018-100342

The National Transportation Safety Board (NTSB) determines that the probable cause of the sinking of *El Faro* and the subsequent loss of life was the captain's insufficient action to avoid Hurricane Joaquin, his failure to use the most current weather information, and his late decision to muster the crew. Contributing to the sinking was ineffective bridge resource management on board *El Faro*, which included the captain's failure to adequately consider officers' suggestions. Also contributing to the sinking was the inadequacy of both TOTE's oversight and its safety management system. Further contributing factors to the loss of *El Faro* were flooding in a cargo hold from an undetected open watertight scuttle and damaged seawater piping; loss of propulsion due to low lube oil pressure to the main engine resulting from a sustained list; and subsequent downflooding through unsecured ventilation closures to the cargo holds. Also contributing to the loss of the vessel was the lack of an approved damage control plan tha

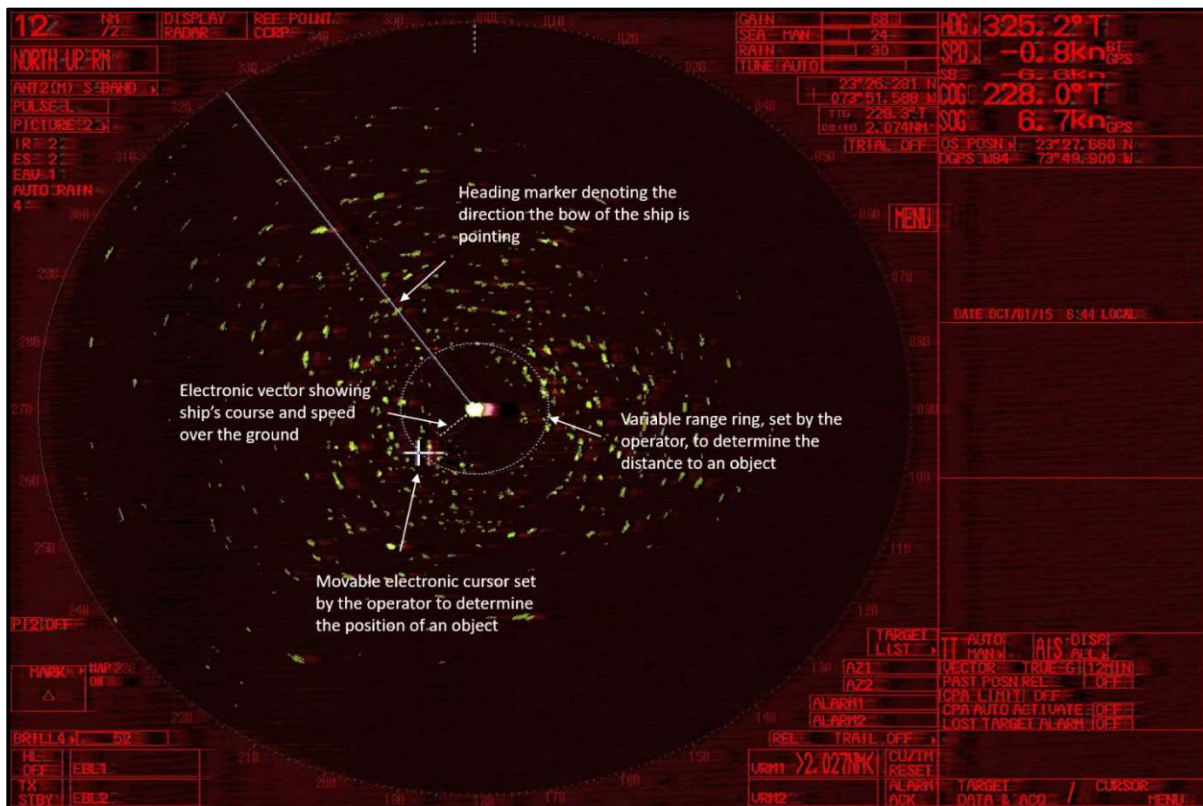
At 0644, the captain told the AB on watch, “You got some turns right now,” meaning that propulsion seemed to have returned. The radar image in figure 8, obtained from the VDR, shows that *El Faro*’s bow was headed northwest but that the ship was actually traveling southwest, at a speed (in relation to the ground) of 6.7 knots—that is, it was being pushed sideways by the wind and waves, nearly perpendicular to its original course before losing propulsion.

Figure 8. Radar image from 0644 on October 1 showing *El Faro* heading (bow direction) northwest (325.2°) but moving southwest (228°).

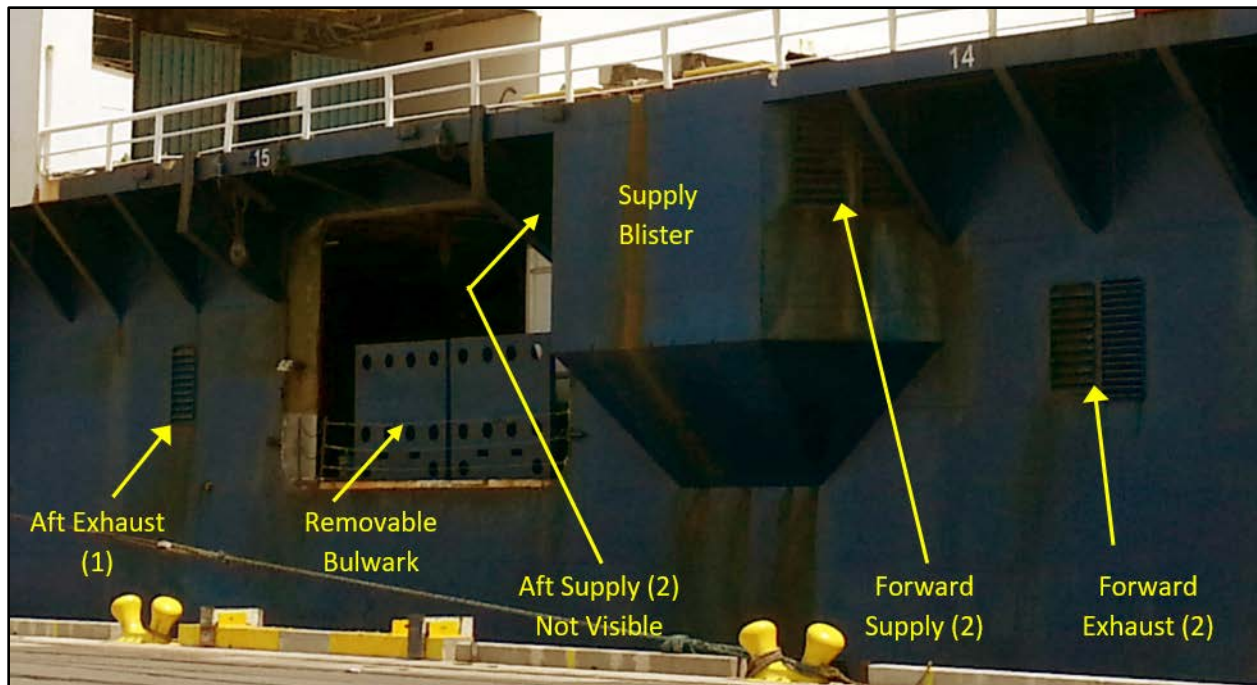
Figure 10. Starboard side of *El Faro* showing supply and exhaust ventilation openings to cargo hold 3. (Photo by Herbert Engineering)

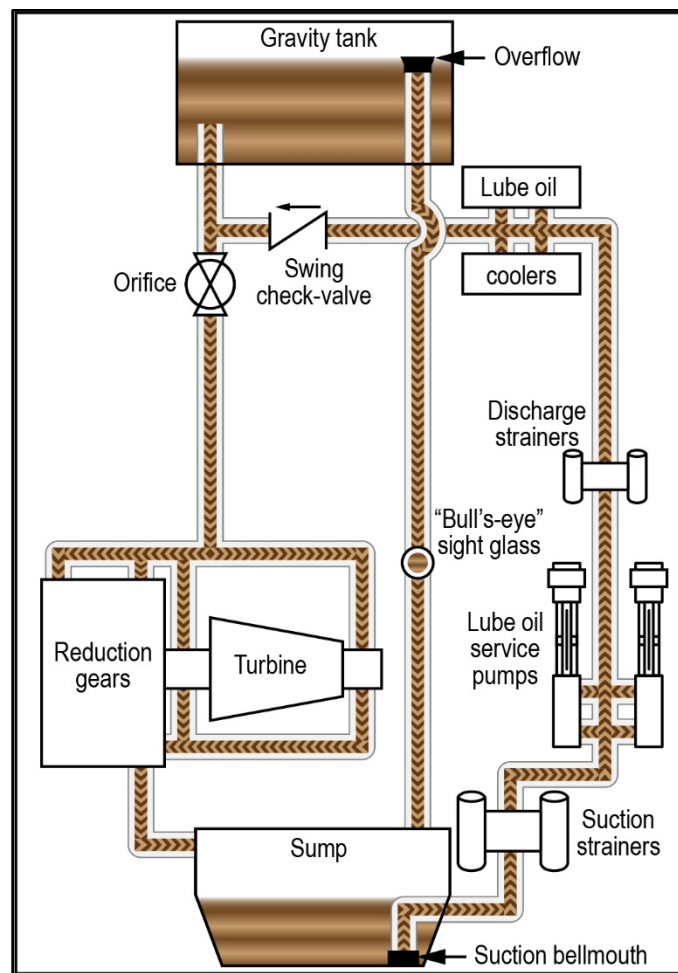
Lubricating Oil. According to the 1973 ABS rules for building and classing steel vessels, the lubricating oil system of the main engine was "to be so arranged that it will function satisfactorily when the vessel is permanently inclined to an angle of 15 degrees athwartship and 5 degrees fore and aft." The Coast Guard had no rules for main engine or lube oil operation angles when the vessel was built (or when it was lengthened in 1993). *El Faro's* lubricating oil system is diagrammed in figure 11. Because the suction for the lubricating oil service pump was located in the starboard, aft section of the sump, a port list with a forward trim would be the worst-case scenario for exposing the suction bellmouth, which could result in a loss of lubricating oil to the main engine.

Figure 11. Schematic of *El Faro's* lubricating oil system, showing component parts and direction of oil flow.

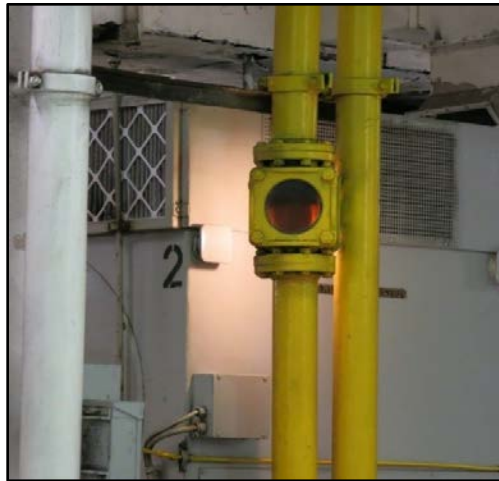
From the engine room, overflowing oil, indicating proper operation of the lube oil service pumps, could be monitored through an illuminated port (“bull’s-eye”) in the supply line that returned oil to the sump (figure 12). An engineer who had served aboard TOTE’s *Ponce*-class vessels (last in 2012) told the third marine board that in rough weather, flow in the bull’s-eye might be interrupted by sloshing oil in the gravity tank. In the event of a pressure loss, about 8 minutes

Figure 12. Bull's-eye for monitoring lube oil flow from gravity tank. (Photo from *El Yunque*)

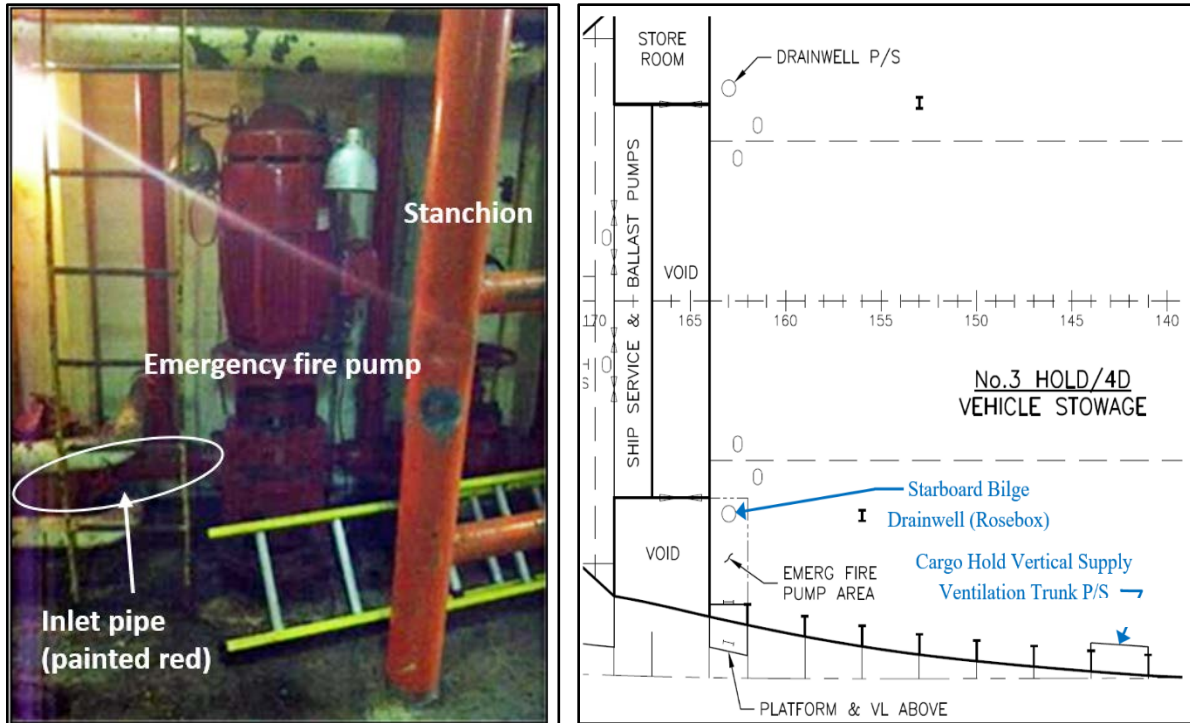
Fire Main. The fire main system consisted of a combination pump, called a bilge, fire, and general service pump, located on the starboard side of the lower engine room. The pump was a Worthington vertical, centrifugal model rated for 575 gpm at 125 psig. An emergency fire pump, rated for 635 gpm at 125 psig, was located on the starboard side of cargo hold 3, on the tanktop. The pump had its own sea suction (seawater inlet pipe) directly outboard of the pump. As seen in figure 13, the fire pump (shown in the photo) was protected by at least one vertical steel stanchion, and a platform (shown in the drawing) was located above the pump, with a vertical ladder installed nearby.

Figure 13. Emergency fire pump. Photo shows emergency fire pump (center rear) in *El Faro*'s hold 3 (photo by Maine Maritime Academy cadet). Diagram, from general arrangement drawing, shows emergency fire pump location in hold 3, fourth deck (VL = vertical ladder).

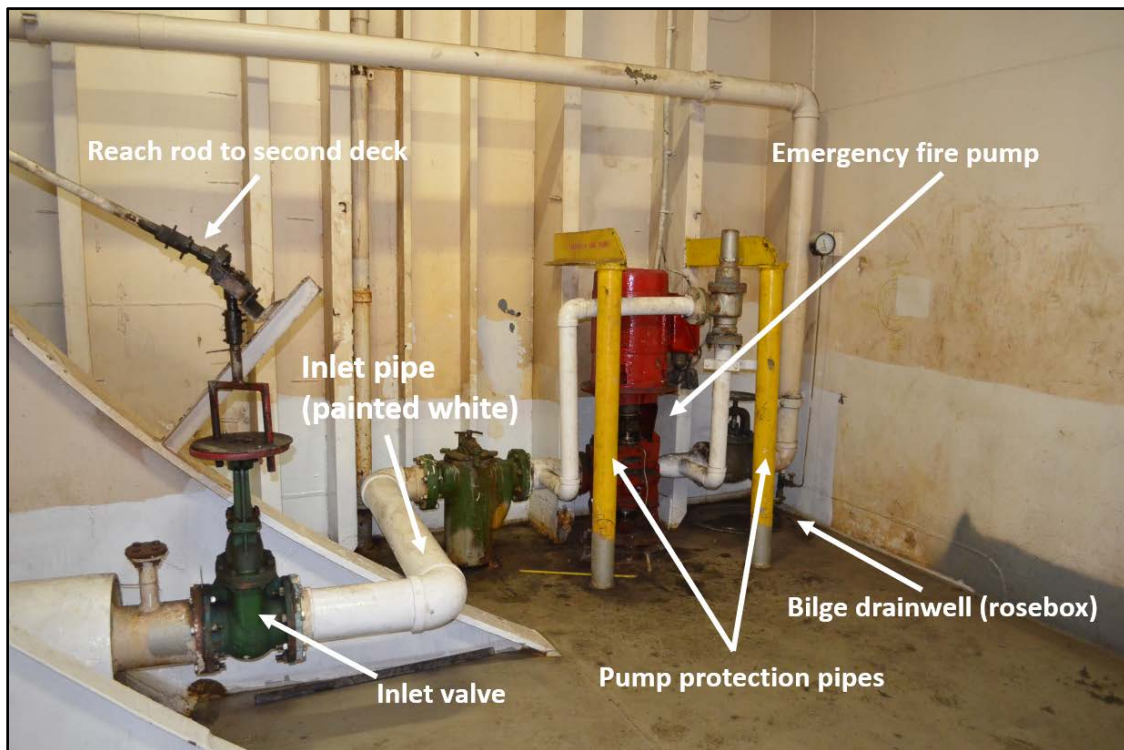
While on board *El Yunque*, investigators photographed the emergency fire pump in hold 3 on the tanktop, in a similar location to that of *El Faro*'s emergency fire pump (figure 14). The pump aboard *El Yunque* had vertical pipes welded to the deck and framing as protection, but the suction pipe and valve had no surrounding protection. The arrangement of the piping for the emergency fire pump was not identical between *El Faro* and *El Yunque*.

Figure 14. Emergency fire pump and inlet piping in hold 3 of *El Yunque*.

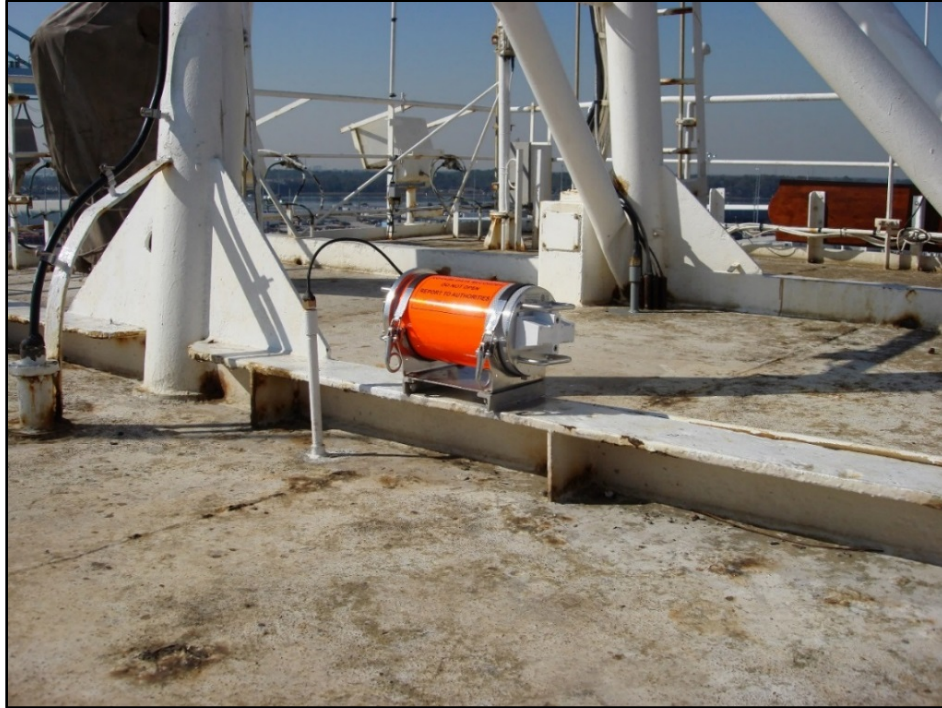
Voyage Data Recorder. As required, *El Faro* was equipped with a simplified VDR (S-VDR) that was installed in January and February 2009.⁷⁸ The device was a Northrop Grumman Sperry Marine Voyage Master II, manufactured by Danelec Marine (Birkerød, Denmark). The VDR capsule was attached to a steel channel at the base of the antenna mast on the deck above the bridge (figure 15).

Figure 15. VDR capsule on deck above *El Faro*'s navigation bridge. (Radio Holland photo⁸⁰)

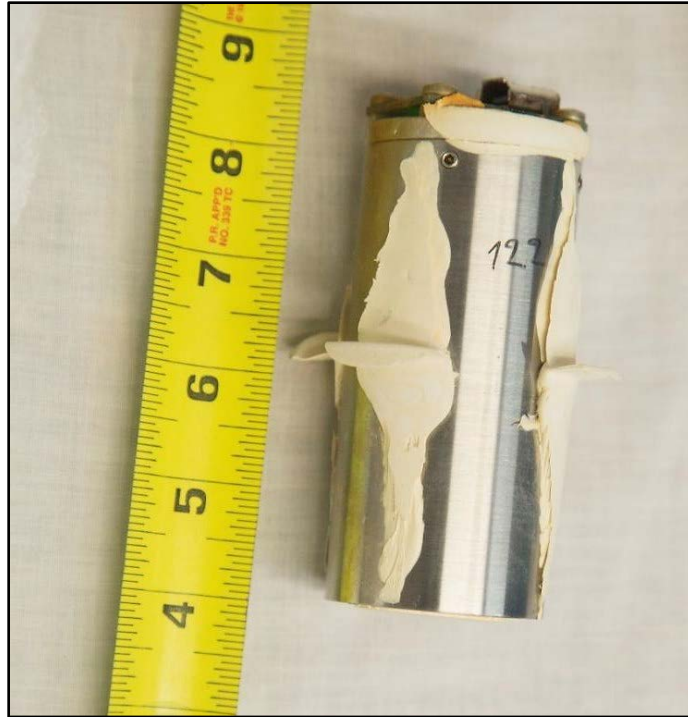
The VDR data were stored on a flash memory chip inside a protective capsule. On August 8, 2016, after the capsule was recovered from *El Faro*'s wreckage, it was submerged in a bath of distilled water aboard the Navy vessel *Apache*, then disassembled and inspected for possible damage to the internal recording medium. Inside the capsule, layers of protective materials housed an inner capsule containing the circuit board assembly that stored the nonvolatile memory (figure 16).⁸² The circuit board assembly was inspected for visible signs of damage or corrosion (figure 17) before being transported to the NTSB laboratory in Washington, DC, on August 12.

Figure 16. Inner VDR capsule assembly after removal from outer capsule.

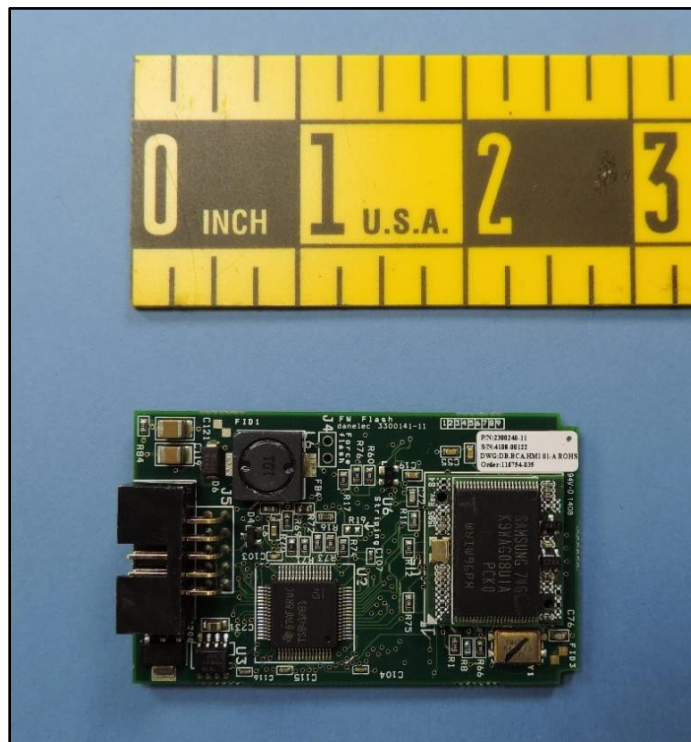
Figure 17. Circuit board assembly from inner VDR capsule.

On August 15, 2016, at the NTSB laboratory, the circuit board assembly from the inner VDR capsule was connected to a functioning surrogate assembly, provided by Danelec. The manufacturer provided technical support and witnessed downloading of the VDR data. A forensic write-blocking bridge was used to copy data from the circuit board assembly.⁸³ Using manufacturer-provided VDR playback software, the data were exported to a common data file structure for further analysis.⁸⁴

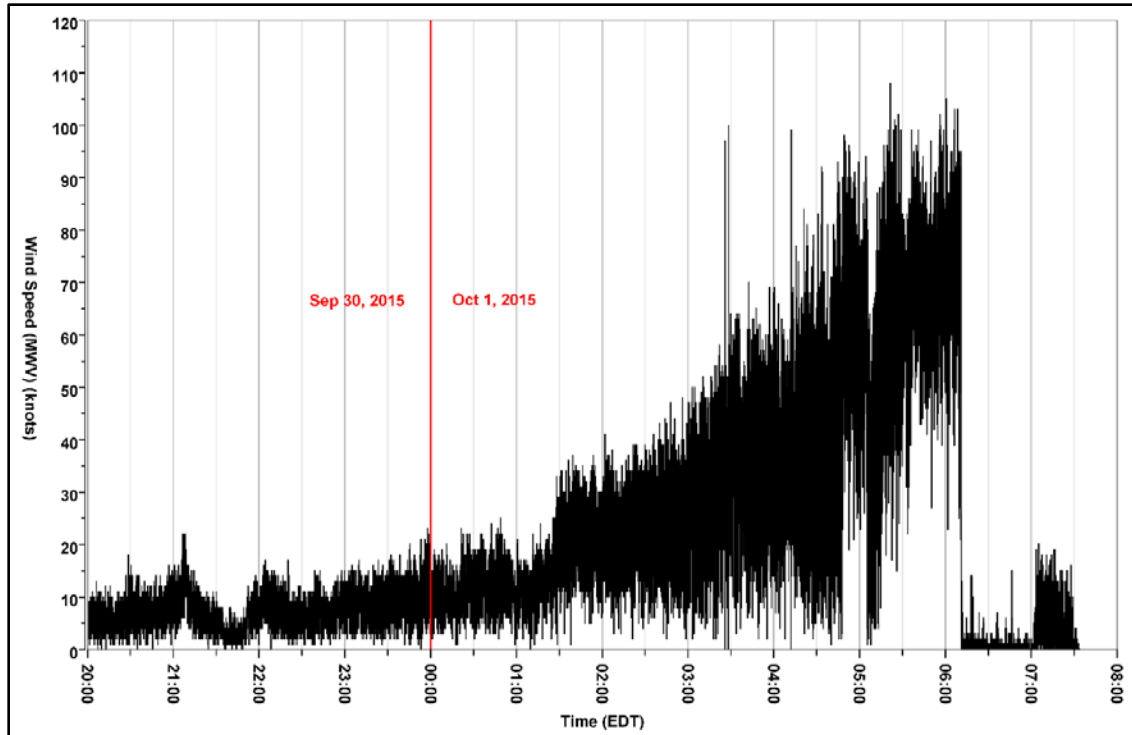
The vessel's anemometer displayed wind data on the bridge. Wind speed and direction were recorded by the VDR.⁹¹ Figure 18 shows raw wind speed data captured by the VDR from 2000 on September 30 until the sinking. Throughout the VDR recording, however, over 99 percent of the anemometer data samples indicated a relative wind direction of between 180° and 193°. On the VDR recording, *El Faro*'s captain, chief mate, and second mate questioned the reliability of the wind speed and stated that the wind direction was "not good" and that "we don't have (any) anemometer."

Figure 18. Raw VDR wind speed data, from 2000 September 30 to data loss.

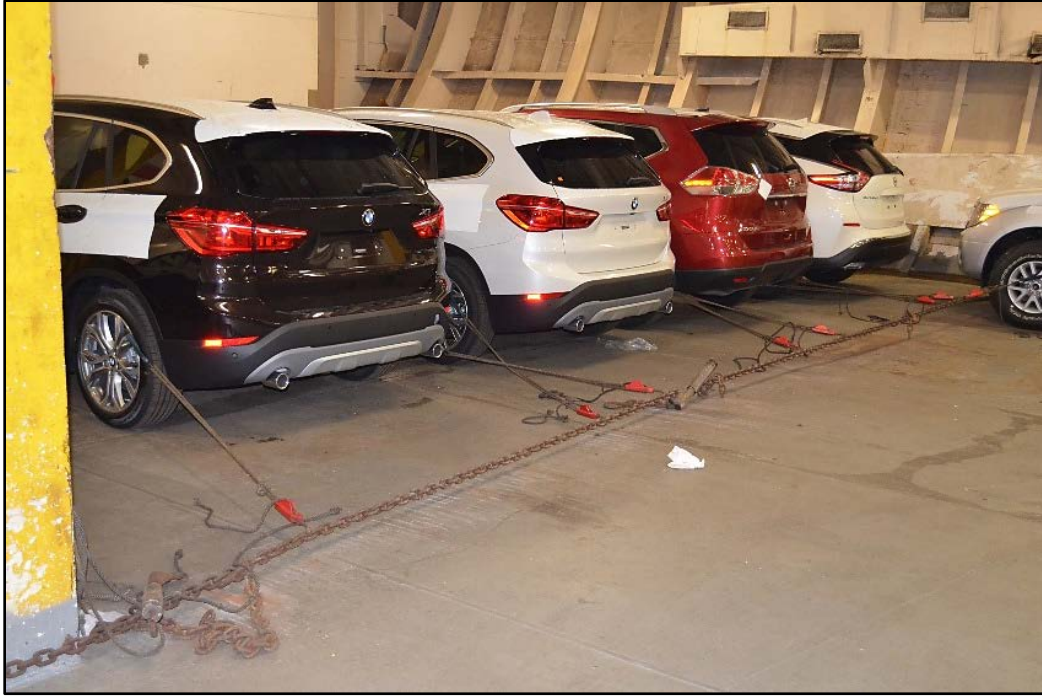
Automobiles, considered semistandardized cargo, were to be lashed using portable securing devices consisting of fiber rope or nylon strapping attached to steel tensioners that were fitted with hooks at both ends. Four lashings were to be run, one from each corner of a vehicle, to the fixed D-rings or cloverleaves on the deck (figure 21). A variation of that securing arrangement, not included in the cargo-securing manual, was to run lashings from the four corners of the automobile to a long chain. The long chain ran across the width of the ship and was secured to D-rings at either end. Some of the chains passed through a D-ring before being secured to additional D-rings at each end. A lashing variation observed on *El Yunque* in October 2015 is shown in figure 22. One of the longshoremen who had lashed the automobiles on *El Faro* before the accident voyage testified when shown a photo of the lashings on *El Yunque* that they had used that arrangement on *El Faro*.

Figure 22. Two automobiles lashed to one length of chain. (Photo from hold 5 of *El Yunque*)

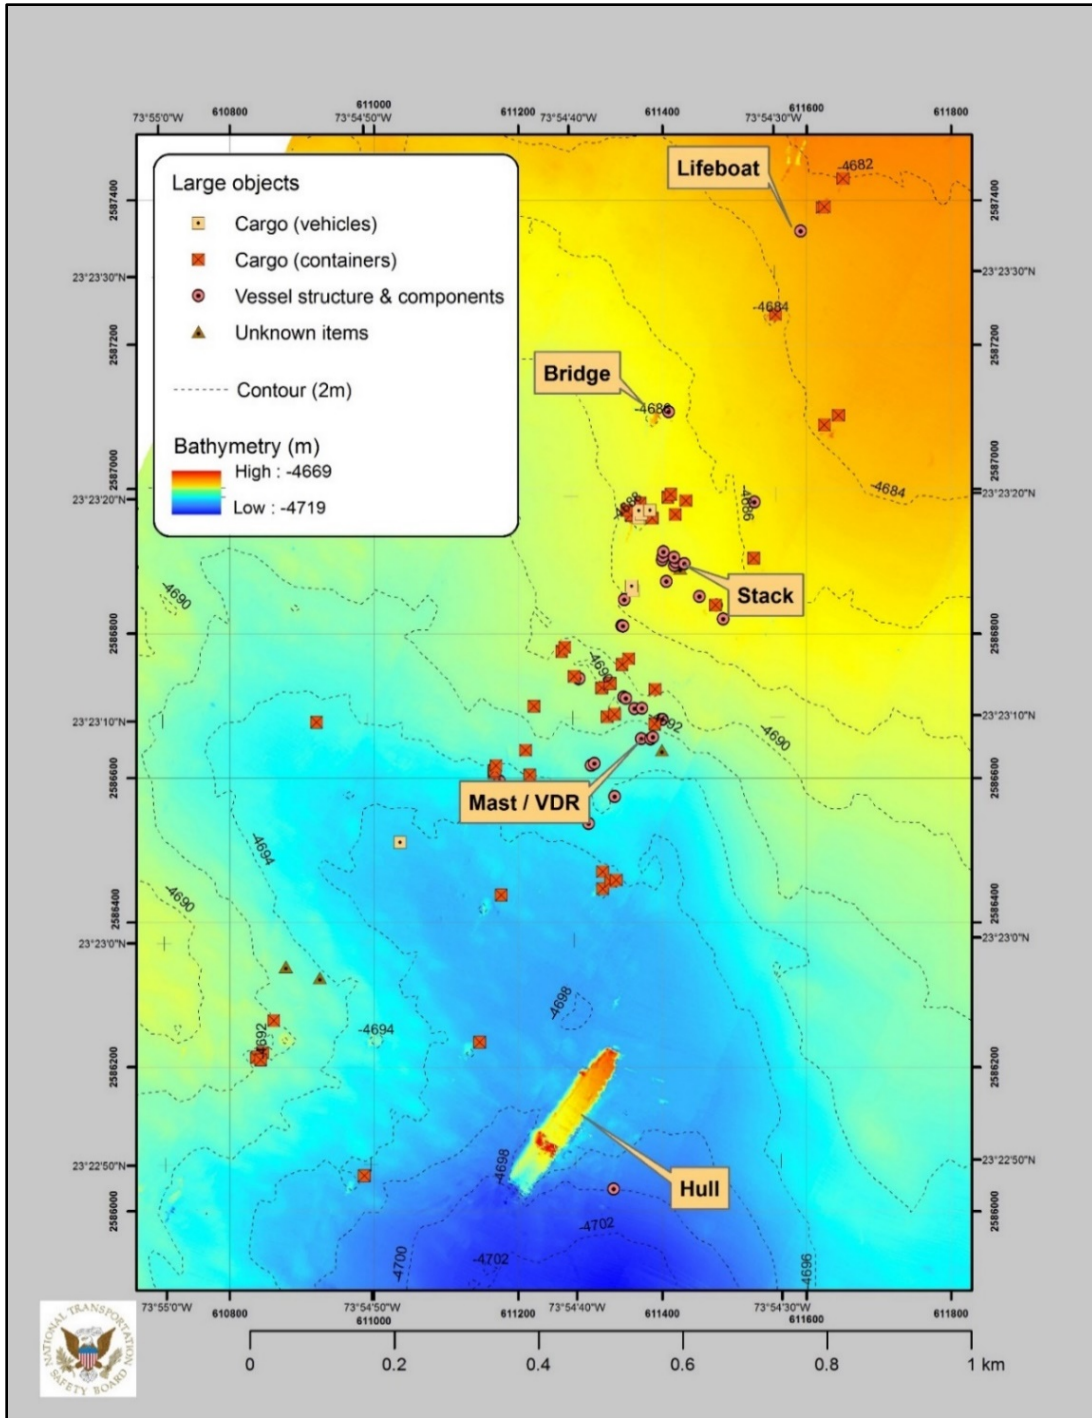
The wreckage of *El Faro* lies at a depth of between 15,318 and 15,482 feet (4,719 to 4,669 meters) in the Atlantic Ocean, about 20 nm northeast of Samana Cay. The primary underwater debris field, which includes the main hull and ship structure, covers an area of about 0.7 square mile (1.8 square kilometers) between latitudes 23.3786N and 23.3936N and longitudes 73.9061W and 73.9172W. Cargo containers, other cargo items, and some ship's equipment and rails were found outside the primary debris field. Inside the primary field were the remains of *El Faro*'s port lifeboat; some of its cargo (about 40 containers and 7 vehicles); the main hull and the structures that separated from it, including the mast (with attached VDR), the exhaust stack, the bridge and the deck below it; and a few unidentified items. Figure 23 is a bathymetric (topographic) map of the seafloor showing the location of the main objects discovered.

Figure 23. Map of *El Faro* debris field showing large objects. Bathymetry from multibeam-sonar site survey, April 2016.

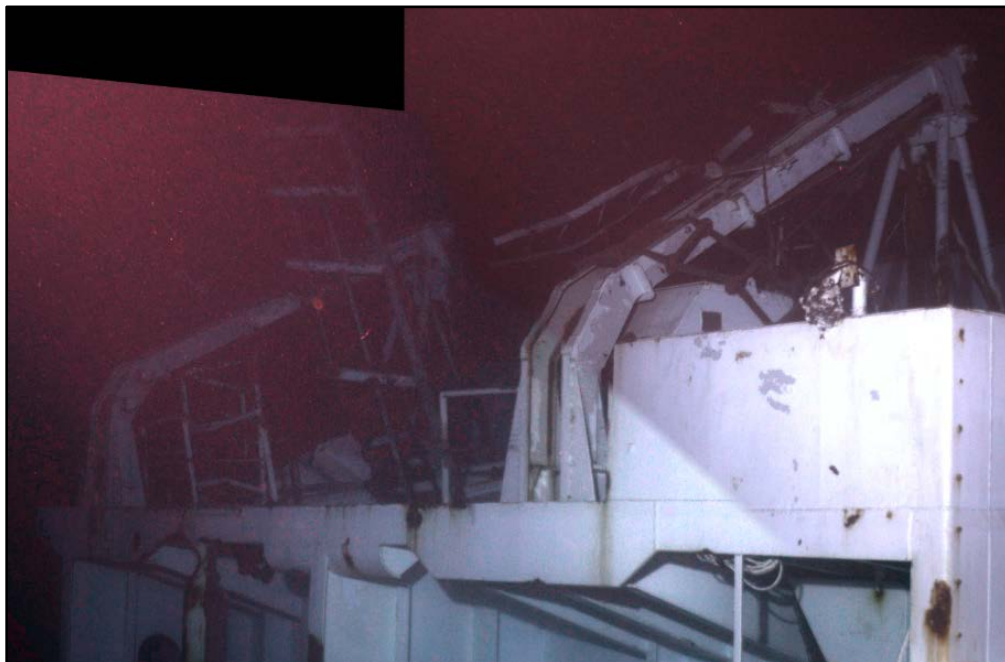
The gravity davits (cranelike devices for lowering boats into the water) for the starboard lifeboat were discovered intact during the second mission (figure 25). The arm for the forward davit was displaced and resting on the deck, but the arm's cable was still attached to the track. The gravity davits for the port lifeboat showed greater damage, with the aft track and davit broken and hanging (figure 26).

Figure 25. Intact gravity davits for starboard lifeboat, with forward davit in foreground. (Photomosaic image from mission 2)

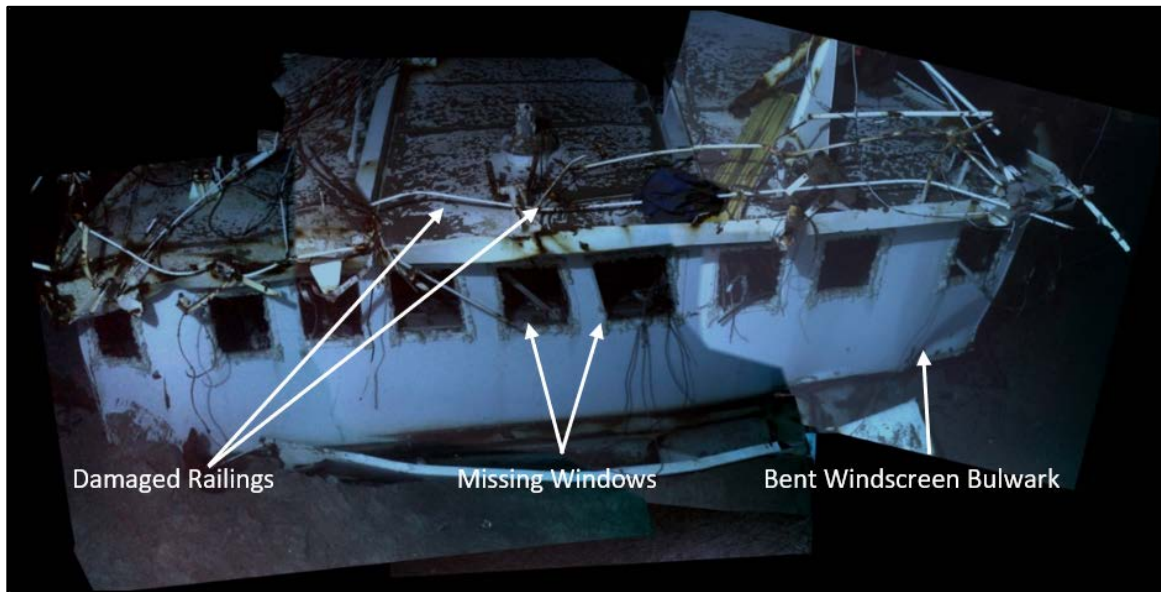
The navigation bridge and bridge deck that had been discovered during the first mission were further explored during mission 2. The photomosaic image in figure 27 shows that all windows on the forward side of the bridge were missing; that the windscreen bulwark was bent forward; and that the top railings were missing, severely bent, or broken. The starboard forward corner of the wreckage had settled deeper into the seabed than the other corners.

Figure 27. Bridge and bridge deck, looking aft. (Photomosaic image from mission 2)

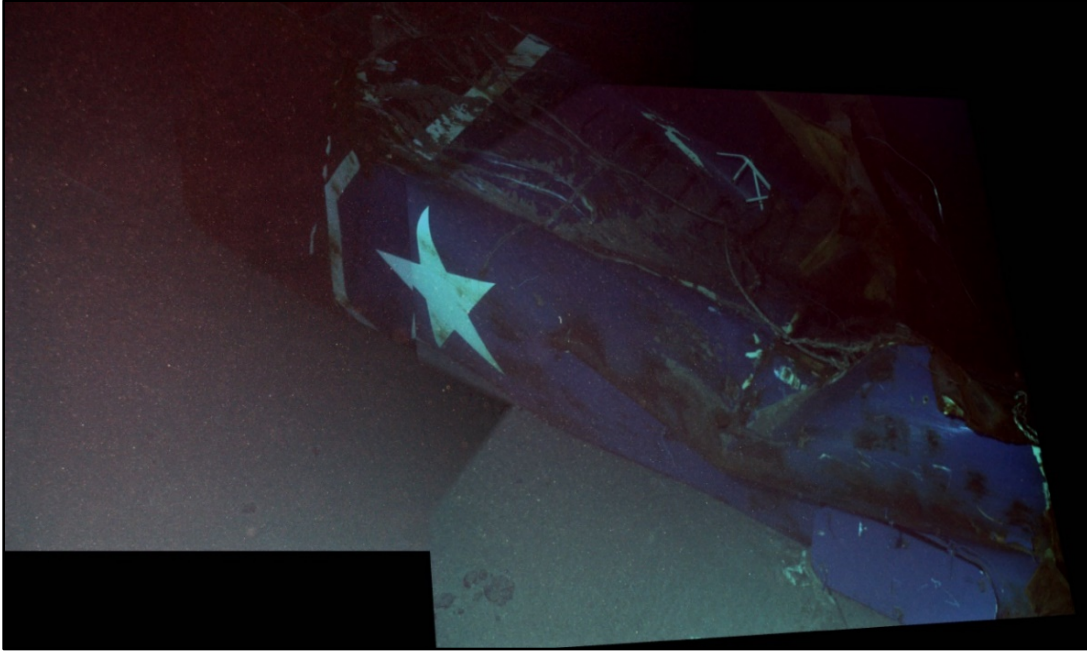
El Faro's exhaust stack was discovered during the second mission about 2,625 feet (0.43 nm) north of the main hull (figure 28). It was largely intact, though the forward face was missing its steel plating and the stack was scratched, dented, and deflected inward. The boiler uptake funnel was missing from the top of the stack.

Figure 28. Exhaust stack lying on seafloor, Sea Star (company) symbol clearly visible. (Photomosaic image from mission 2)

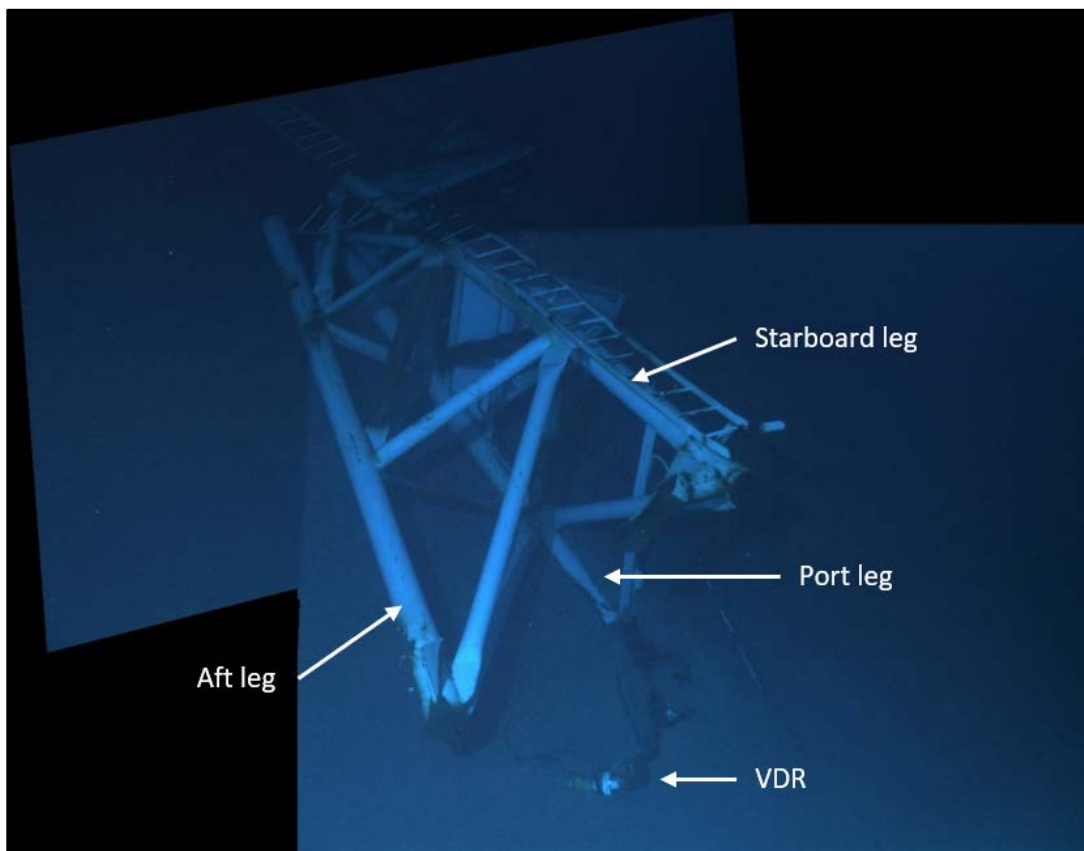
The tripod mast and VDR capsule were discovered on the seafloor about 1,640 feet (0.28 nm) north of the main hull (figure 29). The large structural members were intact, but the overall structure was bent aft. The VDR was attached to the port leg and buried in mud.

Figure 29. Mast and VDR capsule on seafloor. (Photomosaic image from mission 2)

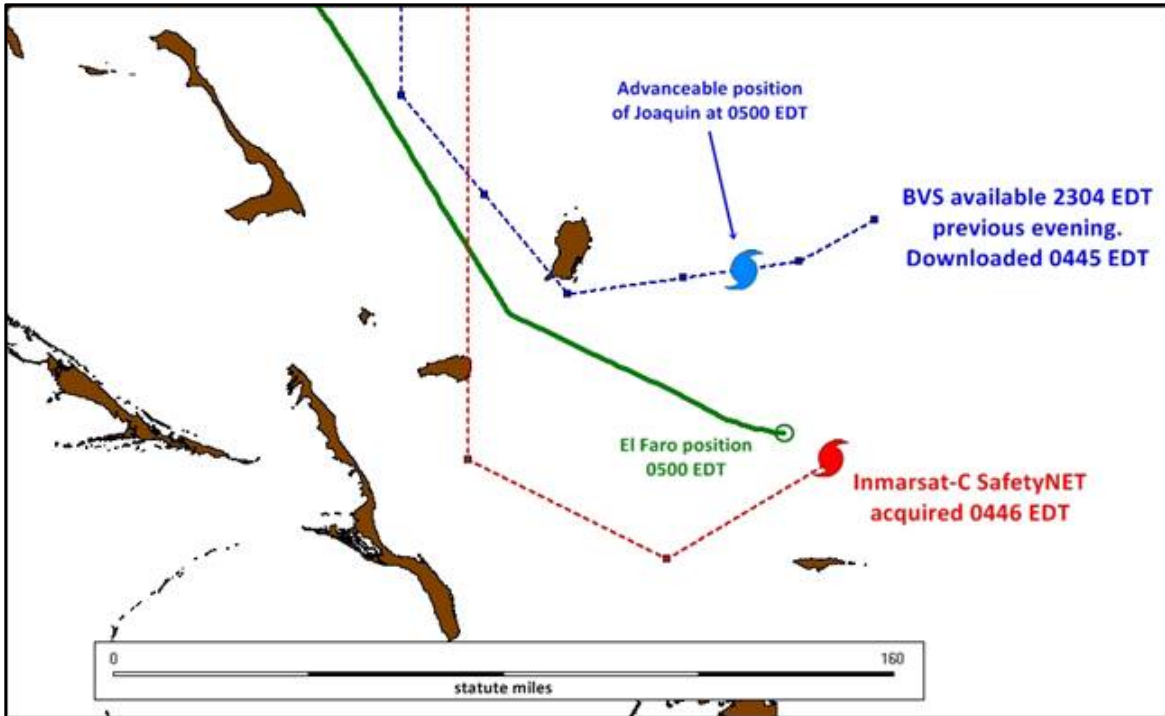
Figure 42 plots the information available to the bridge team around 0500 the morning of the accident, after the captain downloaded the previous evening's BVS file that had been available to him at 2304 and just after the new weather information delivered by Sat-C was available on the bridge (at 0446). At that point, the BVS information (blue) was almost 12 hours old (6-hour latency, as described above, plus additional time between receiving the email and downloading the data). The Inmarsat-C information was current as of 0446.

The captain stated on the VDR at 0503, "We're getting conflicting reports as to where the center of the storm is."

Figure 42. Positions of Joaquin obtained by *El Faro* and available on the bridge around 0500 on October 1. (Plotted by NTSB)

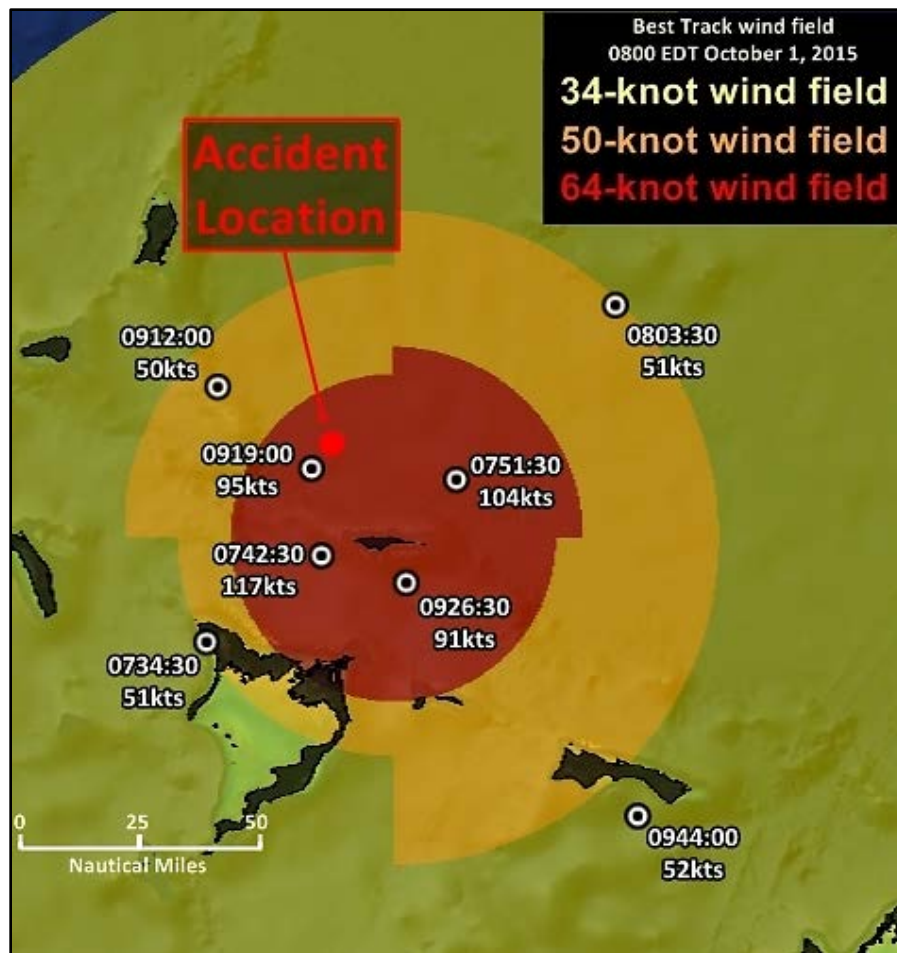
Figure 43 illustrates distances from the storm where 34-, 50-, 64-knot, and peak winds might have occurred near the accident time. Distances are based on SFMR surface wind data retrieved during a reconnaissance flight close to the time of the sinking, as well as the National Hurricane Center's poststorm best-track analysis. The best track is a poststorm, smoothed representation of a tropical cyclone's location and intensity over its lifetime (see section 1.10.5). The SFMR data are peak 10-second average observations of surface wind within a 30-second reporting interval. The red and tan areas depict the best-track estimates of the farthest extent that 50- and 64-knot winds occurred in each storm quadrant about 0800 on October 1. In the storm's northwest quadrant, the best-track analysis was that 50-knot winds extended outward as far as 50 nm from the center.

Figure 43. Surface winds from SFMR observations overlaid on best-track wind fields for 0800 on October 1. SFMR observations are labeled with midpoint of each 30-second reporting interval and average wind magnitude.

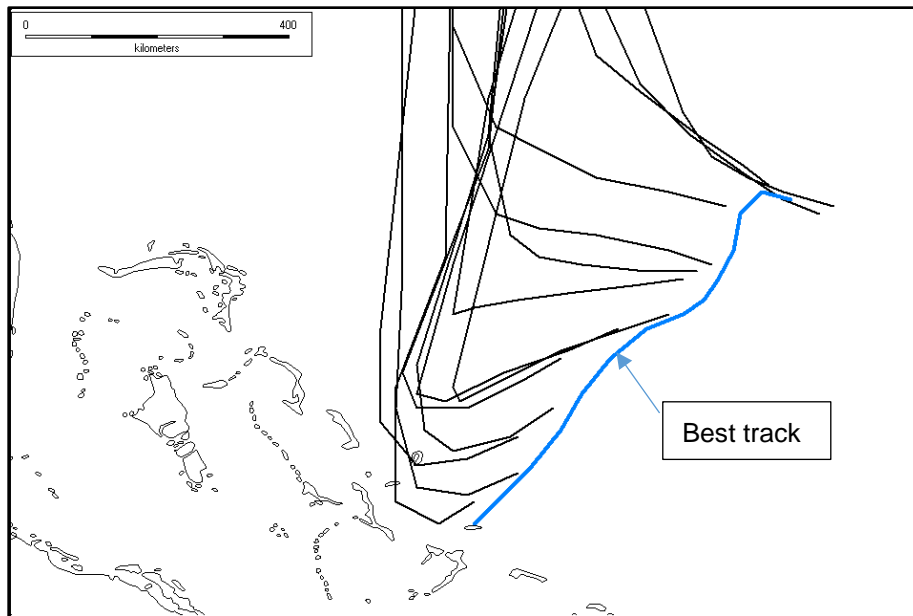
The National Hurricane Center’s report critiques its forecasting for Joaquin. Errors in the forecast track “between 72 and 120 h[ours] were double the mean official errors for the previous 5-[year] period.” The report attributes the errors largely to “Joaquin’s atypical southwestward motion toward the Bahamas” between September 28 and October 1. According to the report, most of the prediction models, as well as the official forecast, indicated that Joaquin would move toward the northwest or west. The model run by the European Centre for Medium-Range Weather Forecasting, however, accurately depicted the hurricane’s southwestward motion after the first two

Figure 46 illustrates the hurricane center’s 5-day forecast tracks and best track for Joaquin through the morning of October 1. With regard to intensity, the National Hurricane Center’s report states, “Official forecast intensity errors were greater than the mean official errors for the previous 5-[ea]r period at all forecast times.”

Figure 46. Official 5-day forecast tracks and best track for Hurricane Joaquin through October 1. Joaquin’s actual overall movement was south-southwest through October 1, as shown by best track (blue line). Forecast tracks (black lines) show Joaquin moving first northwest, then later west and southwest before beginning to track northward. (Lines track right to left.)

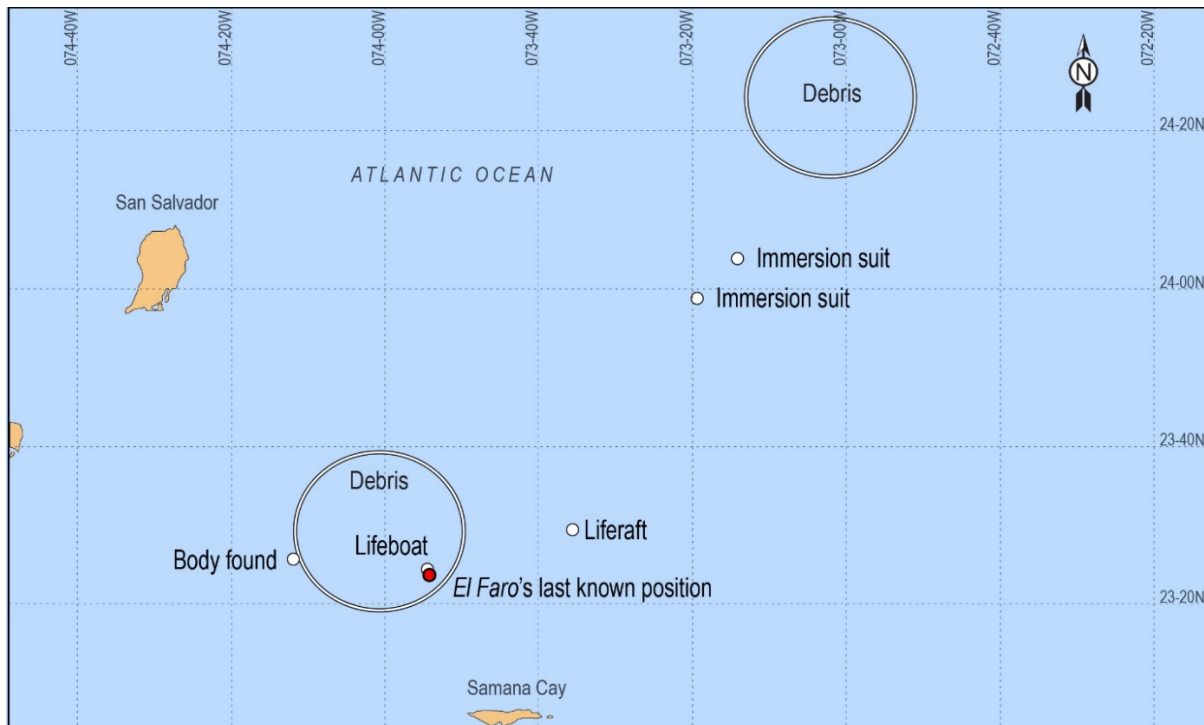
Also on October 3, a Coast Guard HC-130 aircraft located a debris field 120 nm northeast of Crooked Island. A Coast Guard MH-60 helicopter relocated the debris field and found three liferings, one of which was stenciled "El Faro." The helicopter located a second debris field 90 nm northeast of Crooked Island, consisting of small unidentified objects believed to be packing material. Three cutters, the *Northland*, the *Resolute*, and the *Charles Sexton*, were en route to the search area as weather and seas permitted.

Figure 47. Two debris fields located during search-and-rescue operations and *El Faro's* last known position from VDR data. Distance between debris fields was about 77 nm. Degrees of latitude are 60 nm apart. Distance between degrees of longitude varies with distance from equator, where it is about 60 nm. (Adapted from Coast Guard graphic)

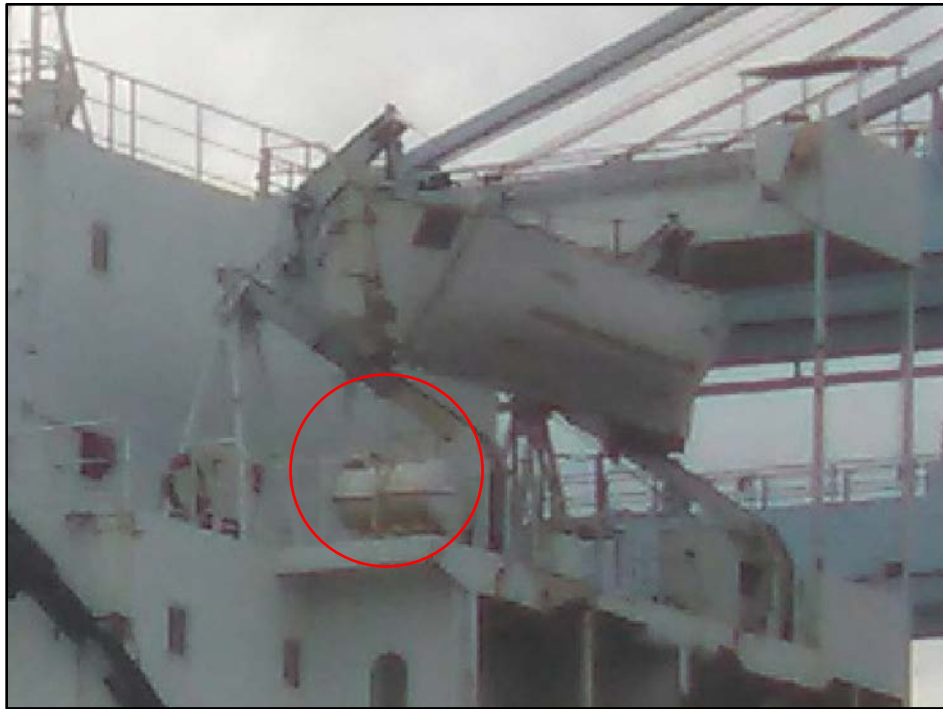
Figure 49. Location of liferaft stowed below *El Faro's* starboard lifeboat. (Photo by Maine Maritime Academy cadet, summer 2015)

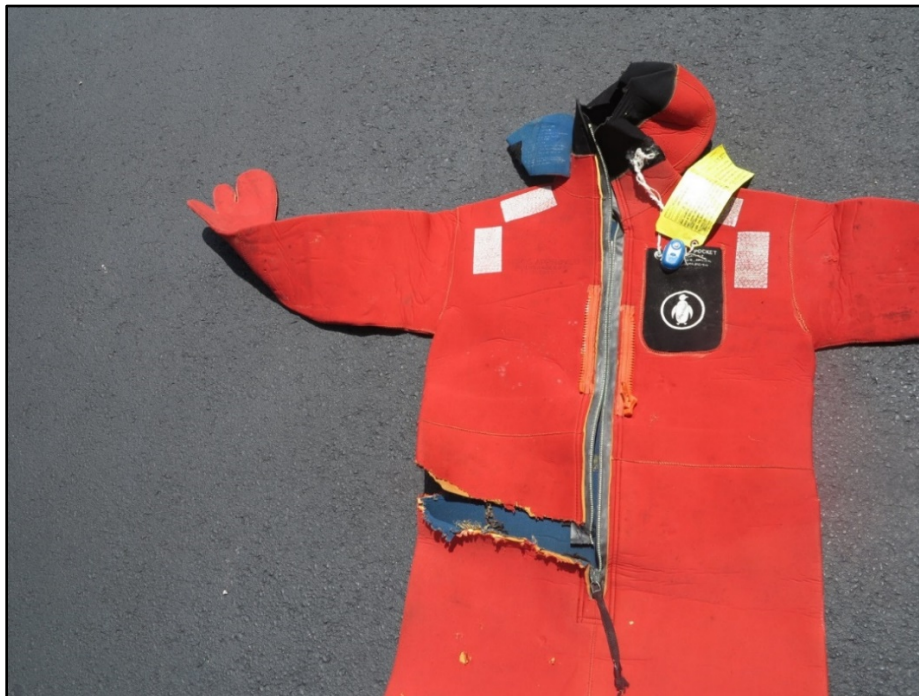
The cutter *Charles Sexton* recovered two of *El Faro*'s immersion suits after the accident. The first suit was recovered on October 6. The back was marked "S.S. El Faro San Juan, P.R." in white but appeared to have been previously marked "El Morro" in black. The second immersion suit (figure 54) was recovered on October 7. It was found with whistle and strobe light (turned off but operational); unzipped, left arm inside out, torn almost in half at right hip seam; and back marked "S.S. El Faro San Juan, P.R." in white but appeared to have been previously marked "El Morro" in black. As noted earlier, an immersion suit containing human remains was located but could not be recovered.

Figure 54. Immersion suit recovered on October 7, 2015.

According to maintenance records for June 2015, the recovered immersion suits were spare immersion suits Nos. 48 and 50. Both were last inspected and pressure-tested in July 2013 by Liferrafts Inc., of Puerto Rico, and each had a light with an expiration date of April 2016.

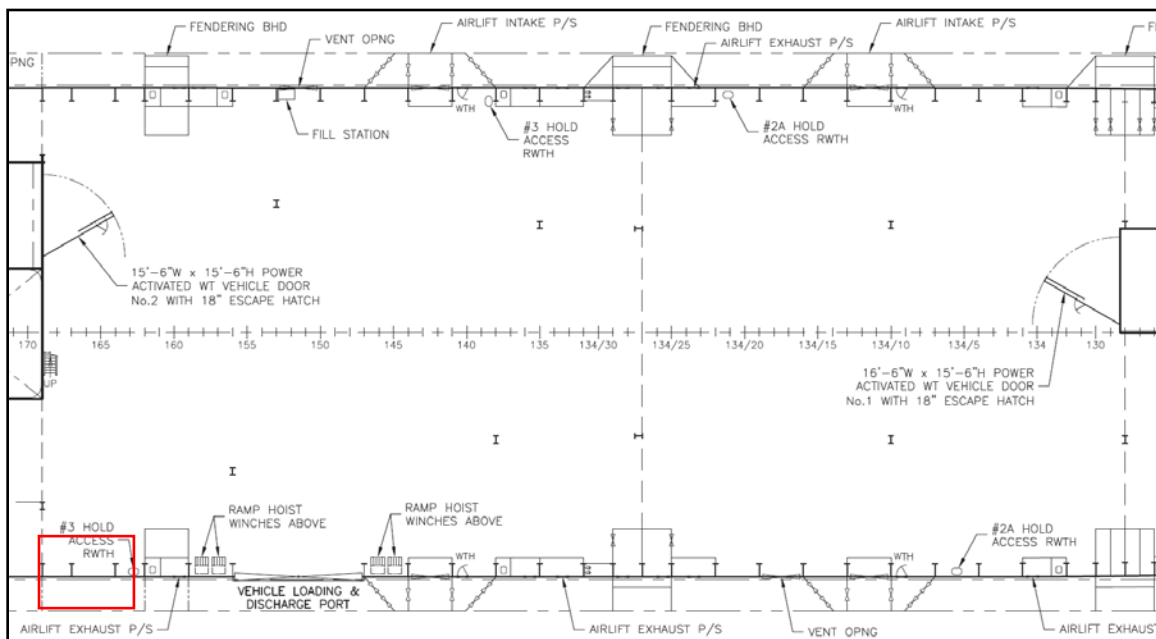
The VDR recording indicates that the vertical-access scuttle on the starboard side of the second deck that led to hold 3 was open during the accident. General arrangement drawings (such as figure 56) show that the second deck had two scuttles (called RWTHs [raised watertight hatches] on the drawings), through the second deck to hold 3, at frame 163 on the starboard side and at frame 138.5 on the port side. Hold 2A also had two such accesses. Figures 57 and 58 show the scuttle on the starboard side of the second deck to hold 3 and the scuttle on the port side to hold 2A.

Figure 56. Second deck plan showing scuttles. (Starboard scuttle to hold 3 outlined in red)

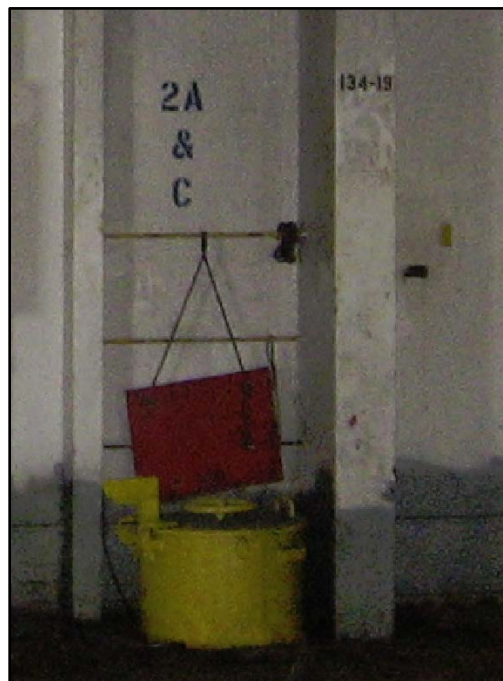
Figure 58. Second deck scuttle to hold 2A, similar to hold 3 scuttle. (Photo by Herbert Engineering)
