Sinking of US Cargo Vessel SS *El Faro*
Atlantic Ocean, Northeast of Acklins and Crooked Island,
Bahamas
October 1, 2015

Accident Report

NTSB/MAR-17/01
PB2018-100342

The National Transportation Safety Board (NTSB) determines that the probable cause of the sinking of *El Faro* and the subsequent loss of life was the captain's insufficient action to avoid Hurricane Joaquin, his failure to use the most current weather information, and his late decision to muster the crew. Contributing to the sinking was ineffective bridge resource management on board *El Faro*, which included the captain's failure to adequately consider officers' suggestions. Also contributing to the sinking was the inadequacy of both TOTE's oversight and its safety management system. Further contributing factors to the loss of *El Faro* were flooding in a cargo hold from an undetected open watertight scuttle and damaged seawater piping; loss of propulsion due to low lube oil pressure to the main engine resulting from a sustained list; and subsequent downflooding through unsecured ventilation closures to the cargo holds. Also contributing to the loss of the vessel was the lack of an approved damage control plan tha

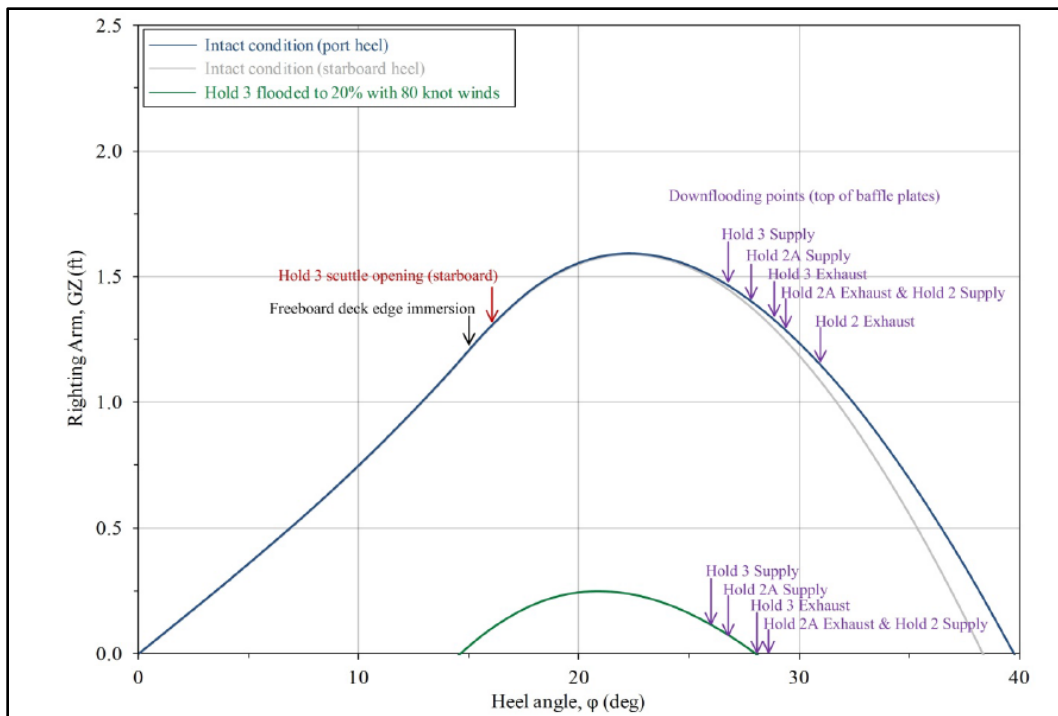
- Hold 3, starboard access scuttle: 16.2° (intact condition), 14.9° (hold 3 flooded to 20 percent).
- Hold 2, vent supply baffle: 29.6° (intact), 28.9° (hold 3 flooded).
- Hold 2, aft and forward exhaust vent baffles: at least 30° in either condition.
- Hold 2A, vent supply baffle: 27.7° (intact), 26.9° (hold 3 flooded).
- Hold 2A, aft vent exhaust baffle: 29.8° (intact), 28.9° (hold 3 flooded).
- Hold 2A, forward vent exhaust baffle: 30.3° (intact), 29.4° (hold 3 flooded).
- Hold 3, vent supply baffle: 27.2° (intact), 26.3° (hold 3 flooded).
- Hold 3, aft vent exhaust baffle: 29.1° (intact), 28.1° (hold 3 flooded).
- Hold 3, forward vent exhaust baffle: 29.5° (intact), 28.6° (hold 3 flooded).
- The other three downflooding points, all in hold 1, required a heel angle of at least 42° to downflood in either condition.

Figure 60 shows the downflooding angles for the downflooding points described above, plus the angle at which the edge of the freeboard deck would have been immersed (about 15°). The downflooding angles are superimposed on two righting arm curves. The upper curve is the righting arm for *El Faro* in the intact condition on the morning of the sinking, before flooding began and with no wind. The lower curve is the righting arm for the vessel with hold 3 flooded to 20 percent and a sustained 80-knot beam wind. The smaller area under the lower righting arm curve, compared with the area under the upper curve, illustrates the severely reduced energy the vessel had available to right itself after hold 3 flooded and the ship lost power, with hurricane winds on its beam (blowing at a 90° angle to its starboard side).

Figure 60. Righting arm curves for *El Faro*, with annotated downflooding angles. Downflooding angles are indicated at various points on curves for convenience; they do not represent values used in righting-arm calculations. (Illustration by Coast Guard Marine Safety Center)

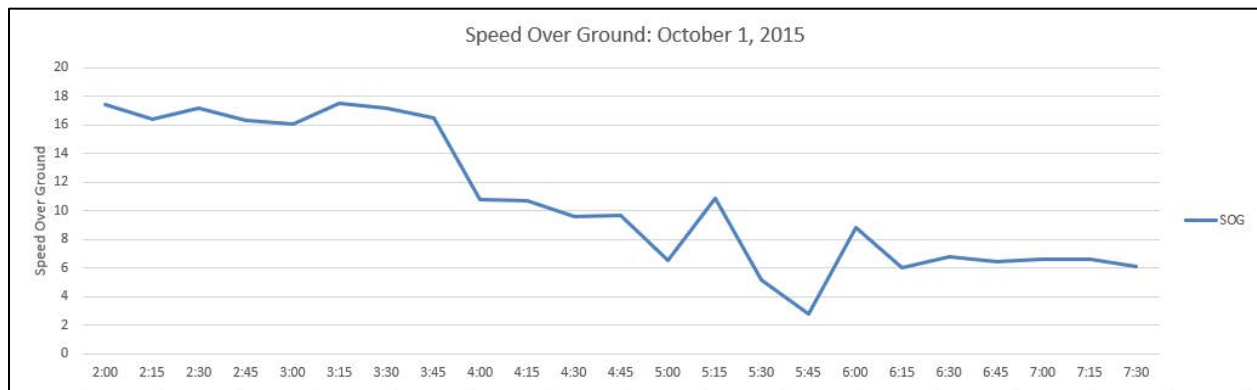
Figure 62. Ship's speed over ground from 0200 to 0730 on October 1.

El Faro sank an hour and a half after it lost propulsion. From the time it left port the evening of September 29, the ship traveled at near-maximum speed, between 19 and 20 knots, for almost 30 hours. But it began to slow and develop a wind-driven starboard list when it came out of the protective lee of San Salvador Island about 0130 on October 1 and encountered the steadily increasing force of the wind. The ship's speed dropped quickly to 18 knots and fell more or less

steadily from then on, as shown in figure 62. (Engine speed, or propeller rpm, was not recorded by the vessel's VDR, but parametric data captured the ship's speed over ground.)

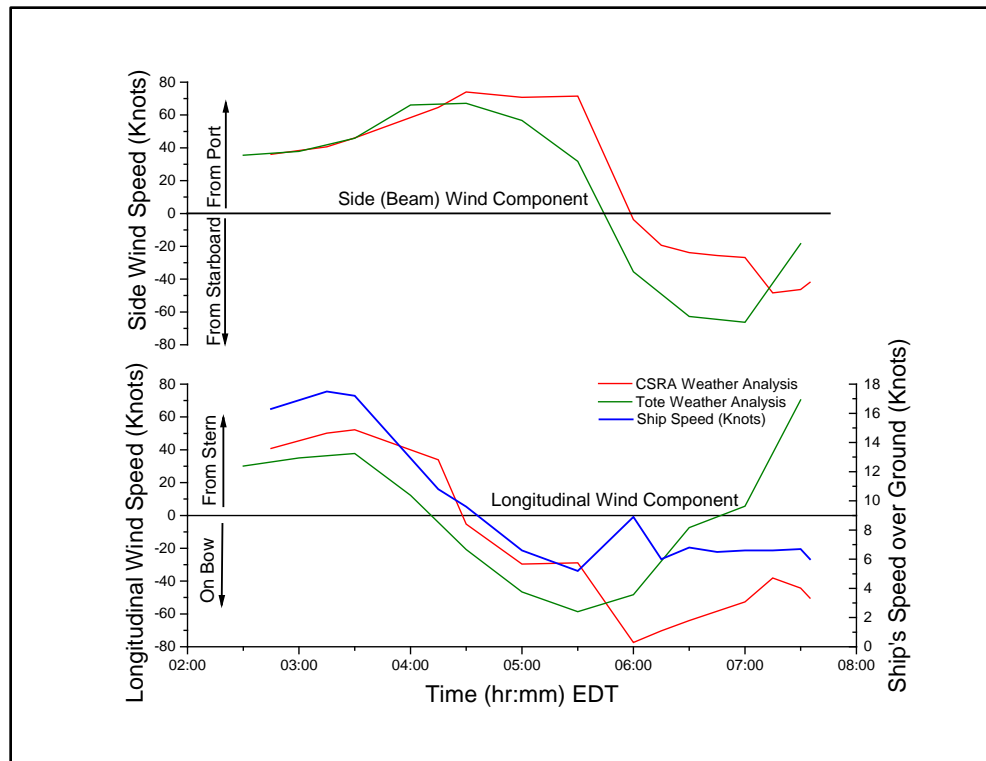
Figure 63. Ship's speed over ground relative to wind direction. Wind directions obtained from NTSB-chartered dynamic analysis (by CSRA Inc.) and TOTE weather analysis submission.

The graph in figure 63 demonstrates the relationship between ship's speed over ground and wind speed and direction, based on poststorm weather analyses. It shows that the increasing winds on the port side between 0400 and 0600 account for the vessel's starboard heel, while the shift of wind to the bow helps explain part of the vessel's slowing after 0400. The NTSB concludes that the initial list was caused by an increasing wind on the vessel's beam generated by Hurricane Joaquin.

About the time the watch changed, the crew began discussing that they were listing, or heeling, to starboard from the force of wind on the port side (windheel). By that point, the vessel's speed had dropped to less than 10 knots. The captain talked about shifting the water in the ballast (ramp) tanks to diminish the list. The vessel continued to make headway, though slowly, despite the sustained starboard list and the deteriorating weather.

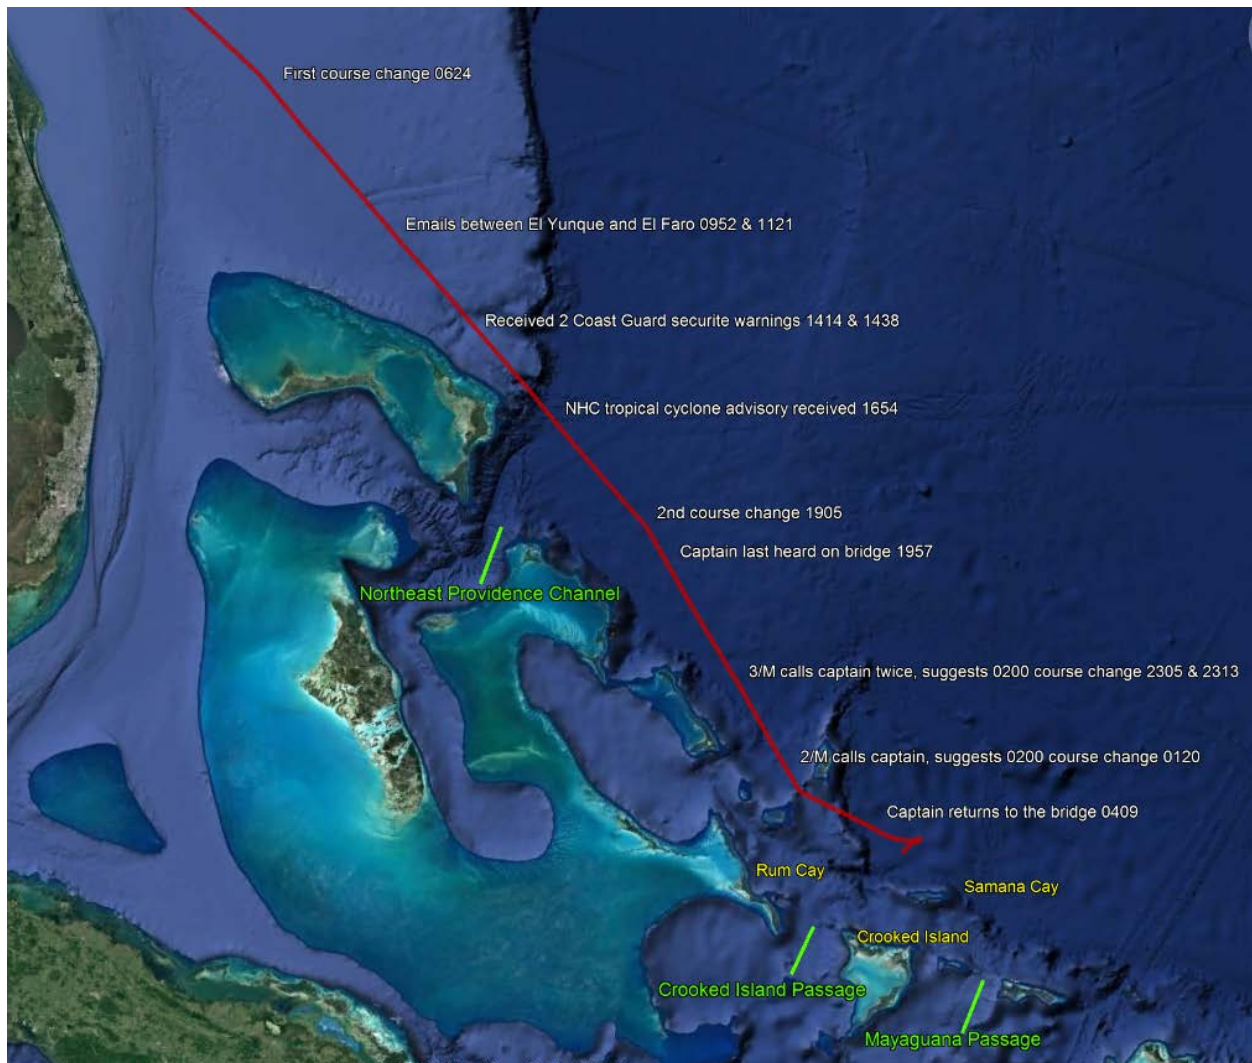
Figure 66. Significant opportunities for decision-making.

While the captain could have taken action at any time, there were several significant points along the accident route where the captain was provided with new information that gave him opportunities to adjust course and avoid heading into the storm (see figure 66). At 0624 on September 30, after reviewing the latest weather data from BVS, which showed the storm tracking west-southwest, the captain and chief mate decided to alter the vessel's path slightly southward. The captain described the course change as a "good little diversion" and suggested that Joaquin was not serious enough to warrant what the chief mate described as more "drastic" evasive action.
