Sinking of US Cargo Vessel SS *El Faro*
Atlantic Ocean, Northeast of Acklins and Crooked Island,
Bahamas
October 1, 2015

NTSB/MAR-17/01
PB2018-100342

Marine Accident Report

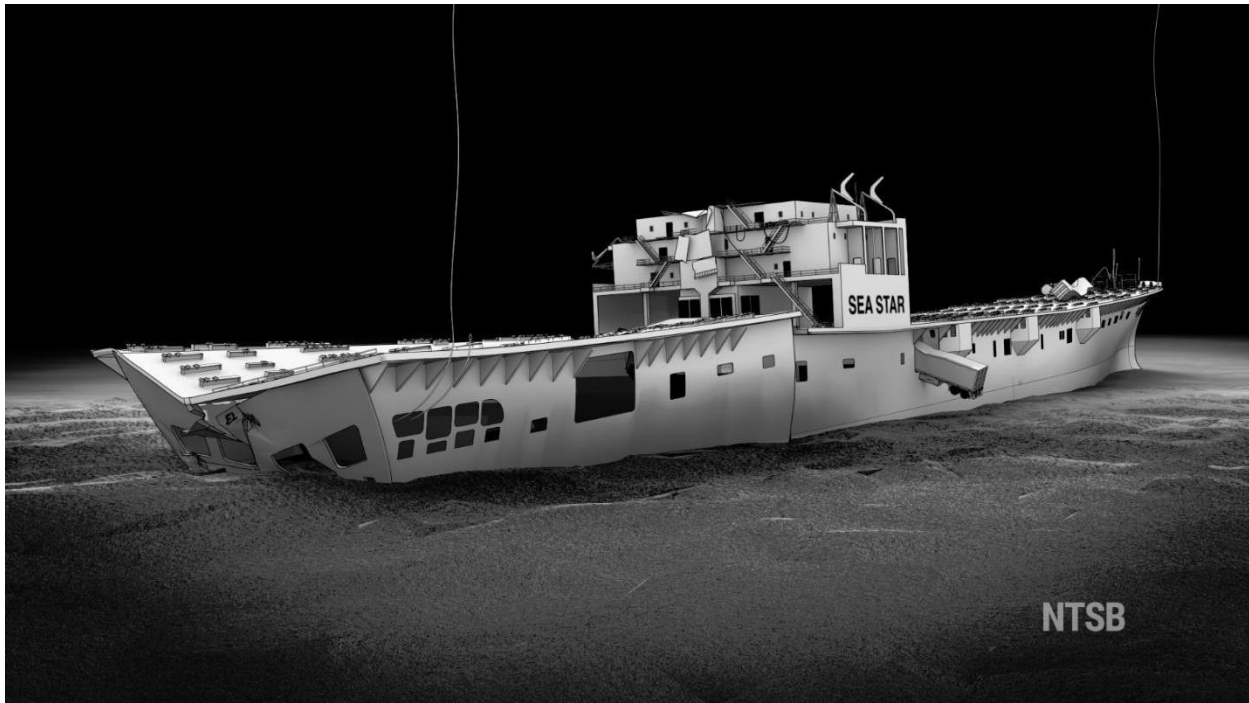
Figure 2. Artist's rendering of *El Faro* hull lying on seabed 15,400 feet below surface of Atlantic Ocean.⁴

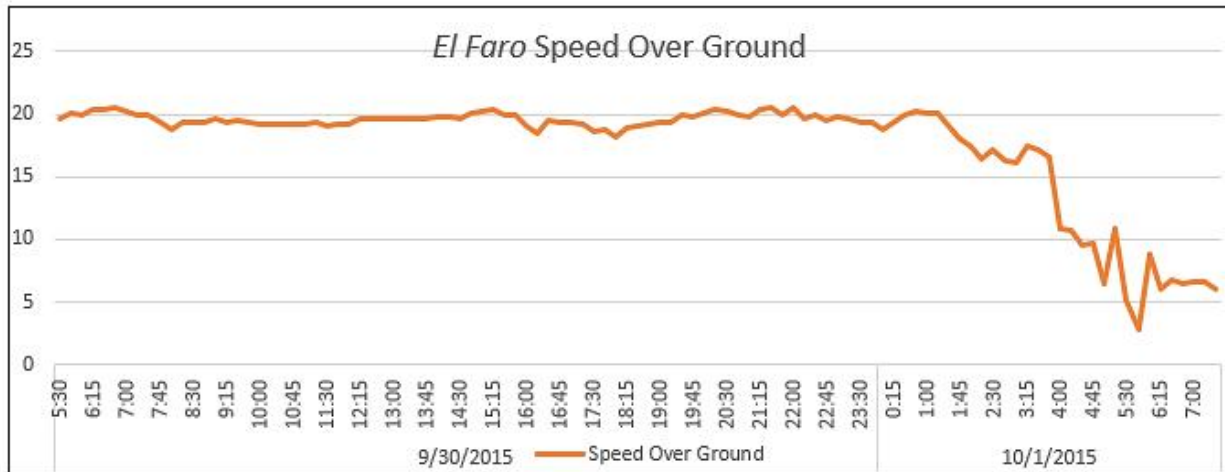
Figure 7 plots the ship’s speed over ground, which is the ship’s motion relative to the earth’s surface, as measured by GPS. The VDR recorded this information from the morning of September 30 to the time of the sinking. On October 1, as shown in the figure, the ship’s speed over ground slowly decreased after 0100, then dropped precipitously about 0400.

Figure 7. Vessel’s speed over ground from 0530 on September 30 until sinking. (Based on VDR parametric data)

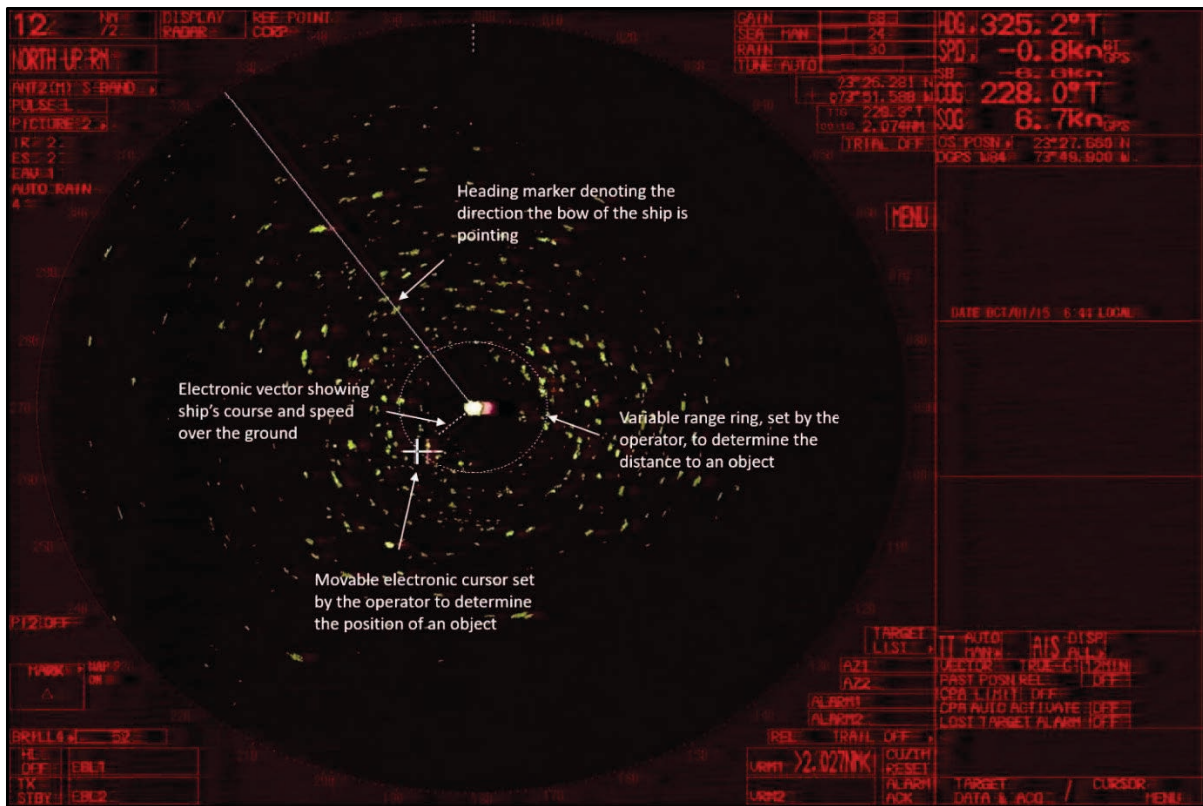
At 0644, the captain told the AB on watch, “You got some turns right now,” meaning that propulsion seemed to have returned. The radar image in figure 8, obtained from the VDR, shows that *El Faro*’s bow was headed northwest but that the ship was actually traveling southwest, at a speed (in relation to the ground) of 6.7 knots—that is, it was being pushed sideways by the wind and waves, nearly perpendicular to its original course before losing propulsion.

Figure 8. Radar image from 0644 on October 1 showing *El Faro* heading (bow direction) northwest (325.2°) but moving southwest (228°).

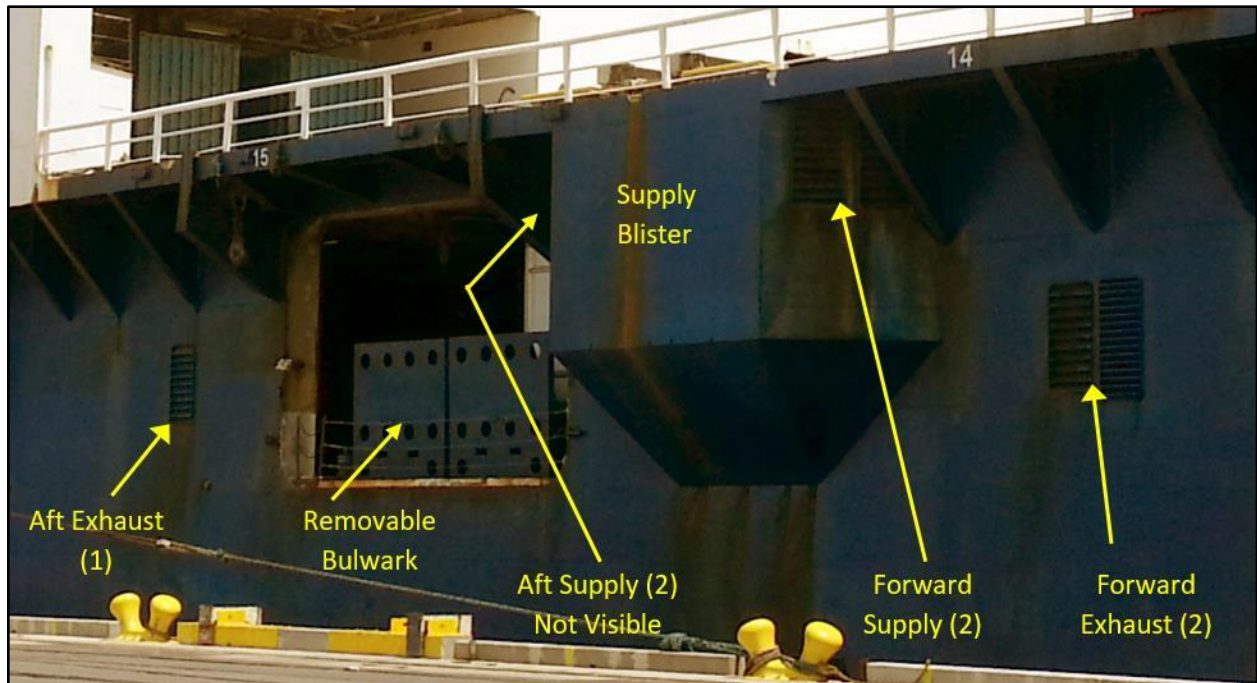
Figure 10. Starboard side of *El Faro* showing supply and exhaust ventilation openings to cargo hold 3. (Photo by Herbert Engineering)

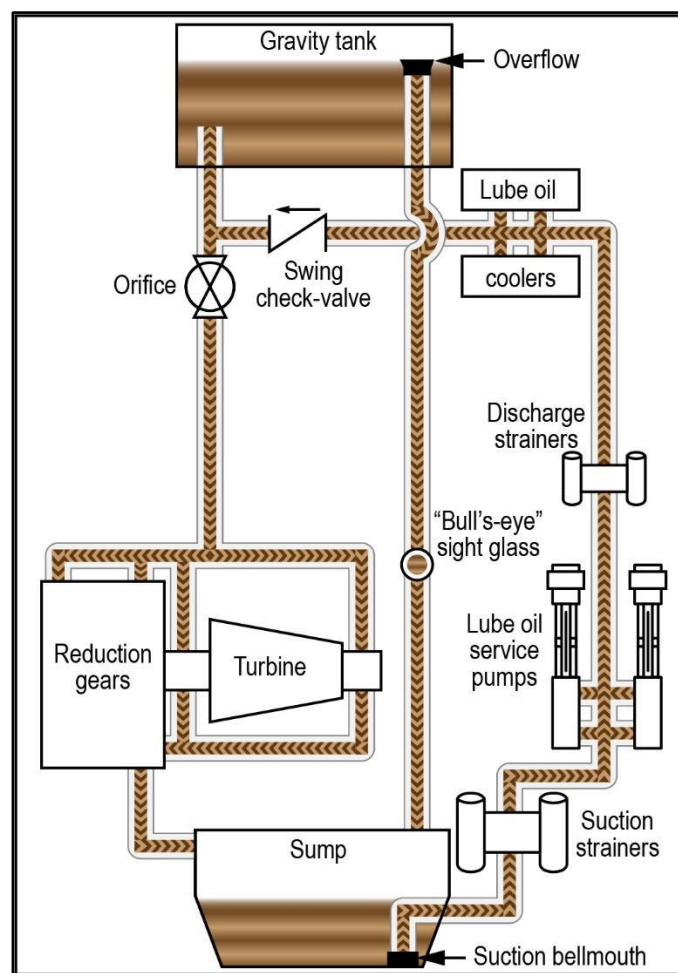
Lubricating Oil. According to the 1973 ABS rules for building and classing steel vessels, the lubricating oil system of the main engine was “to be so arranged that it will function satisfactorily when the vessel is permanently inclined to an angle of 15 degrees athwartship and 5 degrees fore and aft.” The Coast Guard had no rules for main engine or lube oil operation angles when the vessel was built (or when it was lengthened in 1993). *El Faro*’s lubricating oil system is diagrammed in figure 11. Because the suction for the lubricating oil service pump was located in the starboard, aft section of the sump, a port list with a forward trim would be the worst-case scenario for exposing the suction bellmouth, which could result in a loss of lubricating oil to the main engine.

Figure 11. Schematic of *El Faro*’s lubricating oil system, showing component parts and direction of oil flow.

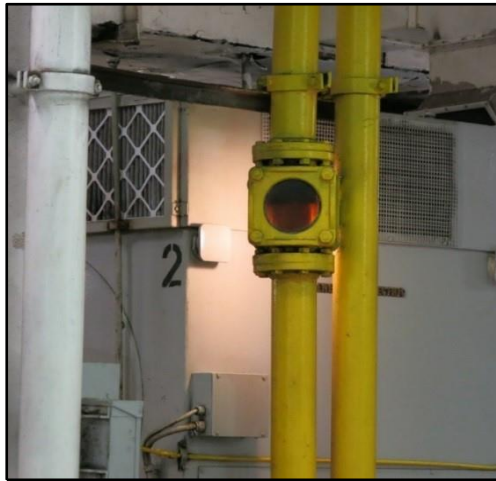
From the engine room, overflowing oil, indicating proper operation of the lube oil service pumps, could be monitored through an illuminated port (“bull’s-eye”) in the supply line that returned oil to the sump (figure 12). An engineer who had served aboard TOTE’s *Ponce*-class vessels (last in 2012) told the third marine board that in rough weather, flow in the bull’s-eye might be interrupted by sloshing oil in the gravity tank. In the event of a pressure loss, about 8 minutes

Figure 12. Bull's-eye for monitoring lube oil flow from gravity tank. (Photo from *El Yunque*)

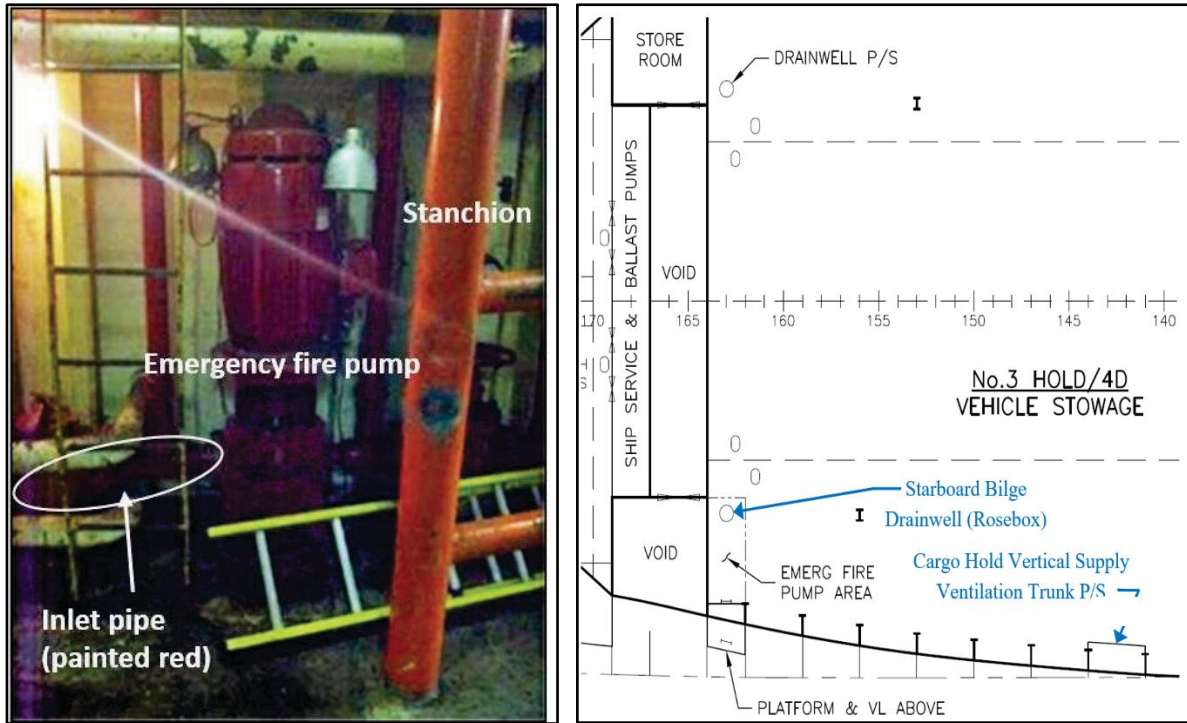
Figure 13. Emergency fire pump. Photo shows emergency fire pump (center rear) in *El Faro*'s hold 3 (photo by Maine Maritime Academy cadet). Diagram, from general arrangement drawing, shows emergency fire pump location in hold 3, fourth deck (VL = vertical ladder).

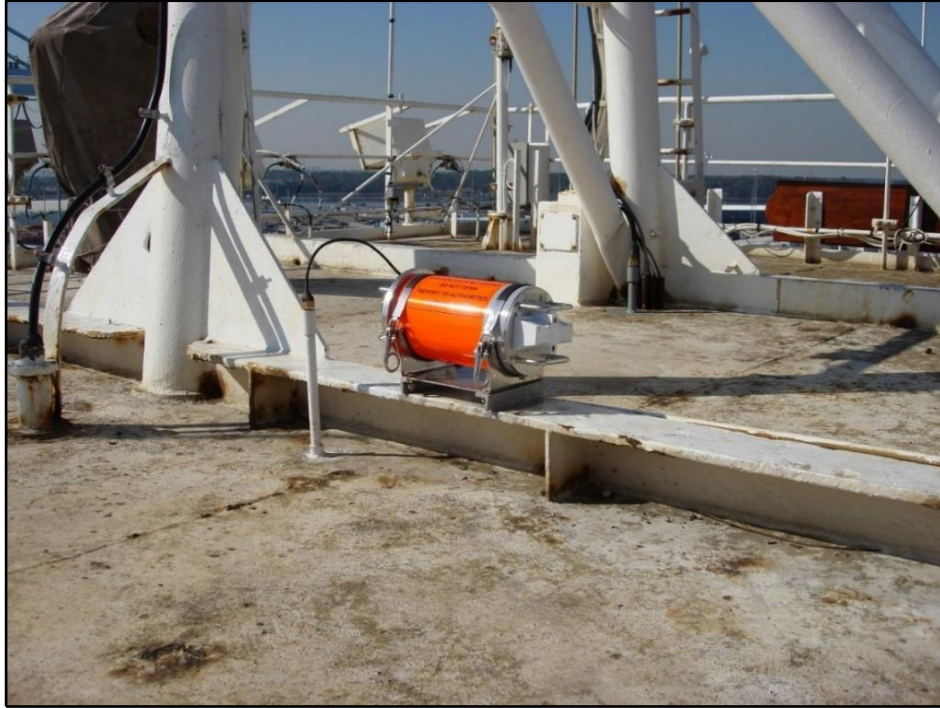
Figure 15. VDR capsule on deck above *El Faro*'s navigation bridge. (Radio Holland photo⁸⁰)

Voyage Data Recorder. As required, *El Faro* was equipped with a simplified VDR (S-VDR) that was installed in January and February 2009.⁷⁸ The device was a Northrop Grumman Sperry Marine Voyage Master II, manufactured by Danelec Marine (Birkerød, Denmark). The VDR capsule was attached to a steel channel at the base of the antenna mast on the deck above the bridge (figure 15).

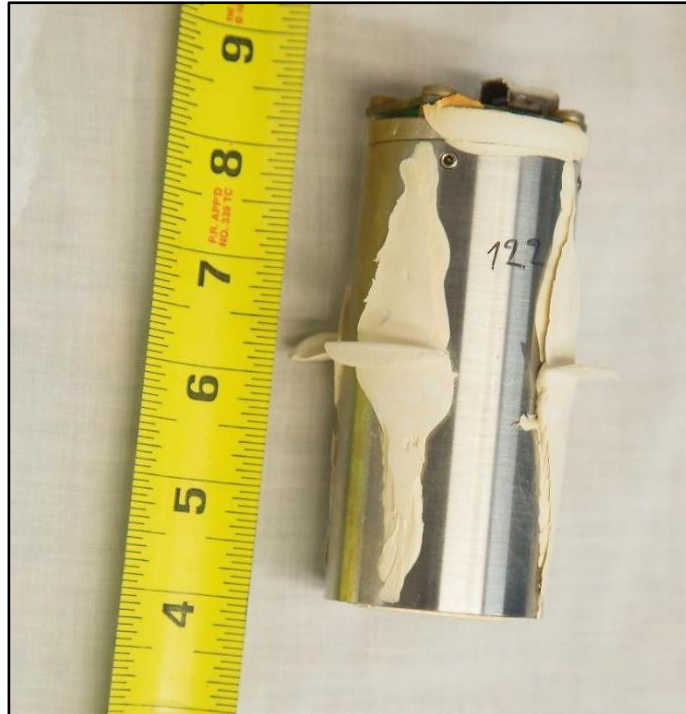
Figure 16. Inner VDR capsule assembly after removal from outer capsule.

The VDR data were stored on a flash memory chip inside a protective capsule. On August 8, 2016, after the capsule was recovered from *El Faro*'s wreckage, it was submerged in a bath of distilled water aboard the Navy vessel *Apache*, then disassembled and inspected for possible damage to the internal recording medium. Inside the capsule, layers of protective materials housed an inner capsule containing the circuit board assembly that stored the nonvolatile memory (figure 16).⁸² The circuit board assembly was inspected for visible signs of damage or corrosion (figure 17) before being transported to the NTSB laboratory in Washington, DC, on August 12.

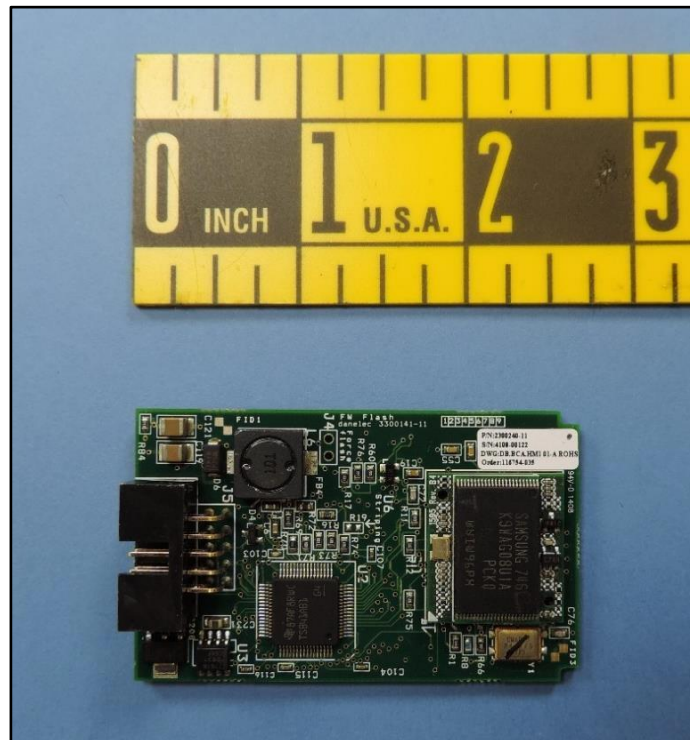
Figure 17. Circuit board assembly from inner VDR capsule.

On August 15, 2016, at the NTSB laboratory, the circuit board assembly from the inner VDR capsule was connected to a functioning surrogate assembly, provided by Danelec. The manufacturer provided technical support and witnessed downloading of the VDR data. A forensic write-blocking bridge was used to copy data from the circuit board assembly.⁸³ Using manufacturer-provided VDR playback software, the data were exported to a common data file structure for further analysis.⁸⁴

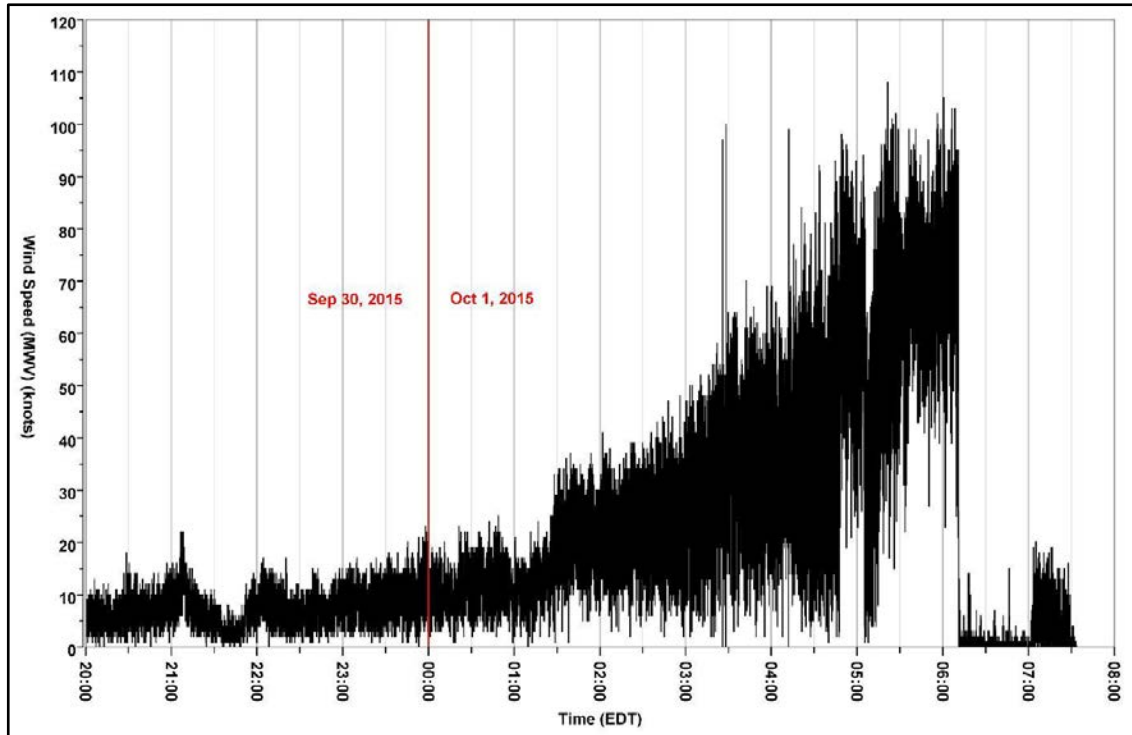
Figure 18. Raw VDR wind speed data, from 2000 September 30 to data loss.

The vessel's anemometer displayed wind data on the bridge. Wind speed and direction were recorded by the VDR.⁹¹ Figure 18 shows raw wind speed data captured by the VDR from 2000 on September 30 until the sinking. Throughout the VDR recording, however, over 99 percent of the anemometer data samples indicated a relative wind direction of between 180° and 193°. On the VDR recording, *El Faro*'s captain, chief mate, and second mate questioned the reliability of the wind speed and stated that the wind direction was "not good" and that "we don't have (any) anemometer."

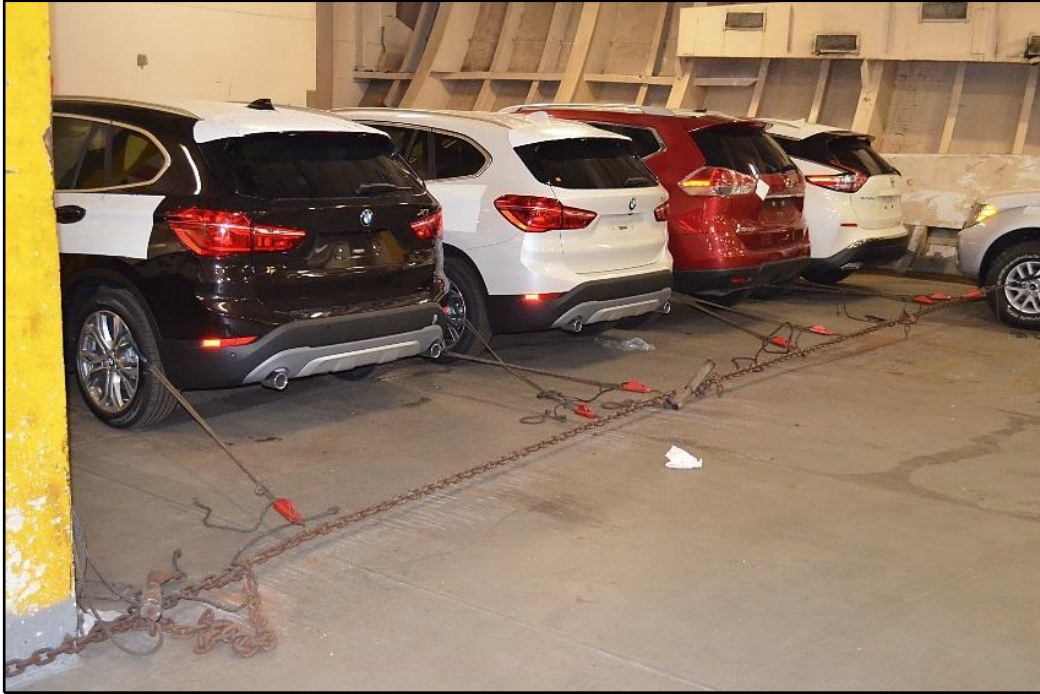
Automobiles, considered semistandardized cargo, were to be lashed using portable securing devices consisting of fiber rope or nylon strapping attached to steel tensioners that were fitted with hooks at both ends. Four lashings were to be run, one from each corner of a vehicle, to the fixed D-rings or cloverleaves on the deck (figure 21). A variation of that securing arrangement, not included in the cargo-securing manual, was to run lashings from the four corners of the automobile to a long chain. The long chain ran across the width of the ship and was secured to D-rings at either end. Some of the chains passed through a D-ring before being secured to additional D-rings at each end. A lashing variation observed on *El Yunque* in October 2015 is shown in figure 22. One of the longshoremen who had lashed the automobiles on *El Faro* before the accident voyage testified when shown a photo of the lashings on *El Yunque* that they had used that arrangement on *El Faro*.

Figure 22. Two automobiles lashed to one length of chain. (Photo from hold 5 of *El Yunque*)

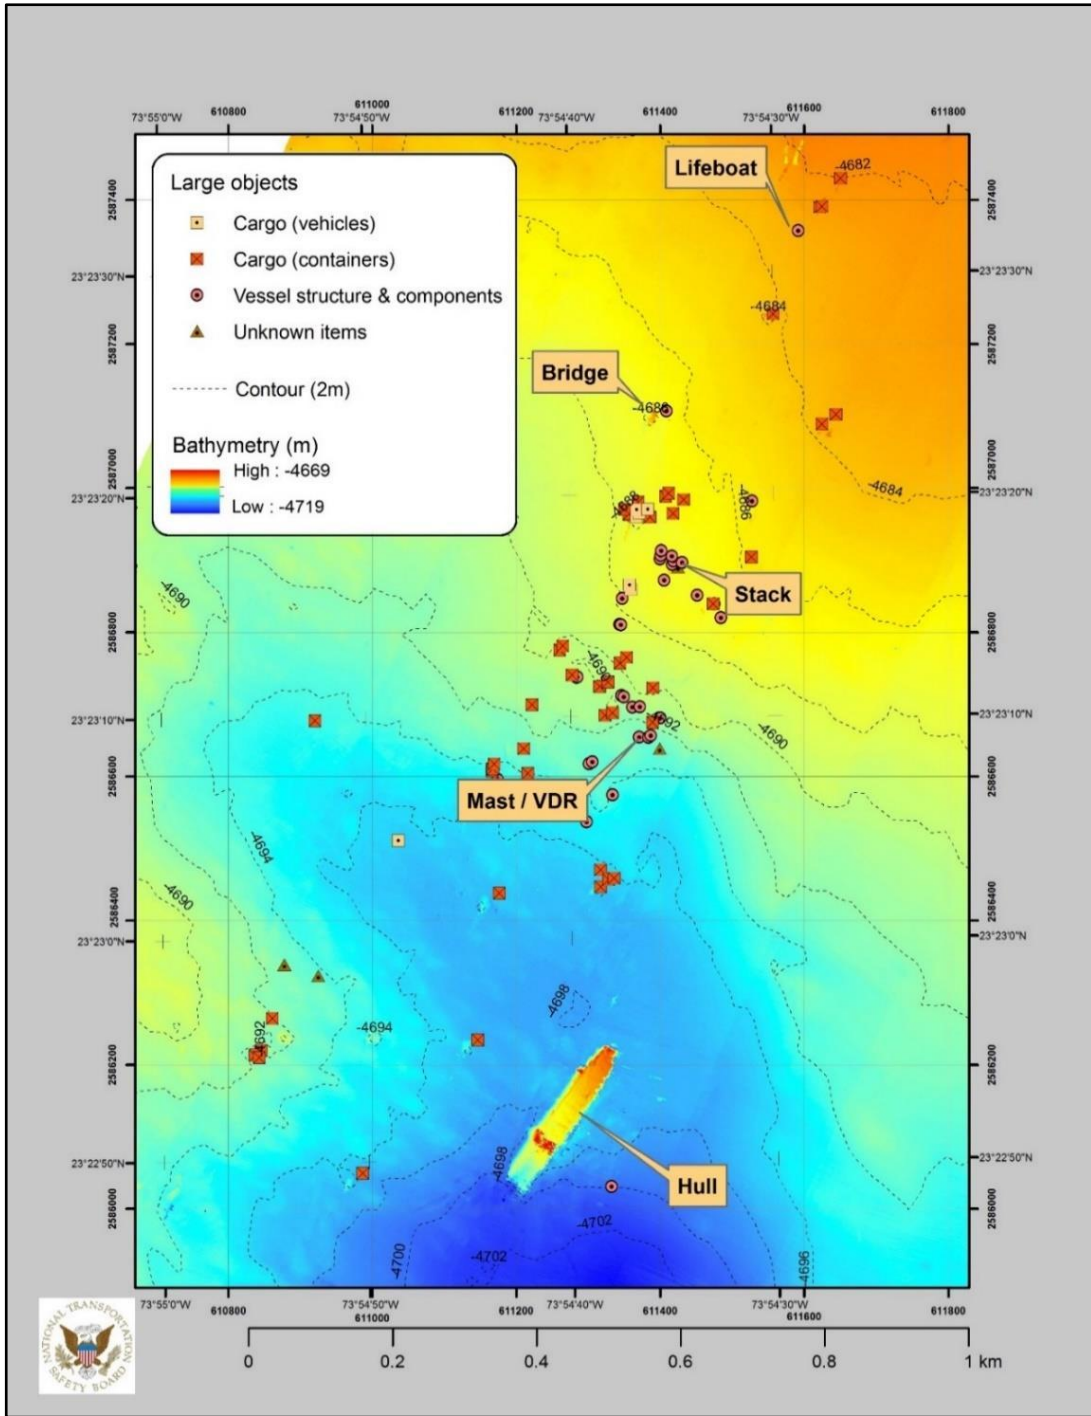
The wreckage of *El Faro* lies at a depth of between 15,318 and 15,482 feet (4,719 to 4,669 meters) in the Atlantic Ocean, about 20 nm northeast of Samana Cay. The primary underwater debris field, which includes the main hull and ship structure, covers an area of about 0.7 square mile (1.8 square kilometers) between latitudes 23.3786N and 23.3936N and longitudes 73.9061W and 73.9172W. Cargo containers, other cargo items, and some ship's equipment and rails were found outside the primary debris field. Inside the primary field were the remains of *El Faro*'s port lifeboat; some of its cargo (about 40 containers and 7 vehicles); the main hull and the structures that separated from it, including the mast (with attached VDR), the exhaust stack, the bridge and the deck below it; and a few unidentified items. Figure 23 is a bathymetric (topographic) map of the seafloor showing the location of the main objects discovered.

Figure 23. Map of *El Faro* debris field showing large objects. Bathymetry from multibeam-sonar site survey, April 2016.

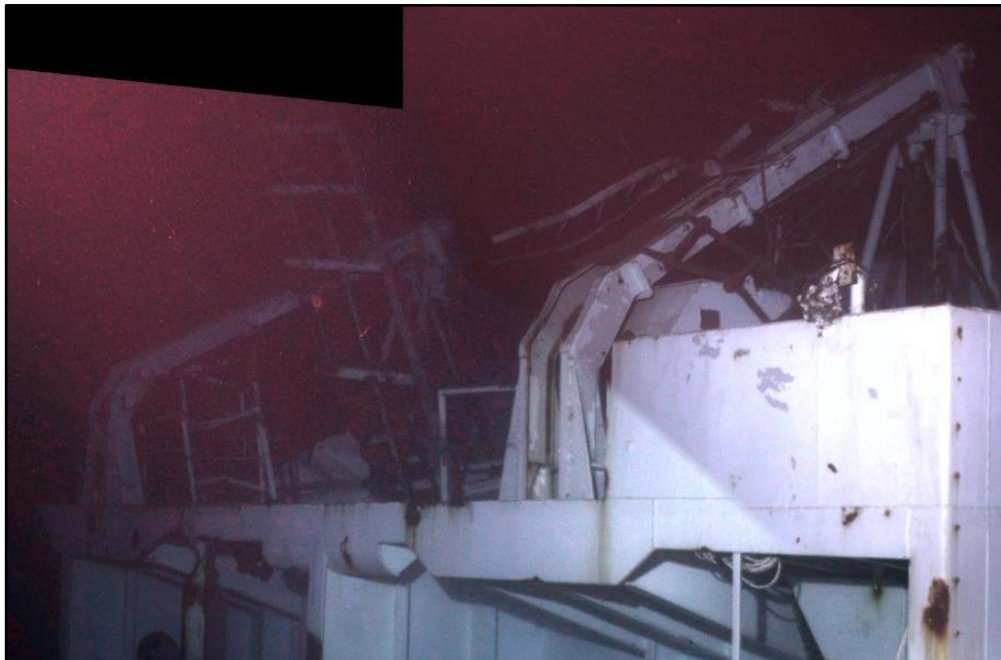
The gravity davits (cranelike devices for lowering boats into the water) for the starboard lifeboat were discovered intact during the second mission (figure 25). The arm for the forward davit was displaced and resting on the deck, but the arm's cable was still attached to the track. The gravity davits for the port lifeboat showed greater damage, with the aft track and davit broken and hanging (figure 26).

Figure 25. Intact gravity davits for starboard lifeboat, with forward davit in foreground. (Photomosaic image from mission 2)

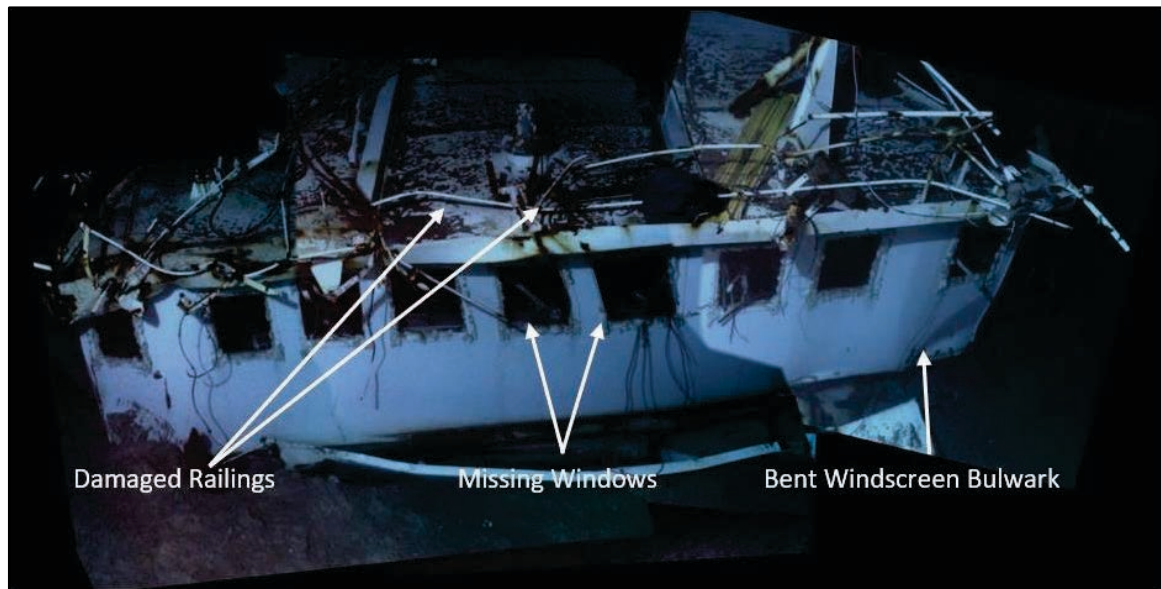
The navigation bridge and bridge deck that had been discovered during the first mission were further explored during mission 2. The photomosaic image in figure 27 shows that all windows on the forward side of the bridge were missing; that the windscreen bulwark was bent forward; and that the top railings were missing, severely bent, or broken. The starboard forward corner of the wreckage had settled deeper into the seabed than the other corners.

Figure 27. Bridge and bridge deck, looking aft. (Photomosaic image from mission 2)

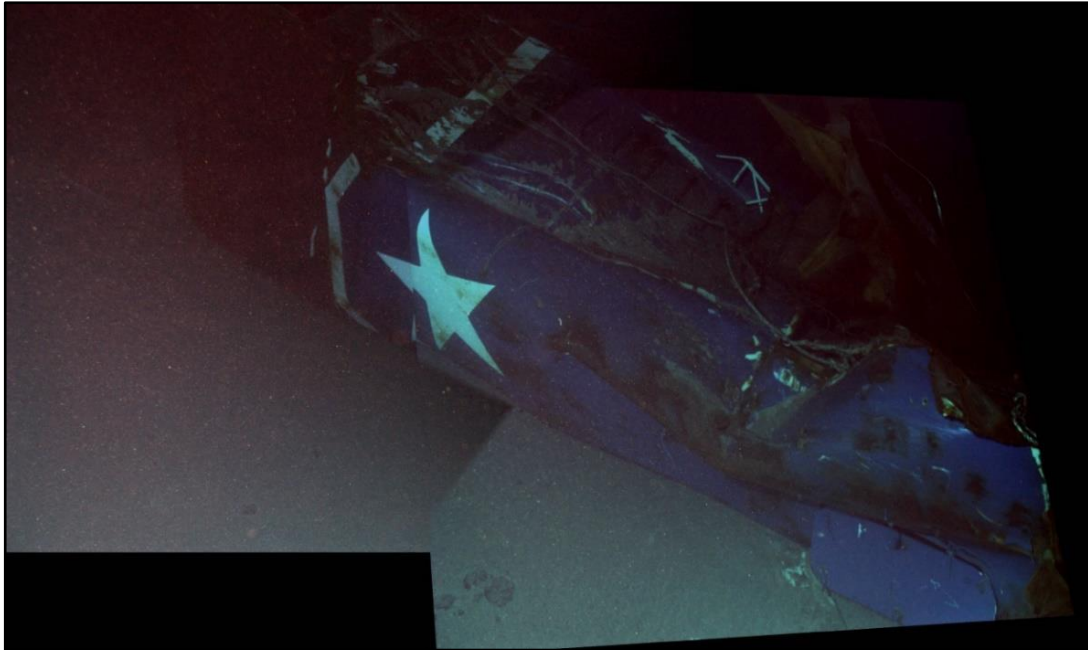
El Faro's exhaust stack was discovered during the second mission about 2,625 feet (0.43 nm) north of the main hull (figure 28). It was largely intact, though the forward face was missing its steel plating and the stack was scratched, dented, and deflected inward. The boiler uptake funnel was missing from the top of the stack.

Figure 28. Exhaust stack lying on seafloor, Sea Star (company) symbol clearly visible. (Photomosaic image from mission 2)

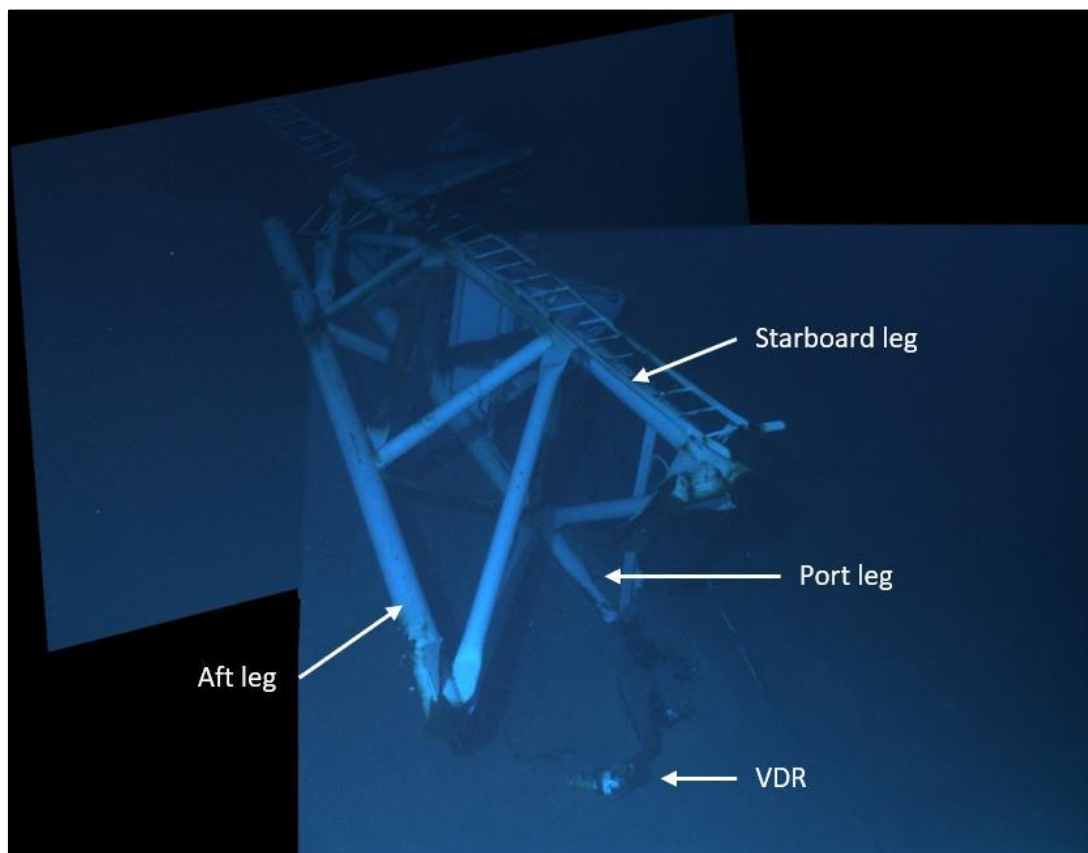
The tripod mast and VDR capsule were discovered on the seafloor about 1,640 feet (0.28 nm) north of the main hull (figure 29). The large structural members were intact, but the overall structure was bent aft. The VDR was attached to the port leg and buried in mud.

Figure 29. Mast and VDR capsule on seafloor. (Photomosaic image from mission 2)

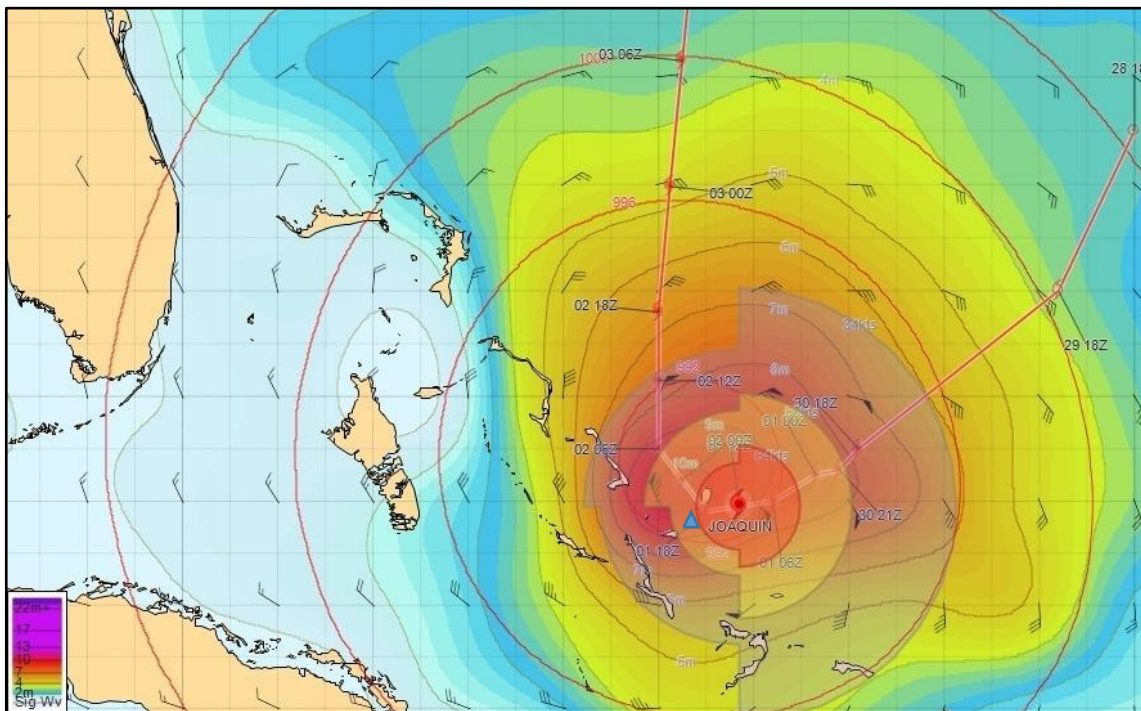
The VDR transcript captures discussions on *El Faro*'s bridge about images from the BVS weather files. Figure 40 illustrates what the *El Faro* captain and other crewmembers could have seen when using the BVS files. The image is a screenshot from the BVS weather file emailed to *El Faro* about 2300 on September 30 but not downloaded by the captain until 0445 the next morning. The image shows Joaquin's center position and wind fields forecast as valid for 0800 on October 1 (shortly after the sinking). (For reference, the ship's position at 2300 on September 30 is shown by a small blue triangle, which would not have appeared on the actual image.)

Figure 40. Screenshot of BVS weather file sent to *El Faro* about 2300 on September 30, showing forecast valid for 0800 on October 1. Image was part of BVS file not downloaded until 0445 on October 1. Ship's position at 2300 on September 30 is shown as blue triangle for reference.

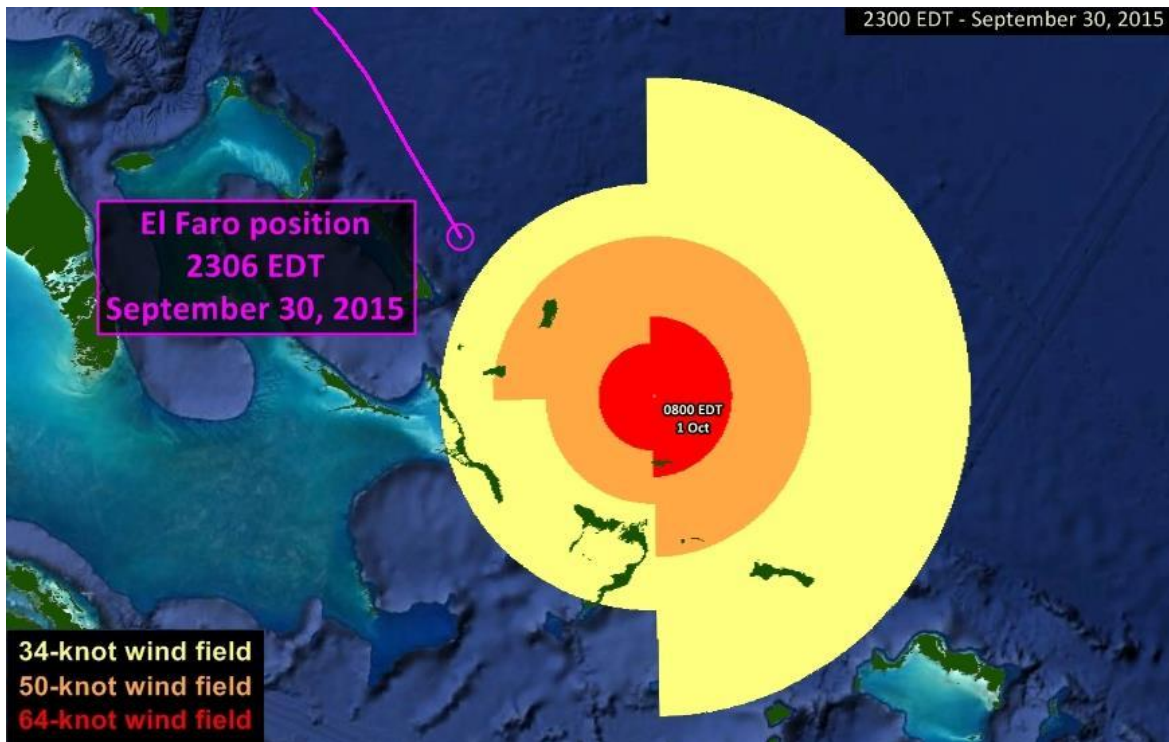
Figure 41 is a display developed by NTSB investigators of the wind fields around Joaquin forecast for 0800 on October 1, based on the tropical cyclone forecast/advisory text issued (nominally) at 2300 on September 30 (advisory No. 13). The display shows the maximum extent of the 34-knot (tropical-storm-force), 50-knot, and 64-knot (hurricane-force) wind fields for each quadrant (northwest, northeast, southeast, southwest) around Joaquin's center that were forecast for the same time.

Figure 41. Depiction of wind fields forecast for 0800 on October 1 using data from tropical cyclone forecast/advisory No. 13, issued about 2300 on September 30 and received on *El Faro's* Sat-C terminal at 2253. Figure also shows ship's position at approximate time forecast was received.

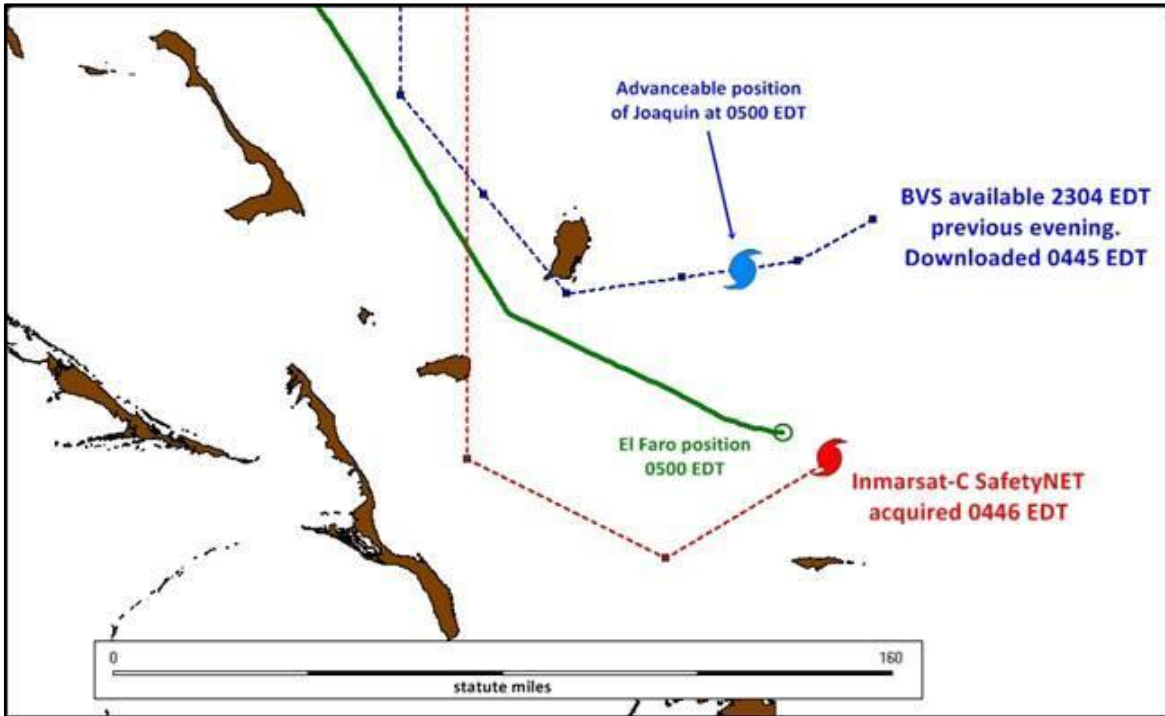
Figure 42 plots the information available to the bridge team around 0500 the morning of the accident, after the captain downloaded the previous evening's BVS file that had been available to him at 2304 and just after the new weather information delivered by Sat-C was available on the bridge (at 0446). At that point, the BVS information (blue) was almost 12 hours old (6-hour latency, as described above, plus additional time between receiving the email and downloading the data). The Inmarsat-C information was current as of 0446.

The captain stated on the VDR at 0503, "We're getting conflicting reports as to where the center of the storm is."

Figure 42. Positions of Joaquin obtained by *El Faro* and available on the bridge around 0500 on October 1. (Plotted by NTSB)

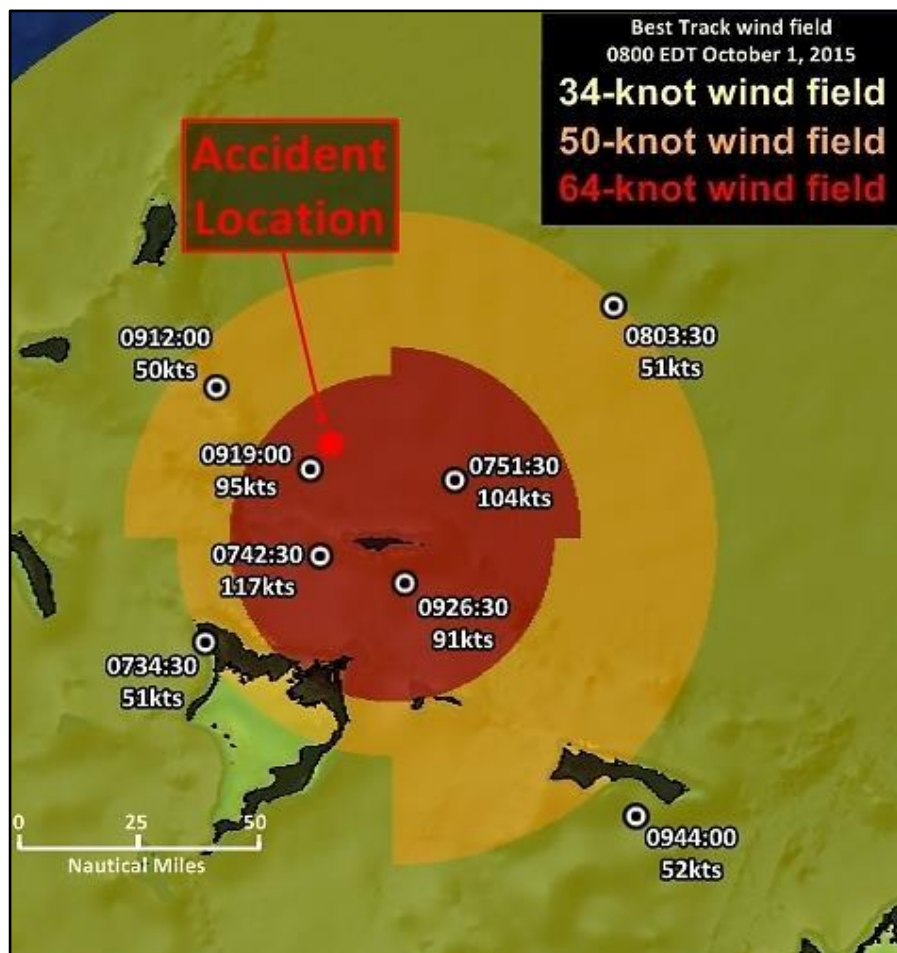
Figure 43 illustrates distances from the storm where 34-, 50-, 64-knot, and peak winds might have occurred near the accident time. Distances are based on SFMR surface wind data retrieved during a reconnaissance flight close to the time of the sinking, as well as the National Hurricane Center's poststorm best-track analysis. The best track is a poststorm, smoothed representation of a tropical cyclone's location and intensity over its lifetime (see section 1.10.5). The SFMR data are peak 10-second average observations of surface wind within a 30-second reporting interval. The red and tan areas depict the best-track estimates of the farthest extent that 50- and 64-knot winds occurred in each storm quadrant about 0800 on October 1. In the storm's northwest quadrant, the best-track analysis was that 50-knot winds extended outward as far as 50 nm from the center.

Figure 43. Surface winds from SFMR observations overlaid on best-track wind fields for 0800 on October 1. SFMR observations are labeled with midpoint of each 30-second reporting interval and average wind magnitude.

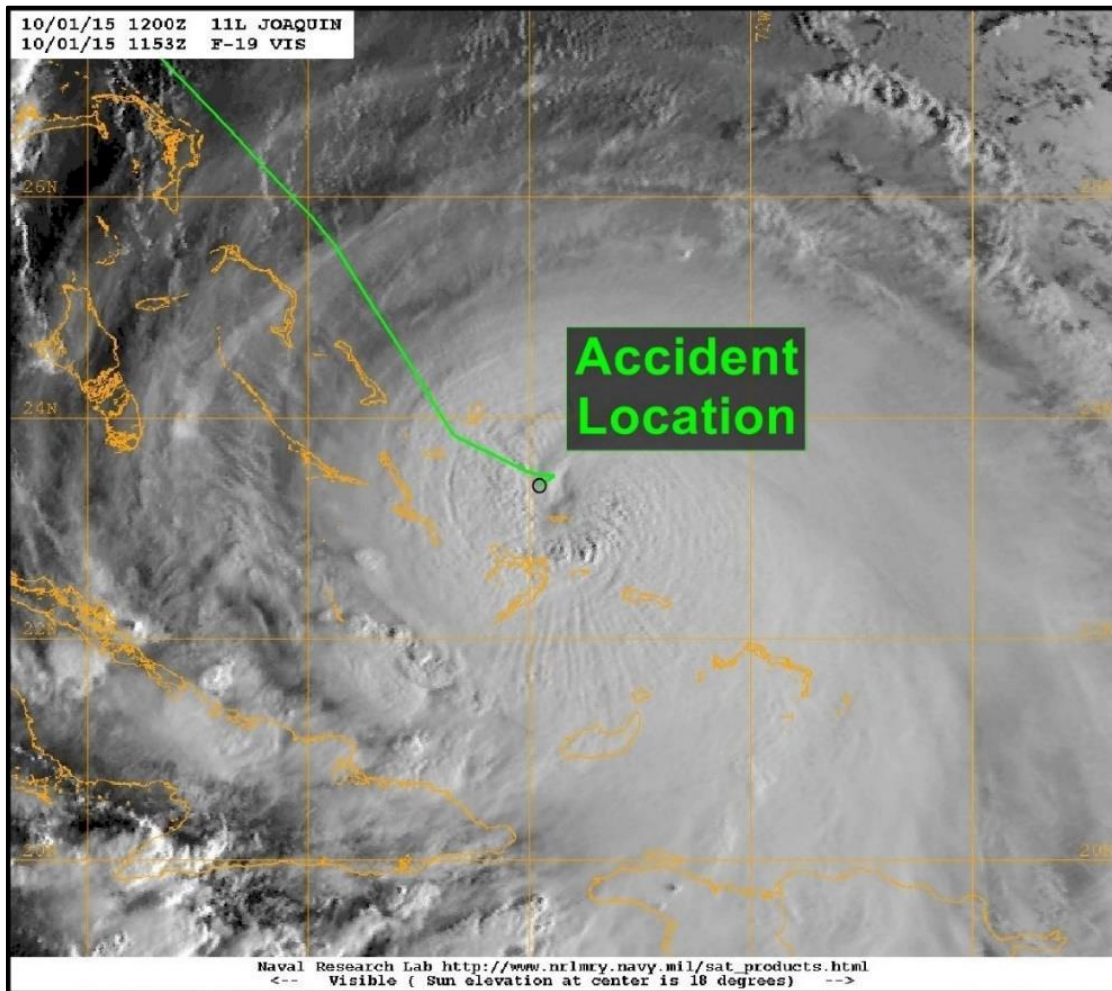
Figure 44 is an image from one of the US weather satellites that passed over the accident site around the time *El Faro* sank. The image is from visible (~0.7 micron) data captured about 0800 the morning of October 1 by the Operational Linescan System instrument on the Defense Meteorological Satellite Program (DMSP) F19 polar-orbiting weather satellite. The satellite was operated jointly by NOAA and the Air Force.

Figure 44. Visible image of Joaquin captured about 0800 on October 1 by DMSP F19 polar-orbiting weather satellite, with *El Faro*'s track superimposed in green.

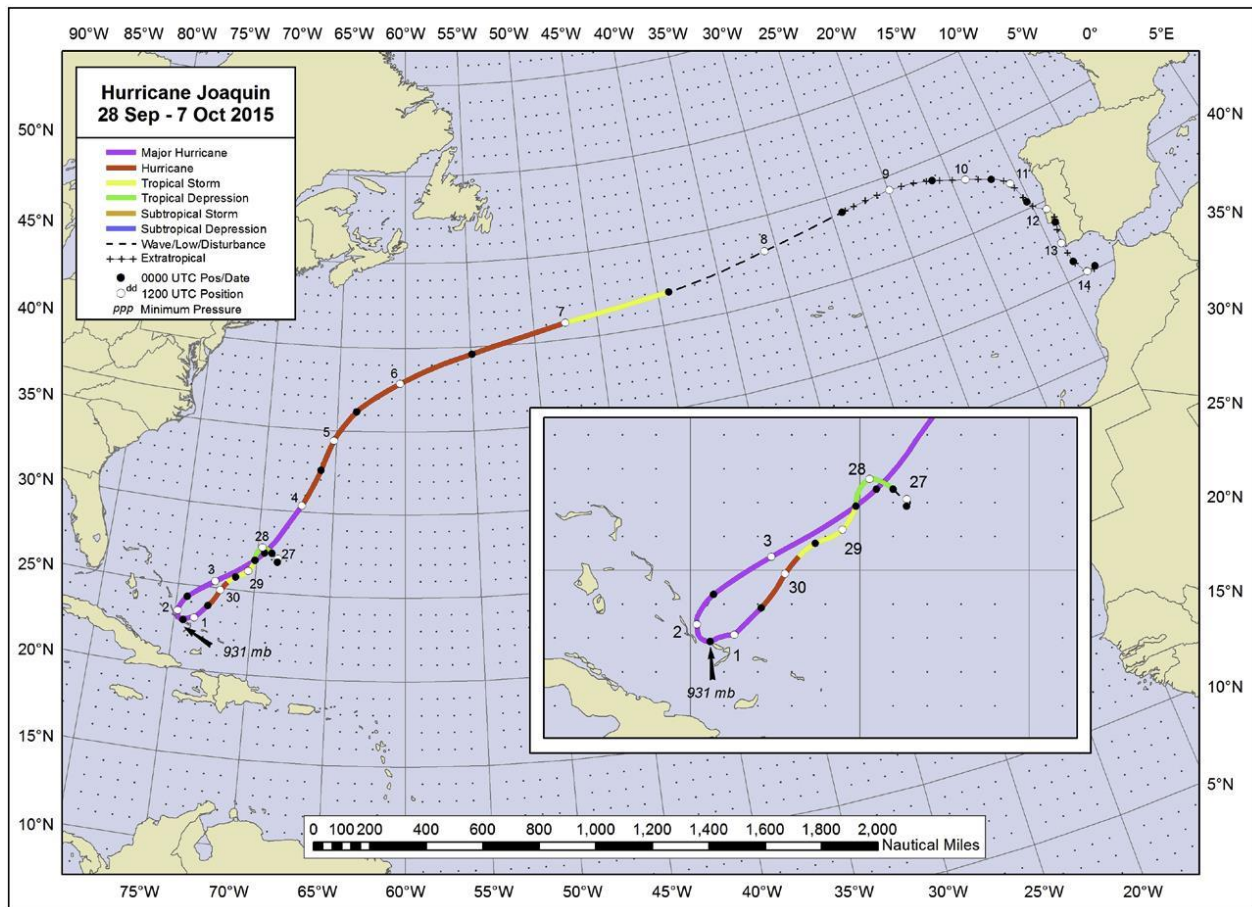
The report surveyed the meteorological environment before and during the hurricane and plotted its best-track positions, reproduced here as figure 45. The best track plots the cyclone’s latitude, longitude, maximum sustained surface winds, and minimum sea-level pressure at 6-hour intervals, ignoring short-term variations in position or intensity that cannot be resolved.

Figure 45. Best-track positions for Hurricane Joaquin. (Image from Berg 2016)
