Sinking of US Cargo Vessel SS *El Faro*
Atlantic Ocean, Northeast of Acklins and Crooked Island,
Bahamas
October 1, 2015

NTSB/MAR-17/01
PB2018-100342

Marine Accident Report

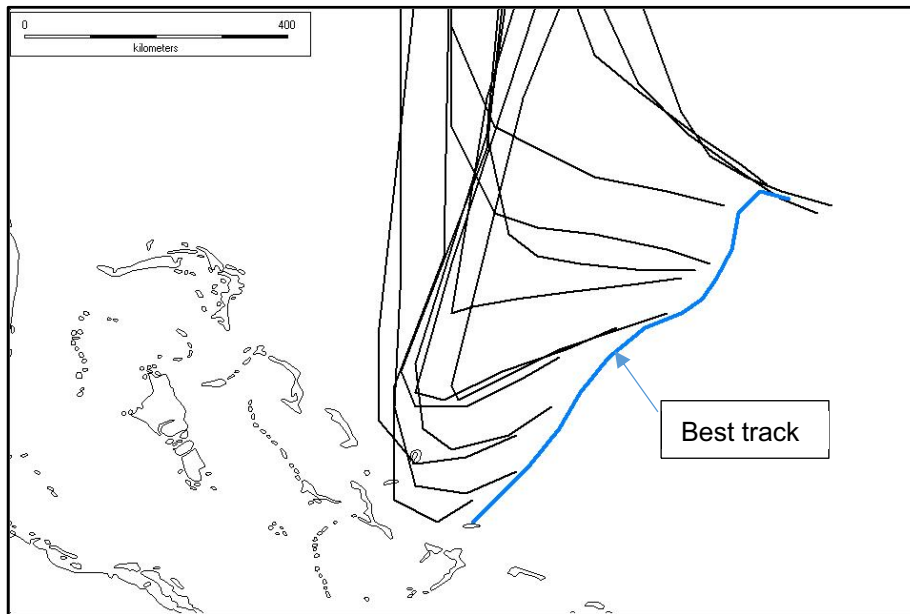
Figure 46 illustrates the hurricane center’s 5-day forecast tracks and best track for Joaquin through the morning of October 1. With regard to intensity, the National Hurricane Center’s report states, “Official forecast intensity errors were greater than the mean official errors for the previous 5-y[ea]r period at all forecast times.”

Figure 46. Official 5-day forecast tracks and best track for Hurricane Joaquin through October 1. Joaquin’s actual overall movement was south-southwest through October 1, as shown by best track (blue line). Forecast tracks (black lines) show Joaquin moving first northwest, then later west and southwest before beginning to track northward. (Lines track right to left.)

National Hurricane Center employees told investigators that Joaquin was one of its most challenging storms when it came to forecasting the storm track. In particular, the computer models had difficulty defining the cyclone’s vertical structure (system depth). According to the hurricane center, early model solutions agreed that Joaquin would remain a relatively weak system because of a strong northerly wind shear and would move northwest.¹³⁵ Contrary to the forecasts, Joaquin strengthened, became a deep system, and moved southwest.

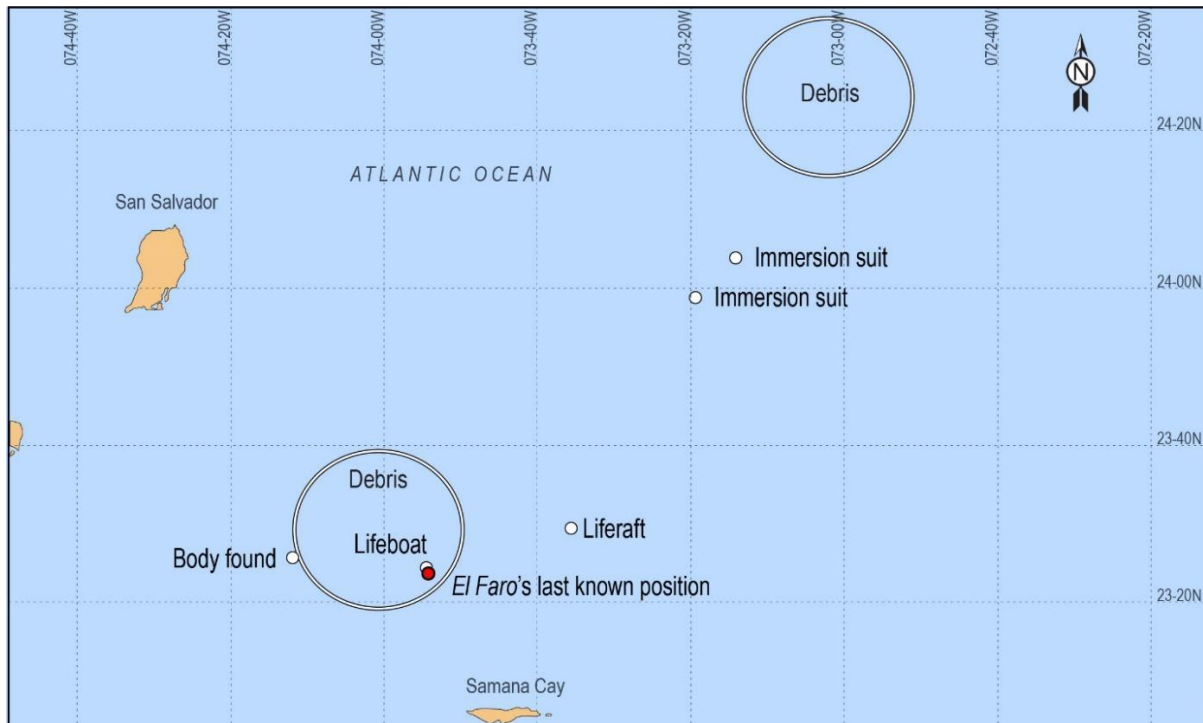
Figure 47. Two debris fields located during search-and-rescue operations and *El Faro*'s last known position from VDR data. Distance between debris fields was about 77 nm. Degrees of latitude are 60 nm apart. Distance between degrees of longitude varies with distance from equator, where it is about 60 nm. (Adapted from Coast Guard graphic)

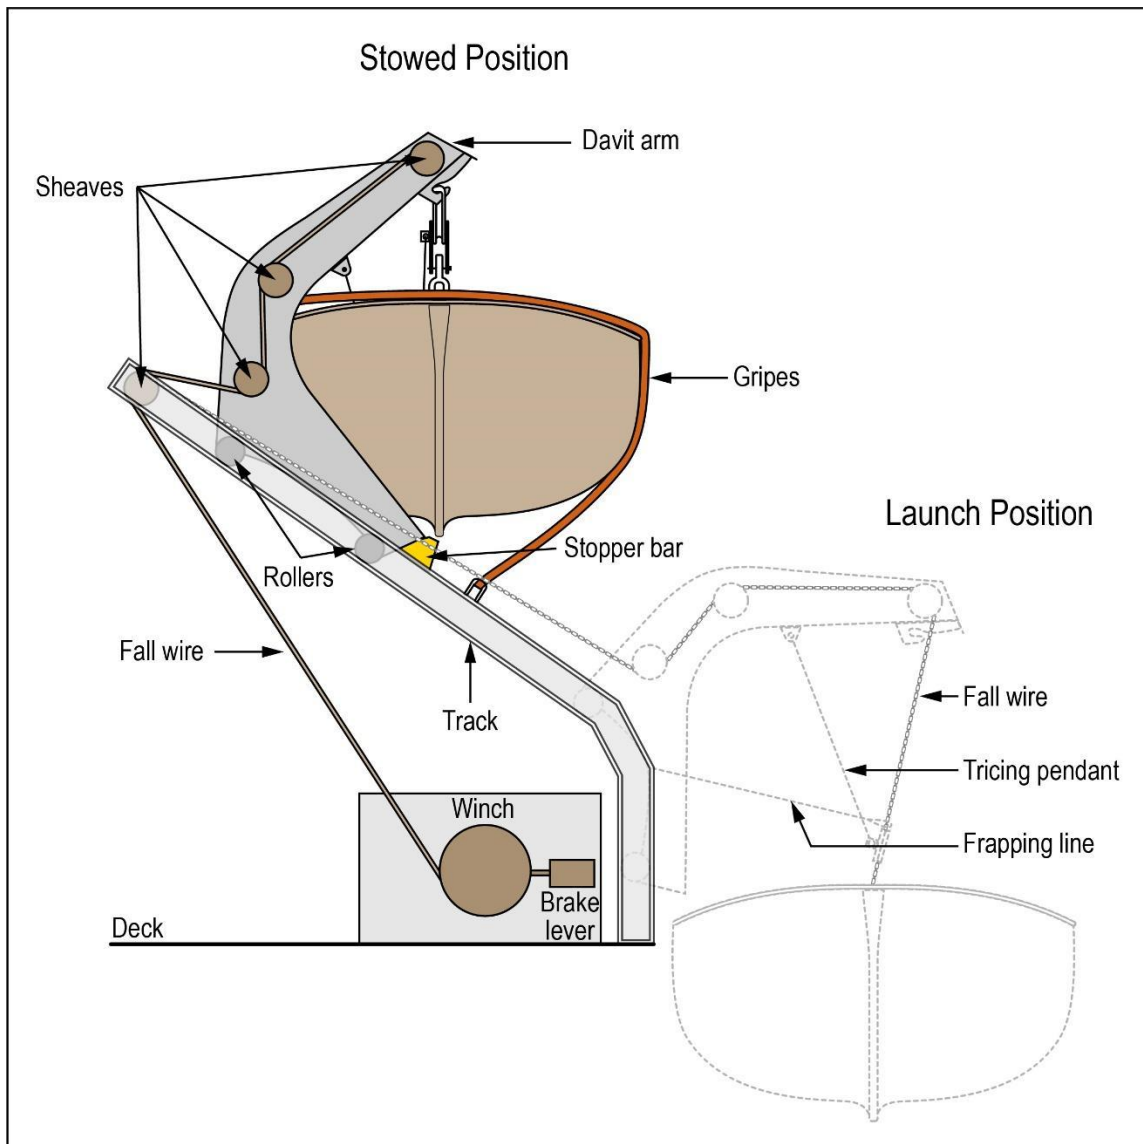
Figure 48. Gravity davit with lifeboat in stowed and launch positions.

A Harding Safety technician was aboard *El Faro* on August 4, 2015, to conduct the annual inspection of the lifeboats and associated launching appliances. The technician found the davits, winches, lifeboats, and hooks to be in operational condition and observed no major faults. The limit switches on the winch motors were inspected, tested, and found to be working properly.¹⁵² The brakes were opened and inspected, then tested by lowering an empty boat and abruptly applying the brake. The engine and hook release were tested in the water on the port lifeboat. Because the vessel was moored to starboard, the starboard lifeboat could not be lowered to the water for the hook-release test.

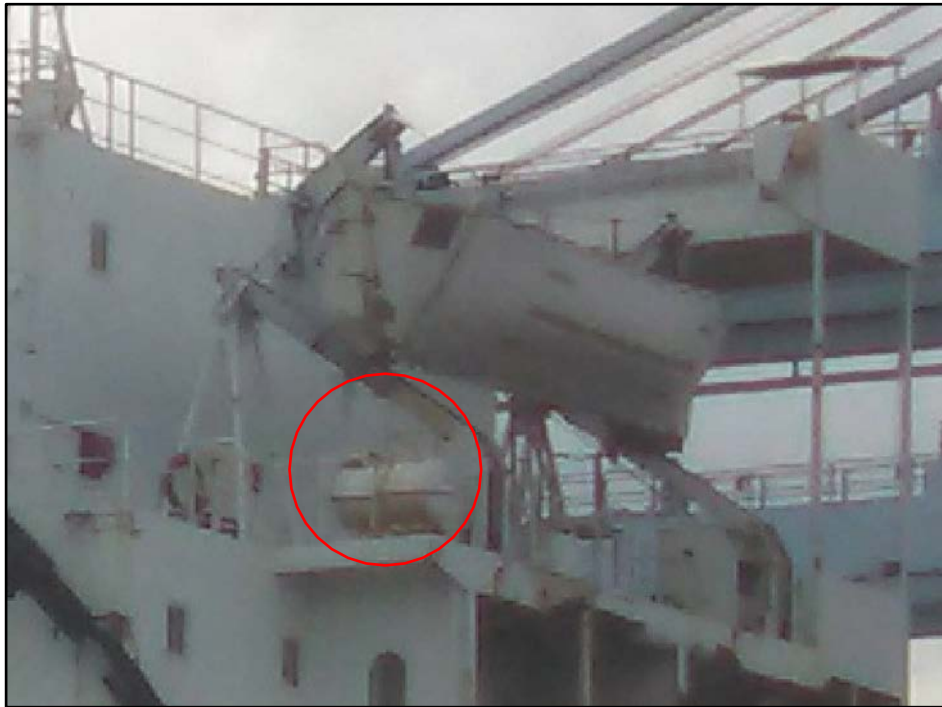
Figure 49. Location of liferaft stowed below *El Faro*'s starboard lifeboat. (Photo by Maine Maritime Academy cadet, summer 2015)

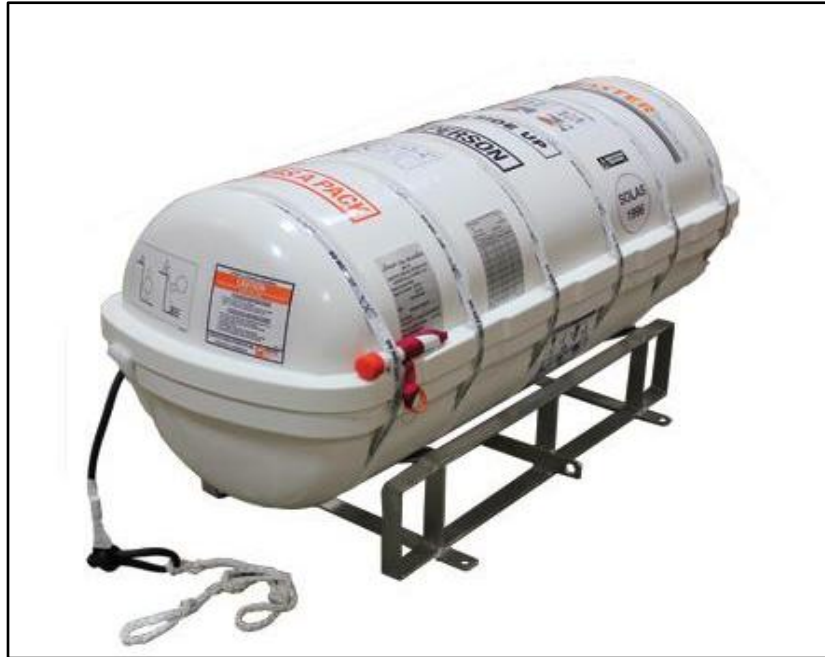
Figure 50. Type of containerized 25-person liferaft carried on *El Faro*. (Photo courtesy Survitec)

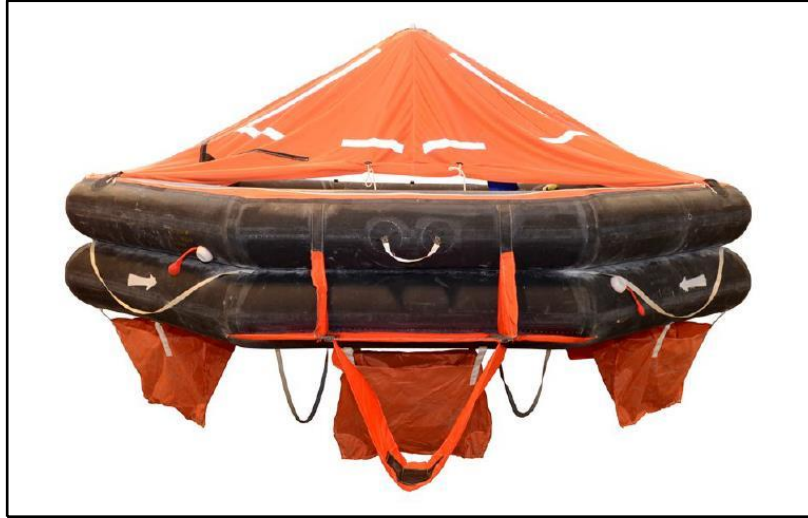
Figure 51. Inflated 25-person liferaft. (Photo courtesy VIKING Life-Saving Equipment A/S)

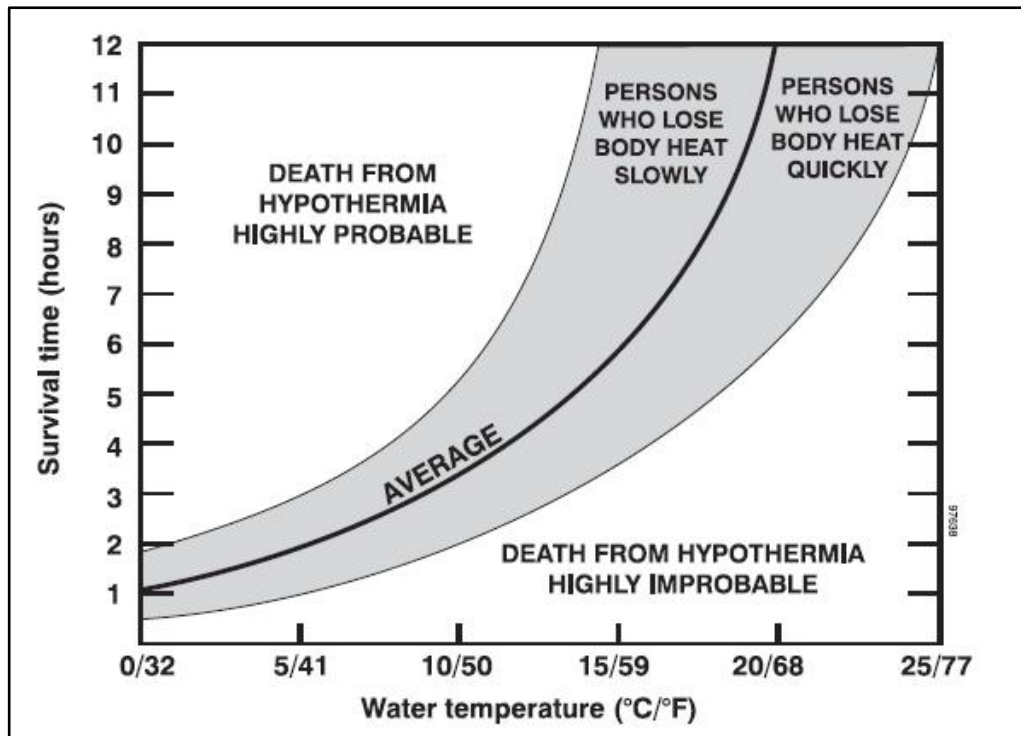
Without immersion suits, the expected survival time for a person in the water ranges from 30 to 90 minutes in cold, 32.5°F water to an indefinitely long time in warm water (above 80°F). With immersion suits, the expected survival time in cold water ranges from 2 1/2 to 5 1/2 hours, depending on whether the suit leaks or stays dry, to indefinitely long in water above 50°F. Figure 52 shows expected survival time as a function of water temperature. According to logs kept by the Coast Guard cutter *Northland*, on October 4, the water temperature in the *El Faro* search area was 85°F to 87°F.

Figure 52. Probability of death from hypothermia as a function of water temperature and time immersed in water. (Graph from IMO/ICAO 2007; reprinted by permission¹⁵⁸)

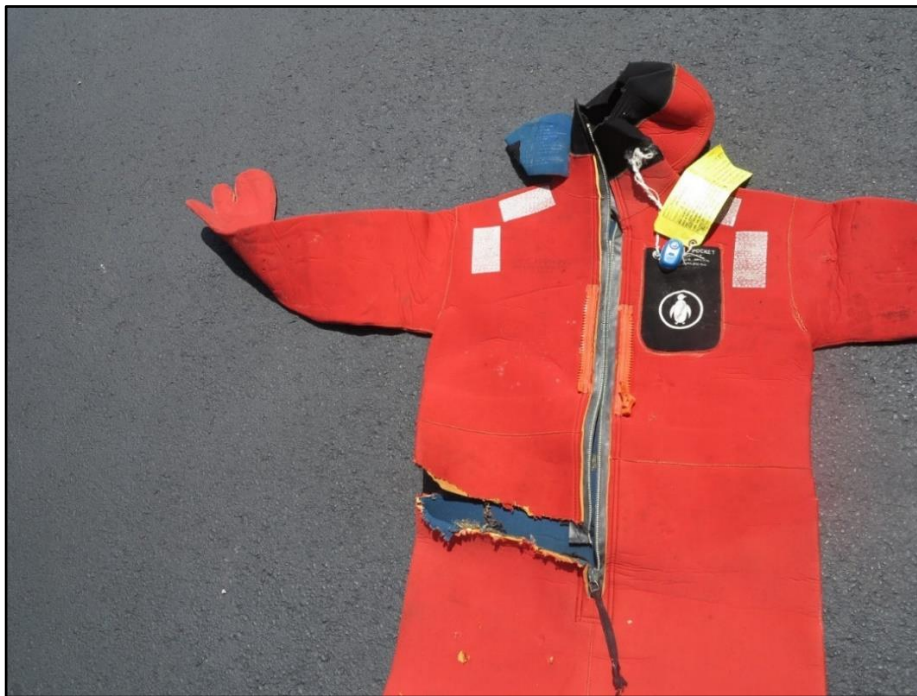
The cutter *Charles Sexton* recovered two of *El Faro*'s immersion suits after the accident. The first suit was recovered on October 6. The back was marked "S.S. El Faro San Juan, P.R." in white but appeared to have been previously marked "El Morro" in black. The second immersion suit (figure 54) was recovered on October 7. It was found with whistle and strobe light (turned off but operational); unzipped, left arm inside out, torn almost in half at right hip seam; and back marked "S.S. El Faro San Juan, P.R." in white but appeared to have been previously marked "El Morro" in black. As noted earlier, an immersion suit containing human remains was located but could not be recovered.

Figure 54. Immersion suit recovered on October 7, 2015.

According to maintenance records for June 2015, the recovered immersion suits were spare immersion suits Nos. 48 and 50. Both were last inspected and pressure-tested in July 2013 by Liferrafts Inc., of Puerto Rico, and each had a light with an expiration date of April 2016.

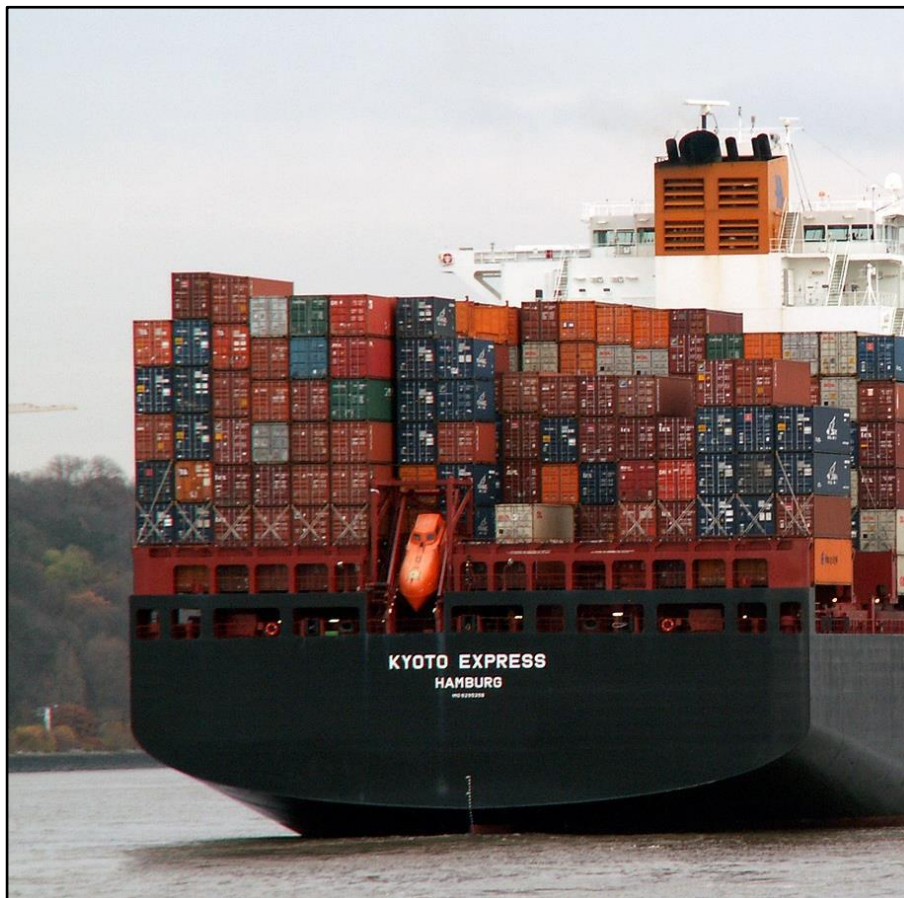
Figure 55. Stern-launched freefall lifeboat on large container ship. Orange lifeboat is shown in launch position amid stacks of containers. (Photo by Sascha Heuer; used by permission)

Stern-launched freefall lifeboats are stowed in the ready-to-launch position and require fewer steps to launch than side-launched lifeboats (Nelson et al. 1994). Only one stern-launched freefall lifeboat is required, as opposed to two conventional side-launched lifeboats. A freefall lifeboat can be launched in high seas under storm conditions because launching does not depend on the hooks and fall wires used to lower side-launched lifeboats. A freefall lifeboat can be launched by one person in about 3 minutes. Crewmembers enter the lifeboat and strap themselves in before the lifeboat is released and falls into the water. Freefall lifeboats are self-righting and,

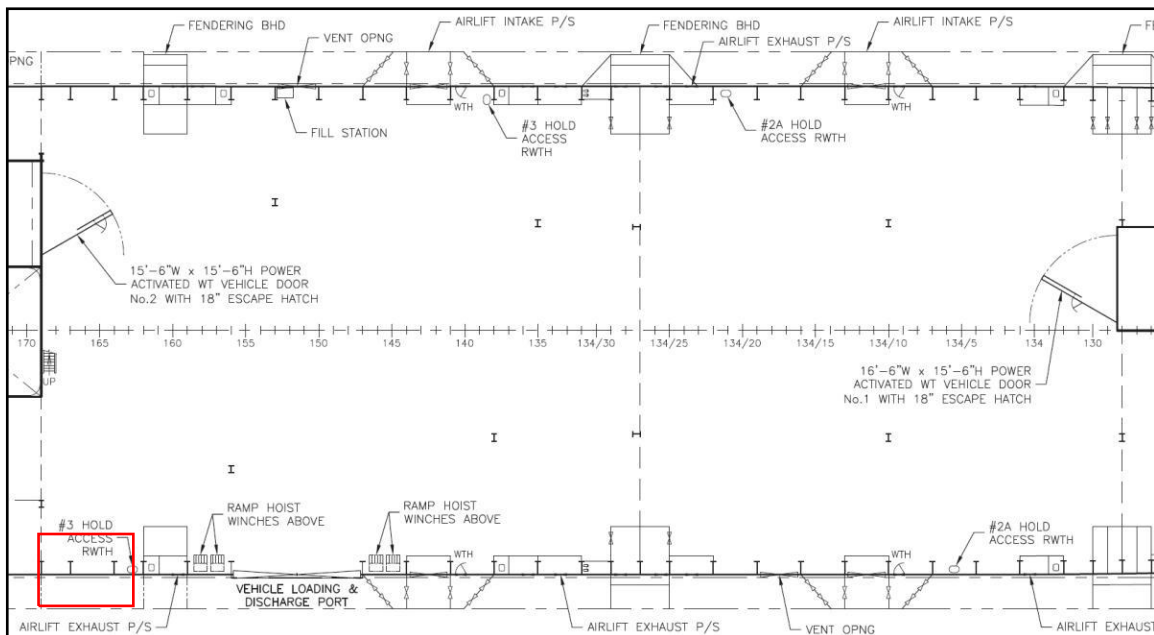
The VDR recording indicates that the vertical-access scuttle on the starboard side of the second deck that led to hold 3 was open during the accident. General arrangement drawings (such as figure 56) show that the second deck had two scuttles (called RWTHs [raised watertight hatches] on the drawings), through the second deck to hold 3, at frame 163 on the starboard side and at frame 138.5 on the port side. Hold 2A also had two such accesses. Figures 57 and 58 show the scuttle on the starboard side of the second deck to hold 3 and the scuttle on the port side to hold 2A.

Figure 56. Second deck plan showing scuttles. (Starboard scuttle to hold 3 outlined in red)

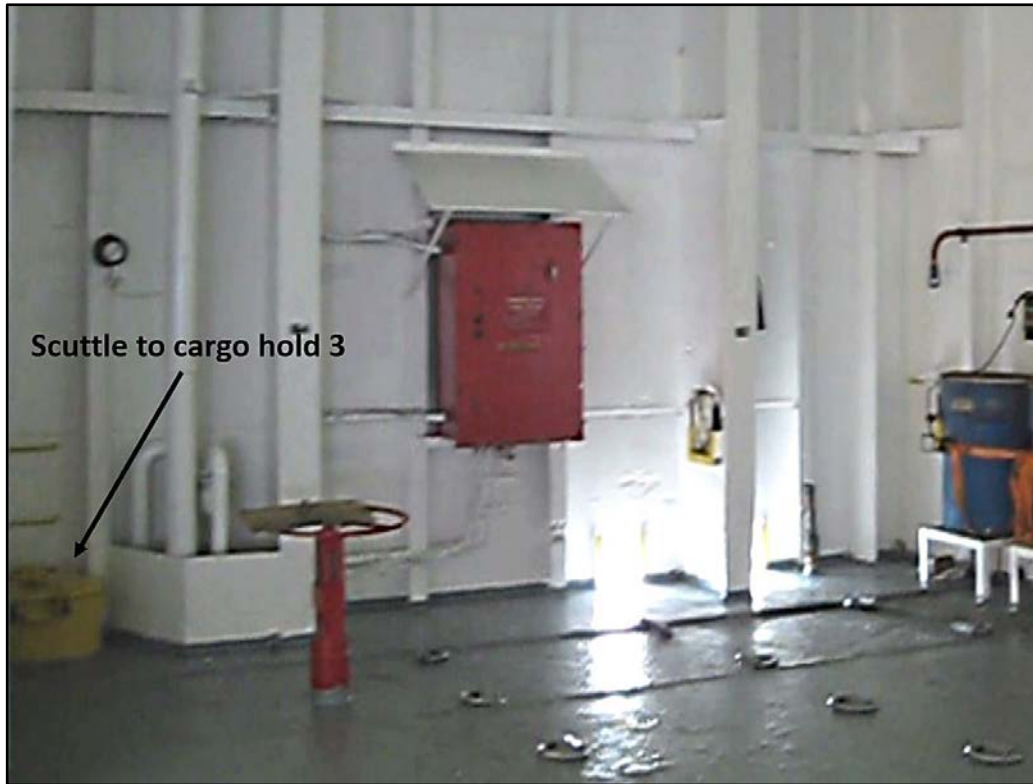
Figure 57. Second deck scuttle to hold 3. (Photo by former *El Faro* second mate)

The steel plates or covers to the scuttles were characterized by crew and officers as being heavy and hard to open. A former *El Faro* chief mate and captain stated that he had “never seen one pop open on its own.” Another former captain of *El Faro*, who had nearly 27 years’ experience as captain or chief mate on that ship and other vessels of the *Ponce* class, stated, “I don’t see a wave getting in there and lifting [a scuttle]. Even if it was not dogged.”

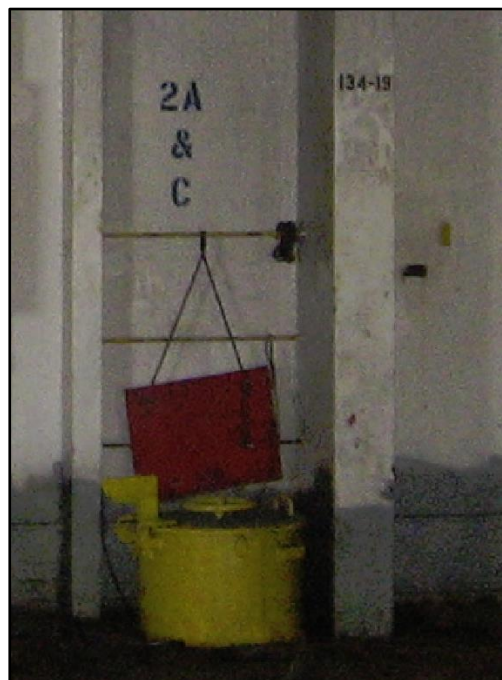
Figure 58. Second deck scuttle to hold 2A, similar to hold 3 scuttle. (Photo by Herbert Engineering)

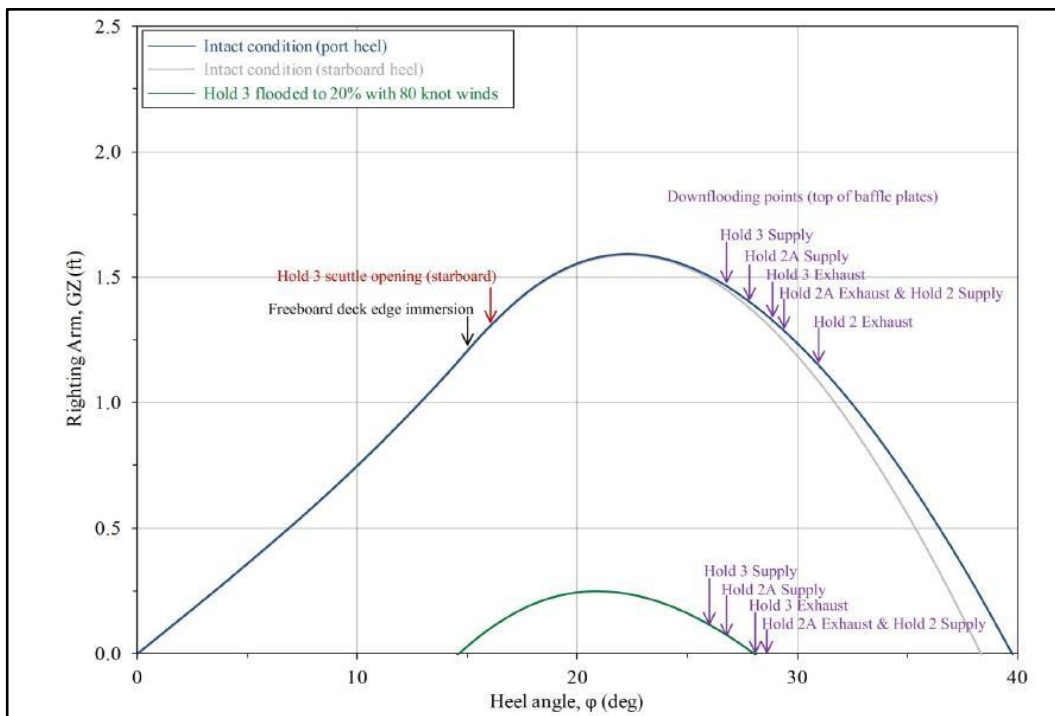
Figure 60. Righting arm curves for *El Faro*, with annotated downflooding angles. Downflooding angles are indicated at various points on curves for convenience; they do not represent values used in righting-arm calculations. (Illustration by Coast Guard Marine Safety Center)

- Hold 3, starboard access scuttle: 16.2° (intact condition), 14.9° (hold 3 flooded to 20 percent).
- Hold 2, vent supply baffle: 29.6° (intact), 28.9° (hold 3 flooded).
- Hold 2, aft and forward exhaust vent baffles: at least 30° in either condition.
- Hold 2A, vent supply baffle: 27.7° (intact), 26.9° (hold 3 flooded).
- Hold 2A, aft vent exhaust baffle: 29.8° (intact), 28.9° (hold 3 flooded).
- Hold 2A, forward vent exhaust baffle: 30.3° (intact), 29.4° (hold 3 flooded).
- Hold 3, vent supply baffle: 27.2° (intact), 26.3° (hold 3 flooded).
- Hold 3, aft vent exhaust baffle: 29.1° (intact), 28.1° (hold 3 flooded).
- Hold 3, forward vent exhaust baffle: 29.5° (intact), 28.6° (hold 3 flooded).
- The other three downflooding points, all in hold 1, required a heel angle of at least 42° to downflood in either condition.

Figure 60 shows the downflooding angles for the downflooding points described above, plus the angle at which the edge of the freeboard deck would have been immersed (about 15°). The downflooding angles are superimposed on two righting arm curves. The upper curve is the righting arm for *El Faro* in the intact condition on the morning of the sinking, before flooding began and with no wind. The lower curve is the righting arm for the vessel with hold 3 flooded to 20 percent and a sustained 80-knot beam wind. The smaller area under the lower righting arm curve, compared with the area under the upper curve, illustrates the severely reduced energy the vessel had available to right itself after hold 3 flooded and the ship lost power, with hurricane winds on its beam (blowing at a 90° angle to its starboard side).

Summary of Sinking Analysis. The analysis found it highly *unlikely* that the vessel sank by the bow, even though the captain said, “bow is down,” but highly *likely* that it capsized (but not that it completely inverted because deck containers washing overboard would have temporarily improved stability). The analysis also found it likely that most or all of the deck containers were lost and that most of the internal Ro/Ro cargo broke free and shifted. The 6,700 tons of iron ore fixed ballast in the double-bottom tanks would have turned the vessel upright as it sank. The report concluded the following:

It is unlikely that the ship could survive uncontrolled flooding into even a single cargo hold with winds in excess of 70 or 80 knots, and it is unlikely that it could survive flooding of more than one cargo hold except in benign conditions with little wind and waves.

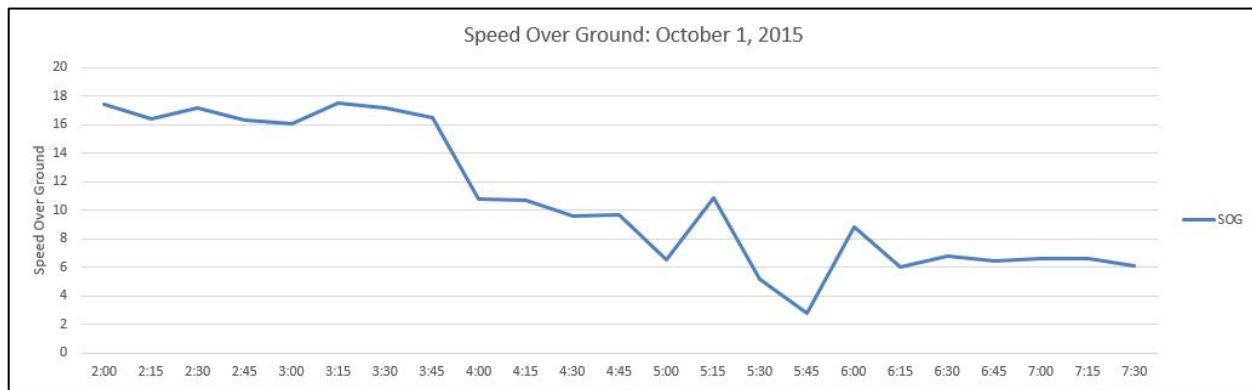
Figure 62. Ship's speed over ground from 0200 to 0730 on October 1.

El Faro sank an hour and a half after it lost propulsion. From the time it left port the evening of September 29, the ship traveled at near-maximum speed, between 19 and 20 knots, for almost 30 hours. But it began to slow and develop a wind-driven starboard list when it came out of the protective lee of San Salvador Island about 0130 on October 1 and encountered the steadily increasing force of the wind. The ship's speed dropped quickly to 18 knots and fell more or less

steadily from then on, as shown in figure 62. (Engine speed, or propeller rpm, was not recorded by the vessel's VDR, but parametric data captured the ship's speed over ground.)

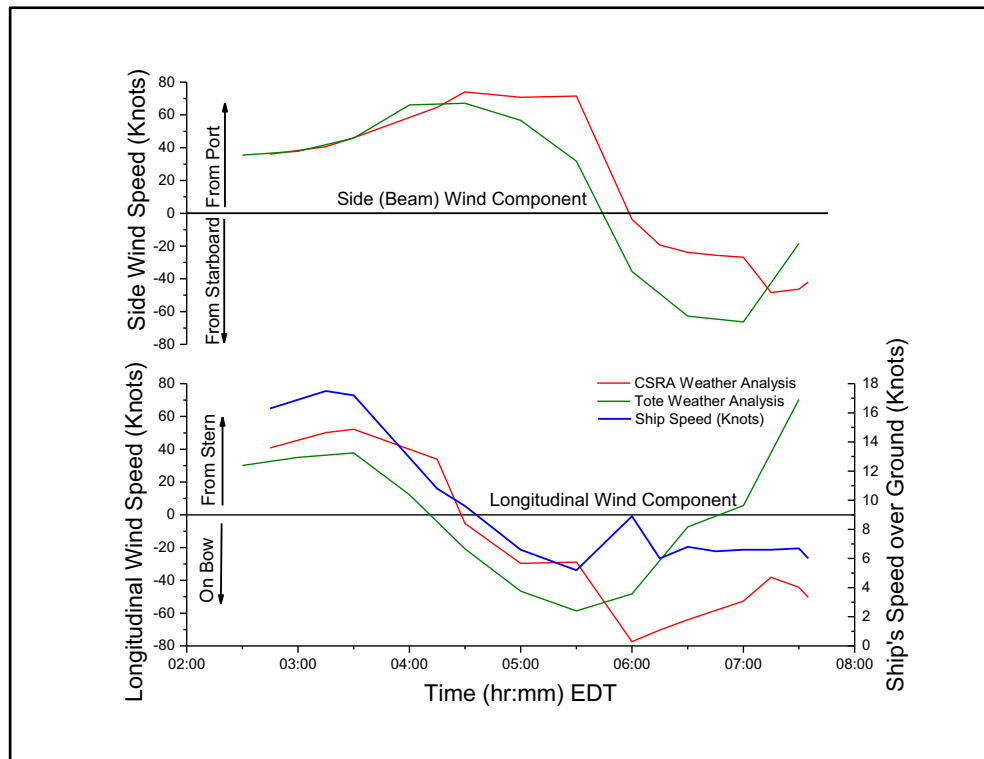
Figure 63. Ship's speed over ground relative to wind direction. Wind directions obtained from NTSB-chartered dynamic analysis (by CSRA Inc.) and TOTE weather analysis submission.

The graph in figure 63 demonstrates the relationship between ship's speed over ground and wind speed and direction, based on poststorm weather analyses. It shows that the increasing winds on the port side between 0400 and 0600 account for the vessel's starboard heel, while the shift of wind to the bow helps explain part of the vessel's slowing after 0400. The NTSB concludes that the initial list was caused by an increasing wind on the vessel's beam generated by Hurricane Joaquin.

About the time the watch changed, the crew began discussing that they were listing, or heeling, to starboard from the force of wind on the port side (windheel). By that point, the vessel's speed had dropped to less than 10 knots. The captain talked about shifting the water in the ballast (ramp) tanks to diminish the list. The vessel continued to make headway, though slowly, despite the sustained starboard list and the deteriorating weather.

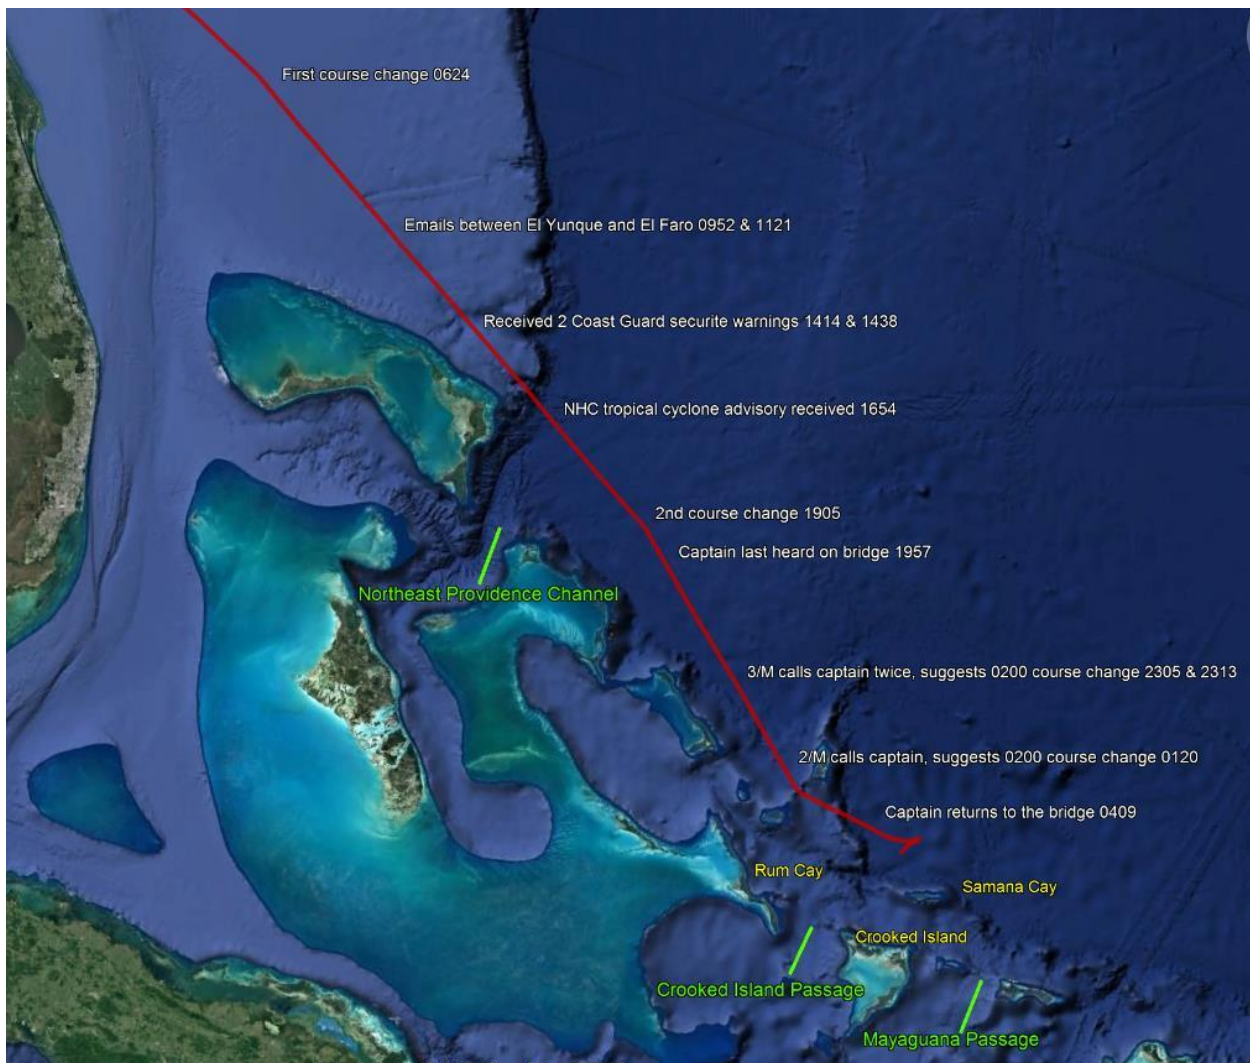
Figure 66. Significant opportunities for decision-making.

While the captain could have taken action at any time, there were several significant points along the accident route where the captain was provided with new information that gave him opportunities to adjust course and avoid heading into the storm (see figure 66). At 0624 on September 30, after reviewing the latest weather data from BVS, which showed the storm tracking west-southwest, the captain and chief mate decided to alter the vessel's path slightly southward. The captain described the course change as a "good little diversion" and suggested that Joaquin was not serious enough to warrant what the chief mate described as more "drastic" evasive action.
