NATIONAL TRANSPORTATION SAFETY BOARD

Sound Study

Addendum 1

| NTSB Number: | DCA15MR006 |

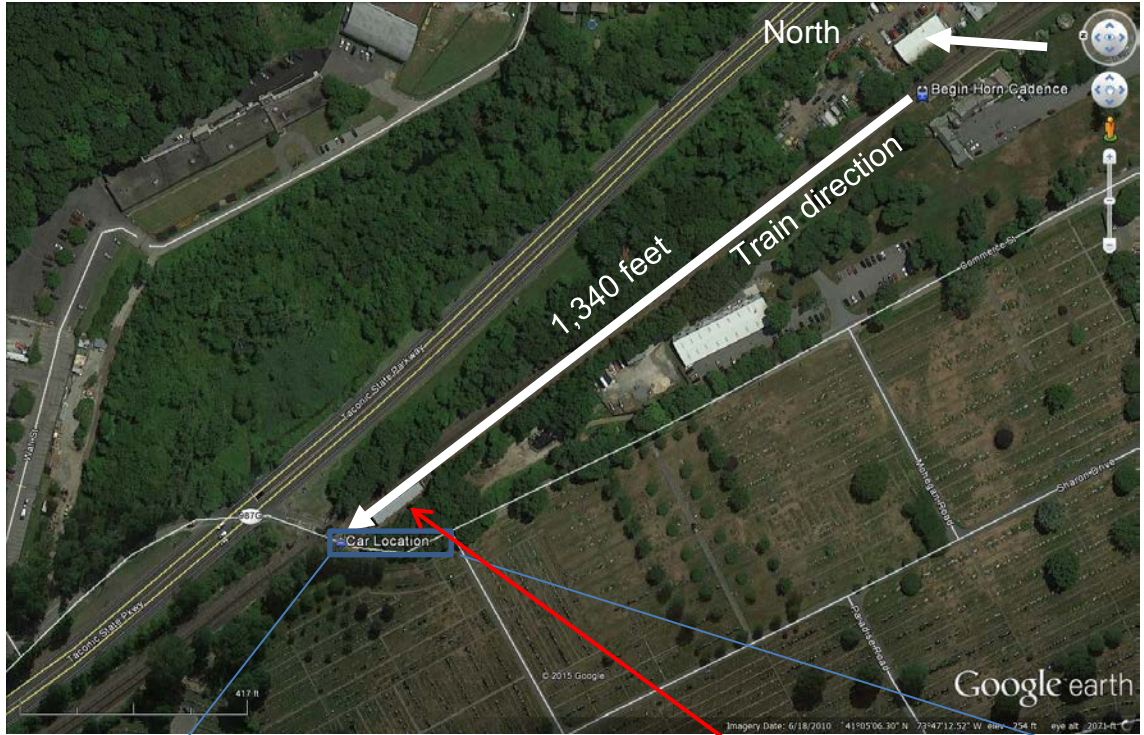
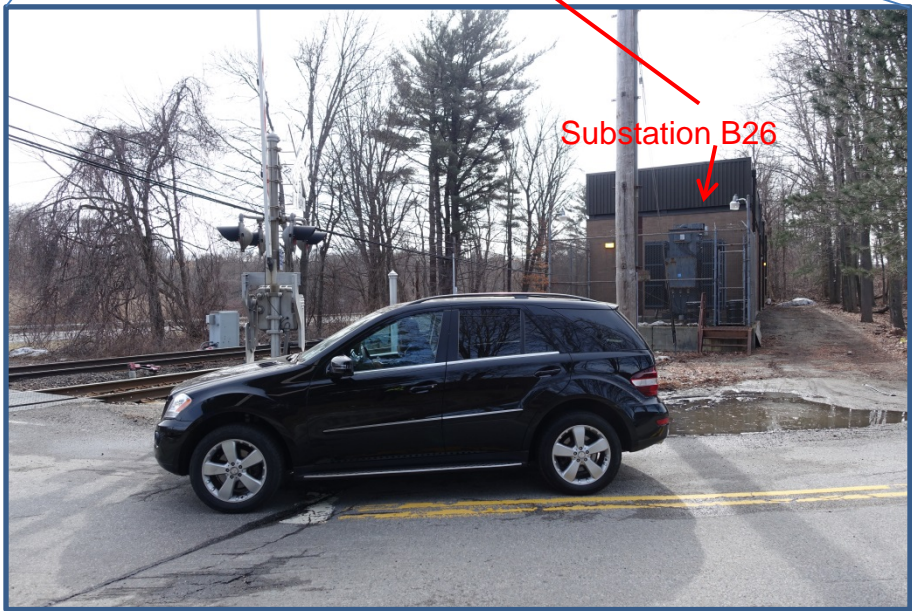
Figure 1. Overhead and street view of west side of test area.

Figure 1 shows an overview of the grade crossing and its approach. A test point consisted of measurements collected from the activation of the grade crossing lights to when the entire train consist passed the crossing.

Approximate accident conditions were recreated by placing the exemplar vehicle as close to the west side crossing gate as possible without fouling the track. A track sign

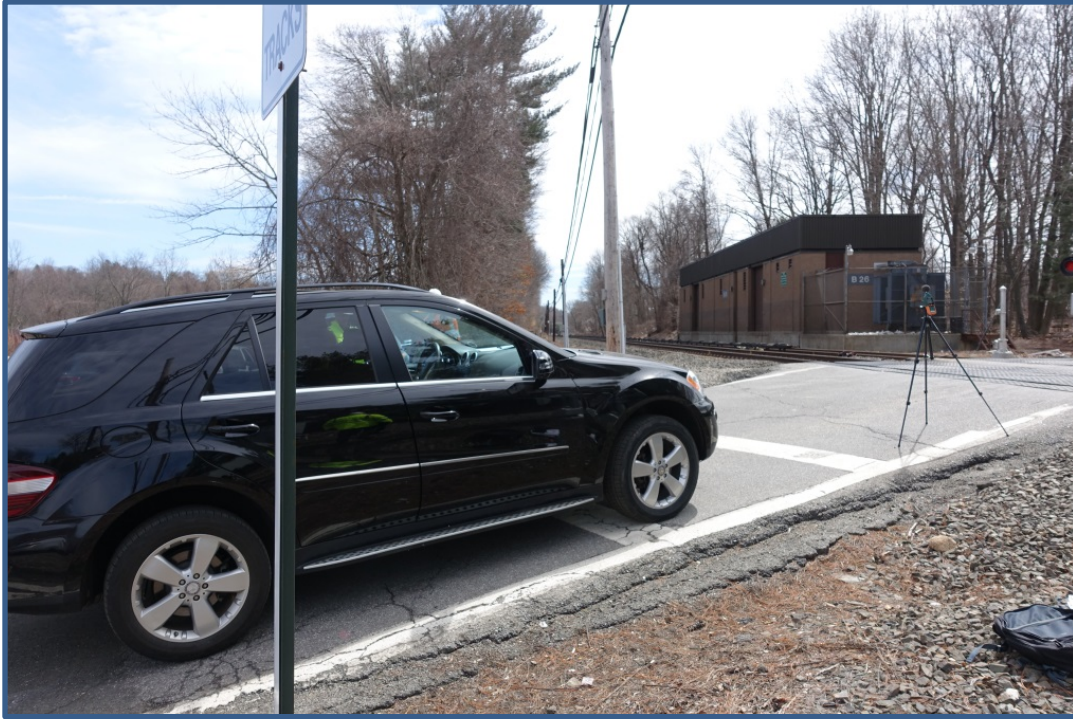
Figure 2. Equipment set up on east side of test area.

A similar test was performed on the east side of the track to determine the difference in outside sound pressure profiles from the east side of the track against the west side of the track (figure 2). Only one sound level meter was used and it was relocated to the outside area of the east track. A total of 2 data points were captured using this procedure.
