**NATIONAL TRANSPORTATION SAFETY BOARD**

**ADDENDUM 2**

**STRUCTURES GROUP CHAIRMANS FACTUAL REPORT**

**DCA09MA026**

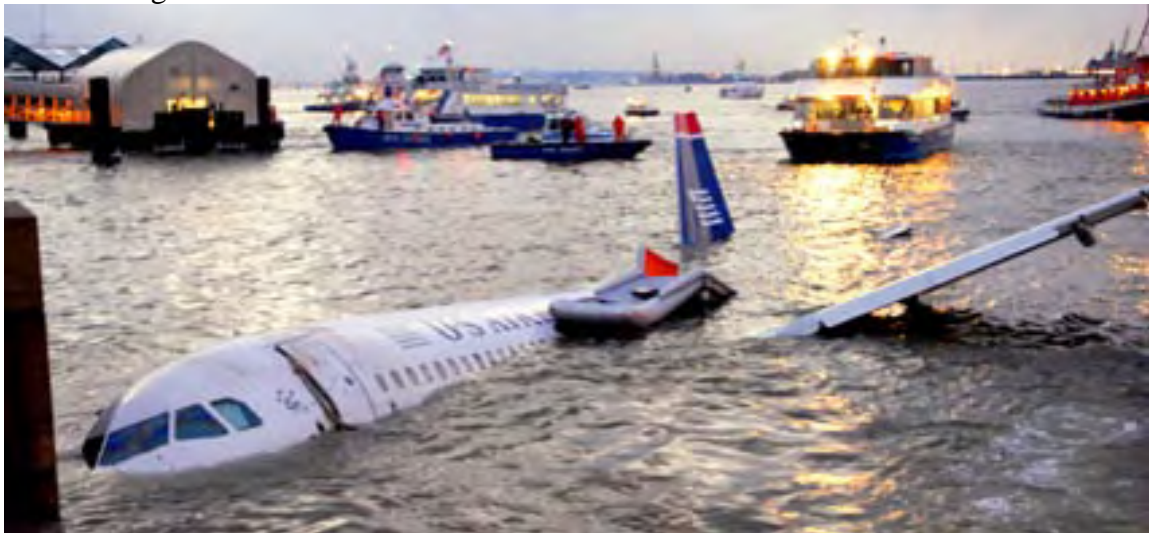
Figure 1- USAirways N106US After the passenger evacuation.  
(photo taken 3 hours after the accident)

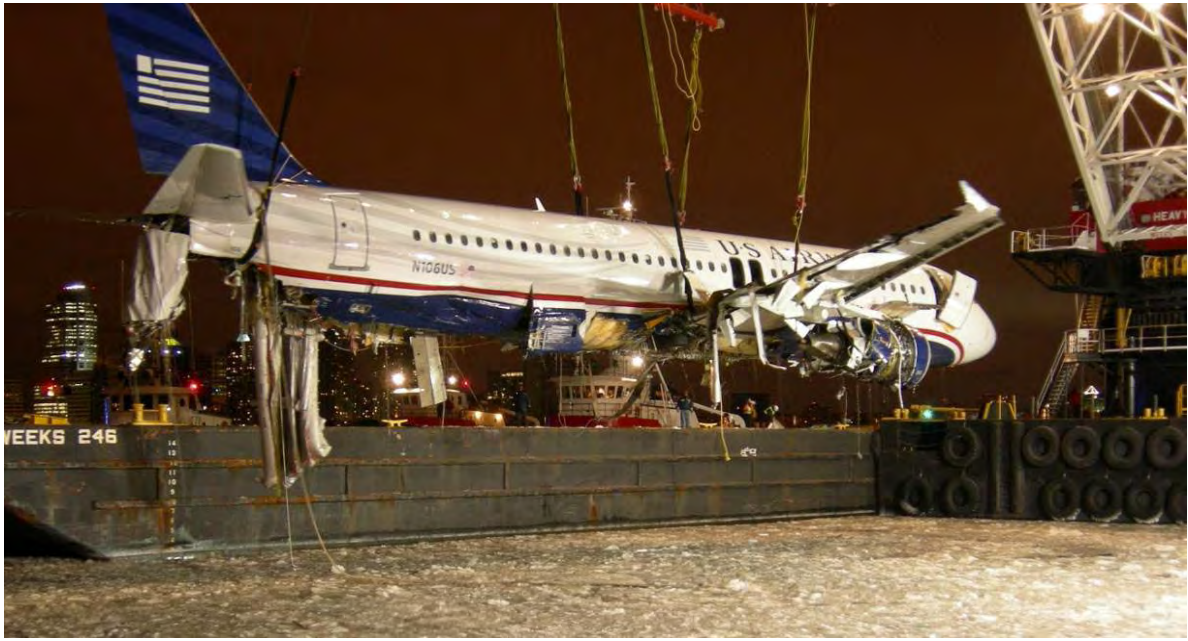
Figure 2 – US Airways N106US being placed on the recovery barge.

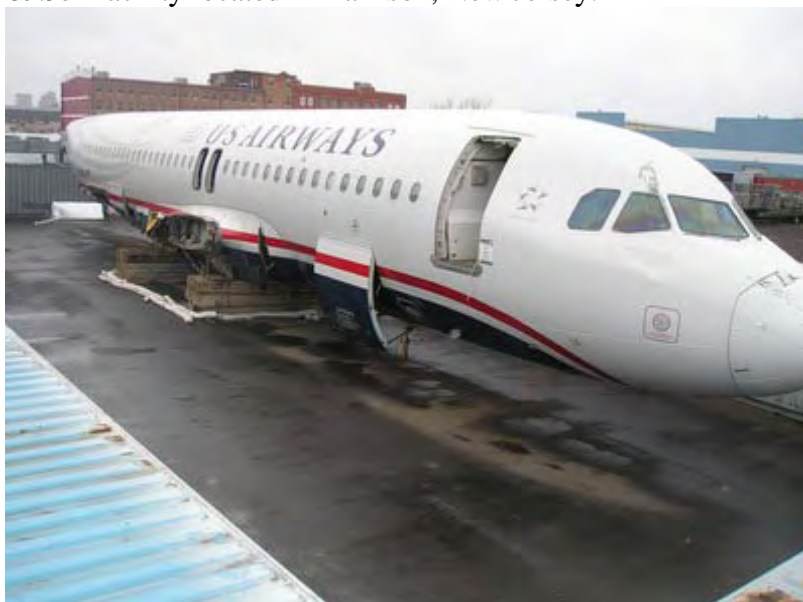
Following the original damage assessment performed just after the event, the wings were cut off outboard of wing rib 1 (including the main landing gear) and the vertical tail (VTP) and horizontal tail (HTP) planes were removed to allow for wreckage transportation. To facilitate the removal of the HTP, the fuselage structure below the HTP was cut between frame stations 74 and 75. The wreckage was then transferred from Weeks Marine in Jersey City, New Jersey to Harrison, New Jersey by truck. The airplane wreckage was again inspected at Joe Supor & Son facility located in Harrison, New Jersey.

Figure 3 – US Airways N106US After removal of the wing and stabilizers.

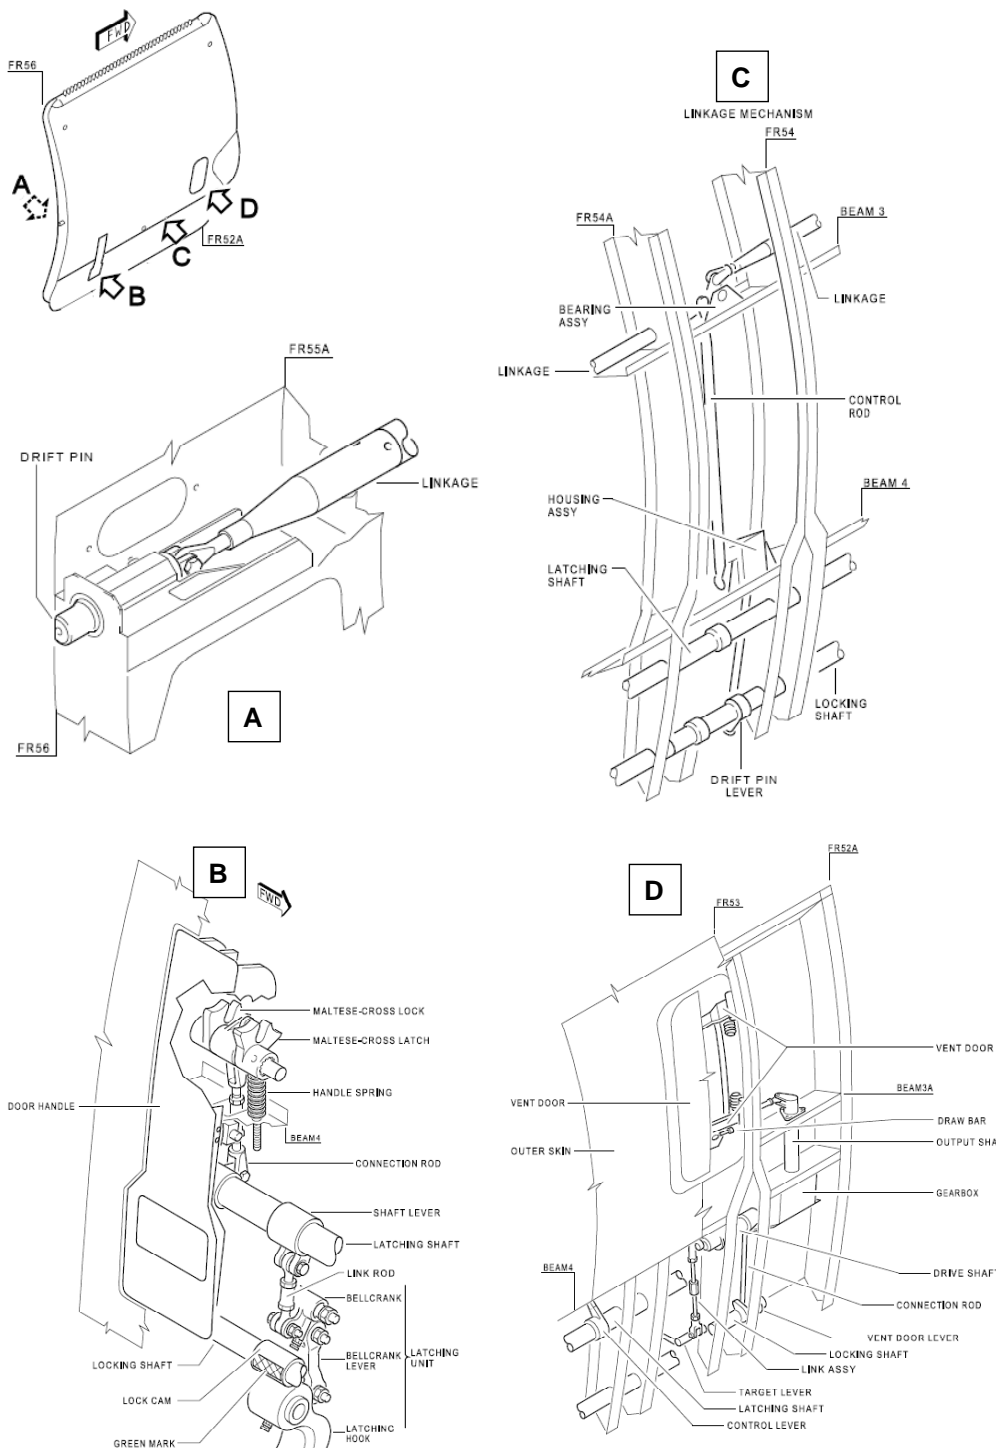
The locking shaft and connecting rods were undeformed and intact (refer to Figure 19 for schematic). No damage was visible to the link between the locking shaft and the drift pin mechanism. The forward and aft drift pins extended about 12 millimeters (mm) and 5.5 mm respectively from the edge of the forward and aft cargo door frames. The measured extensions exceed the normally expected tolerances for the cargo door when it is in the open and unlatched position. The vent door link to locking shaft via sequence shaft was undamaged and in good condition and the vent door was in open position. The latching shaft was bent between frames 55 and 55A, and the latching mechanism was seized in the fully unlatched position. Accordingly the six latching hooks were unlatched from the six latching spools. The cargo door handle was fractured into multiple pieces. Only the handle structure directly attached to the linkage mechanism remained attached to the door structure (refer to Figure 18). The handle body is attached to the handle mechanism using three shear fasteners on each side of the handle. One of the aft three fasteners exhibited features consistent with a ductile tension failure and the fastener was deformed in the aft direction (refer to Figures 17&18). A piece of carbon fiber reinforced plastic (CFRP) was wedged between the door handle and the door handle housing (refer to Figure. 17). The interlock mechanism did not show any signs of damage and functioned properly.

Description: Cargo door schematics.
