**ADDENDUM NUMBER 20 TO THE STRUCTURES GROUP CHAIRMAN'S
FACTUAL REPORT**

DCA02MA001

1. ***“Incoming inspection of the rear lug cut outs LH side shell of the fin box from the aircraft MSN 513 of the American airlines”***

Report Nr.: TN – ESWNG – 1238/03

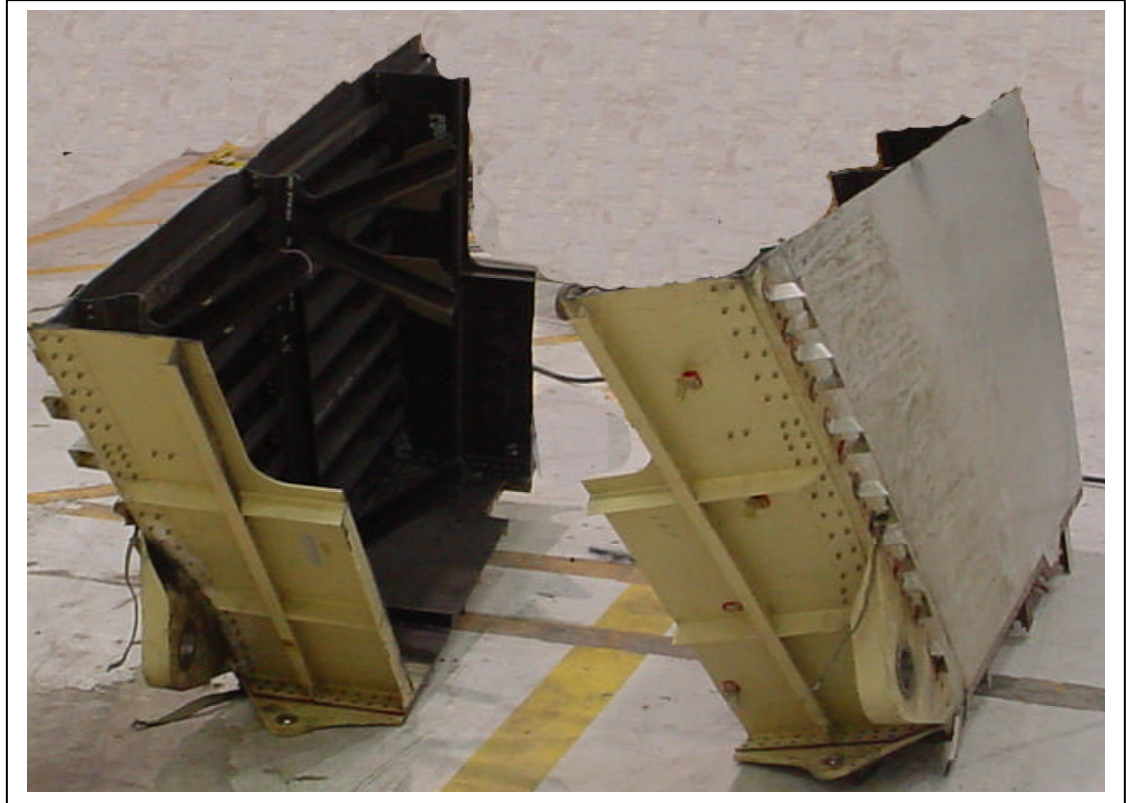
The cut out (figure 1.) consists of an area between stringer P1 to P8, Rib 1 to 4 and the rear attachment fitting. The structure elements of the cut outs are shown in figure 2.

Figure 1: Cut outs of the RH side shell and the LH side shell of the fin box of the aircraft MSN513

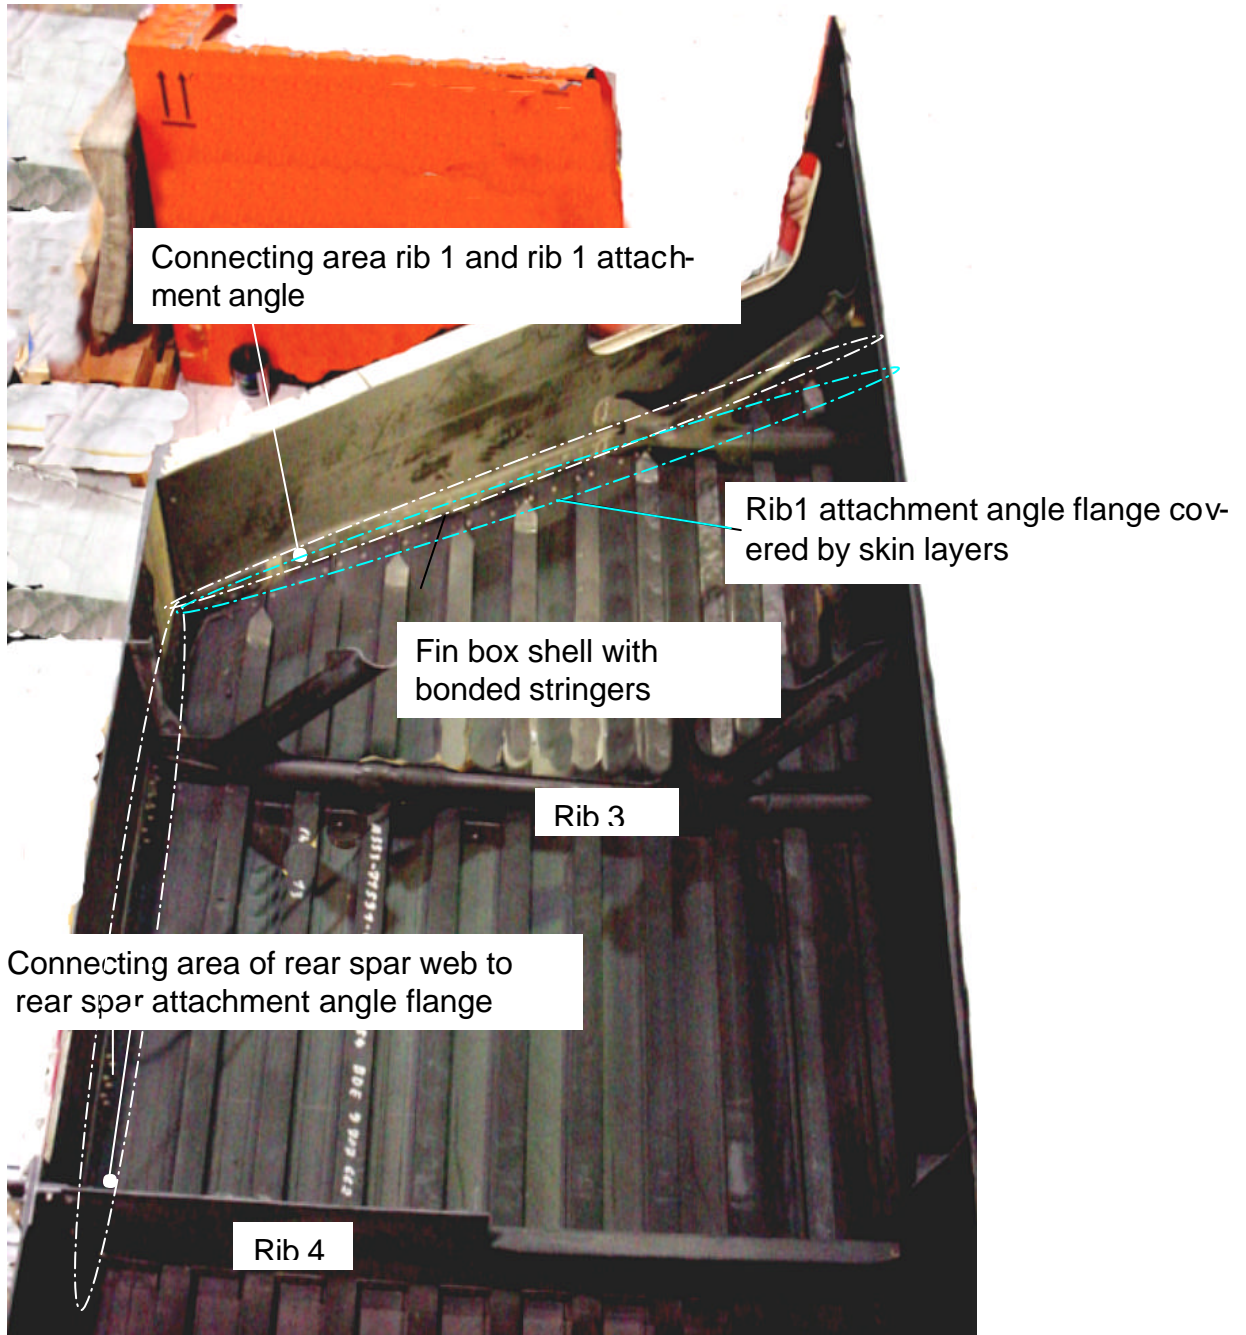
Figure 2: Structure elements of the cut out (view from the inboard side)
