NATIONAL TRANSPORTATION SAFETY BOARD

Structural Analysis and Evaluation for the Airbus A300-
600R/MSN420 VTP and rudder for the accident flight AA587
Part 3: Analysis of the rupture sequence of the rudder following the accident

Technical Note

Part III: Analysis of the rupture sequence of the rudder following the accident

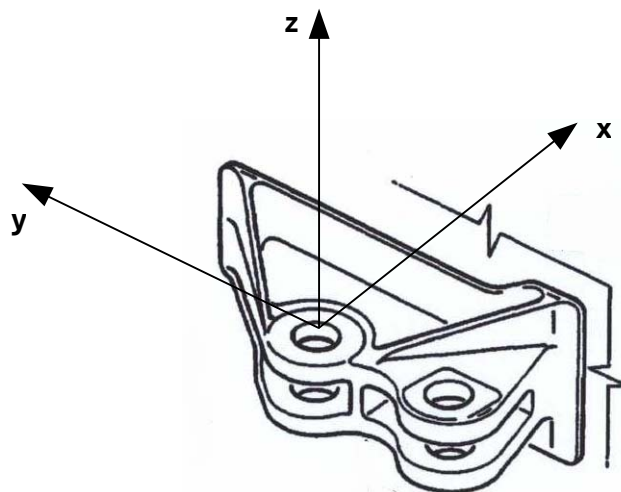
Figure 11

During the first FEM analysis the rudder and its supports to the vertical stabilizer are intact. The hinge arm forces (see figure 10) and the rudder hinge fitting attachment forces (see figure 11) are given in the hinge line coordinate system (see figure 12).

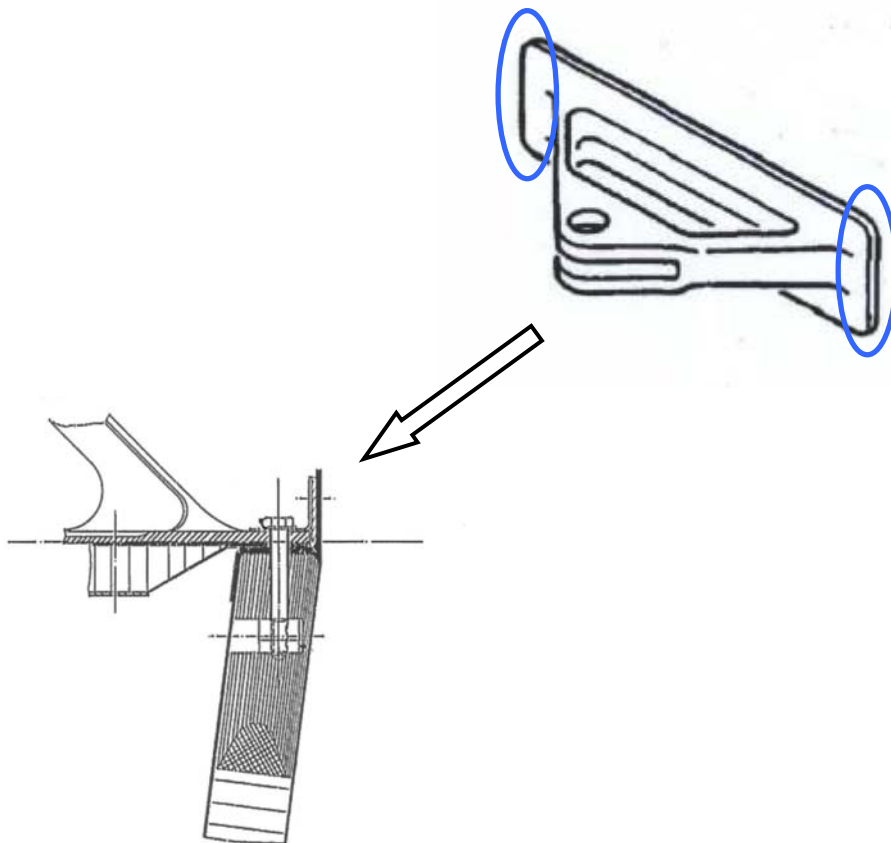
Figure 14

The second FEM analysis takes into account that hinge arm fitting no. 6 has ruptured on RHS. The forces are redistributed to hinges no. 5 and 7. The hinge fitting attachment forces (connection between rudder hinge fitting and rudder skin panels, see figure 14) are listed in figure 15.
