Number: A3537
Original Issue: January 30, 2012
ATA System: 5410

SUBJECT: NACELLE - Inboard and Outboard Nacelle Strut Midspar Fitting - Inspection

Summary

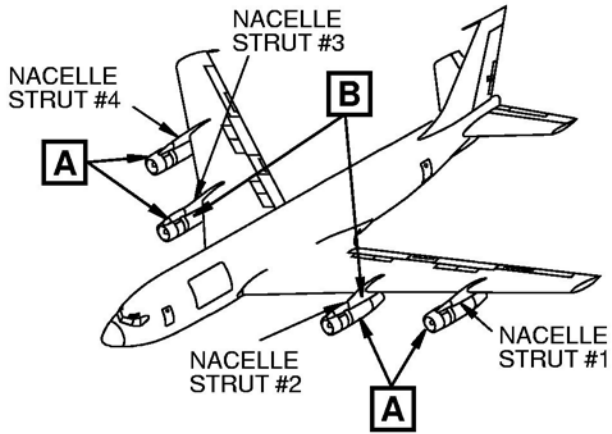
DO A GENERAL VISUAL INSPECTION OF THE NACELLE STRUT TO MAKE SURE IT IS NOT DROOPED BELOW ITS NORMAL POSITION AND APPLY STRIPE. MAKE SURE THE NACELLE HAS NOT DROOPED BELOW ITS NORMAL POSITION.
