BODY BUTTLINE 0.00 RIB - WING CENTER TANK

CW-1106
Z-2773
GREEN

CENTER WING
BL O RIB
CW-110 ~~B~~
Z-?
GREEN FIELD

BL Ø RIB FAILURE DIRECTION

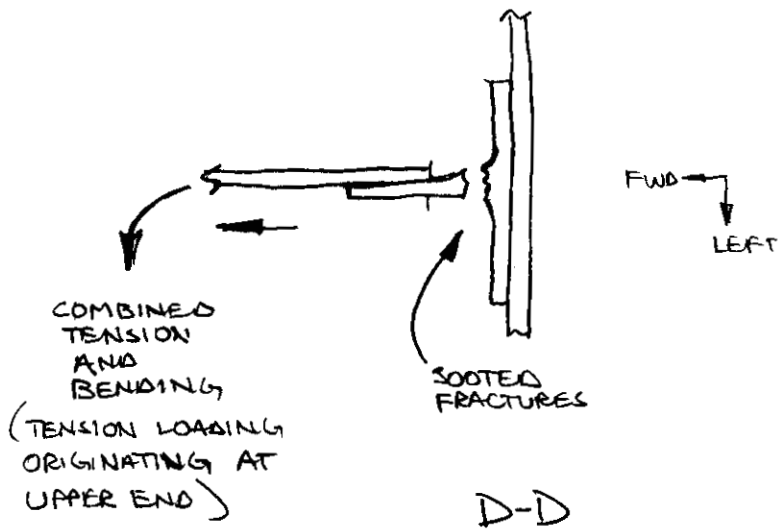
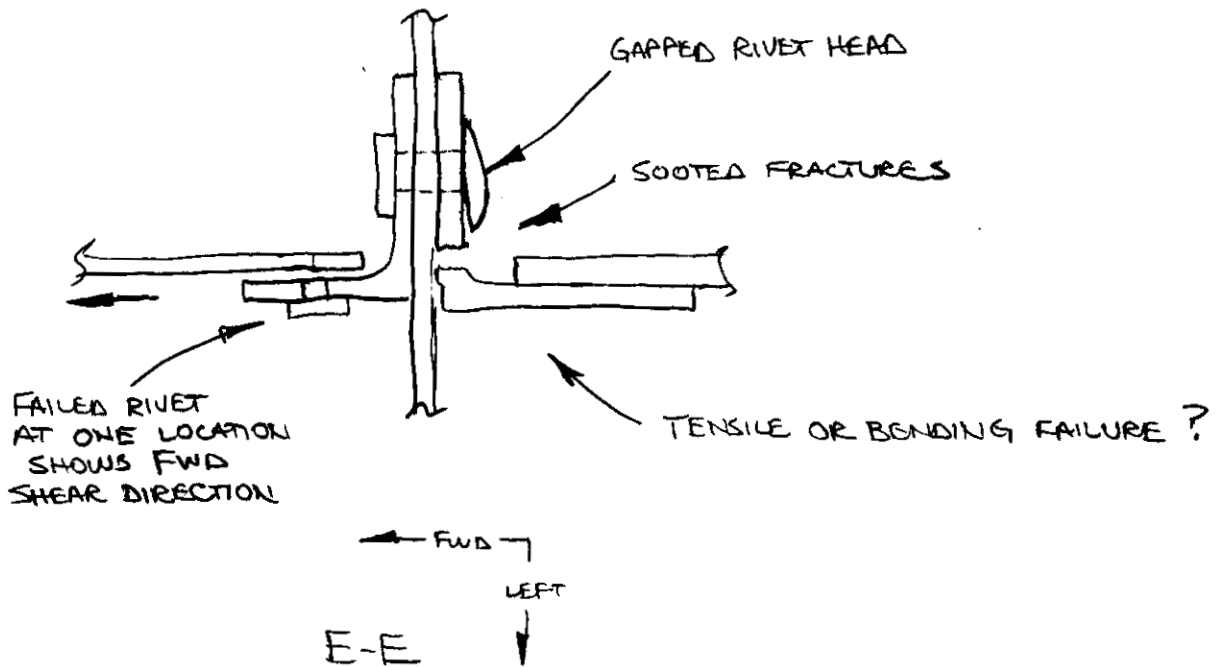
BENDING FAILURE
FOR TOP HALF OF
BL Ø RIB. BOTTOM
HALF OF RIB IS
INCONCLUSIVE.

FRACTURE DIRECTION TO
LEFT BUT
INCONCLUSIVE
SINCE THIS IS AN
UNSOOTED FRACTURE AND
STRUCTURE ABOVE THIS
IS NOT RECOVERED
