CW-504  
A-236  
RED

## FRONT SPAR

# WING BOX FRONT SPAR

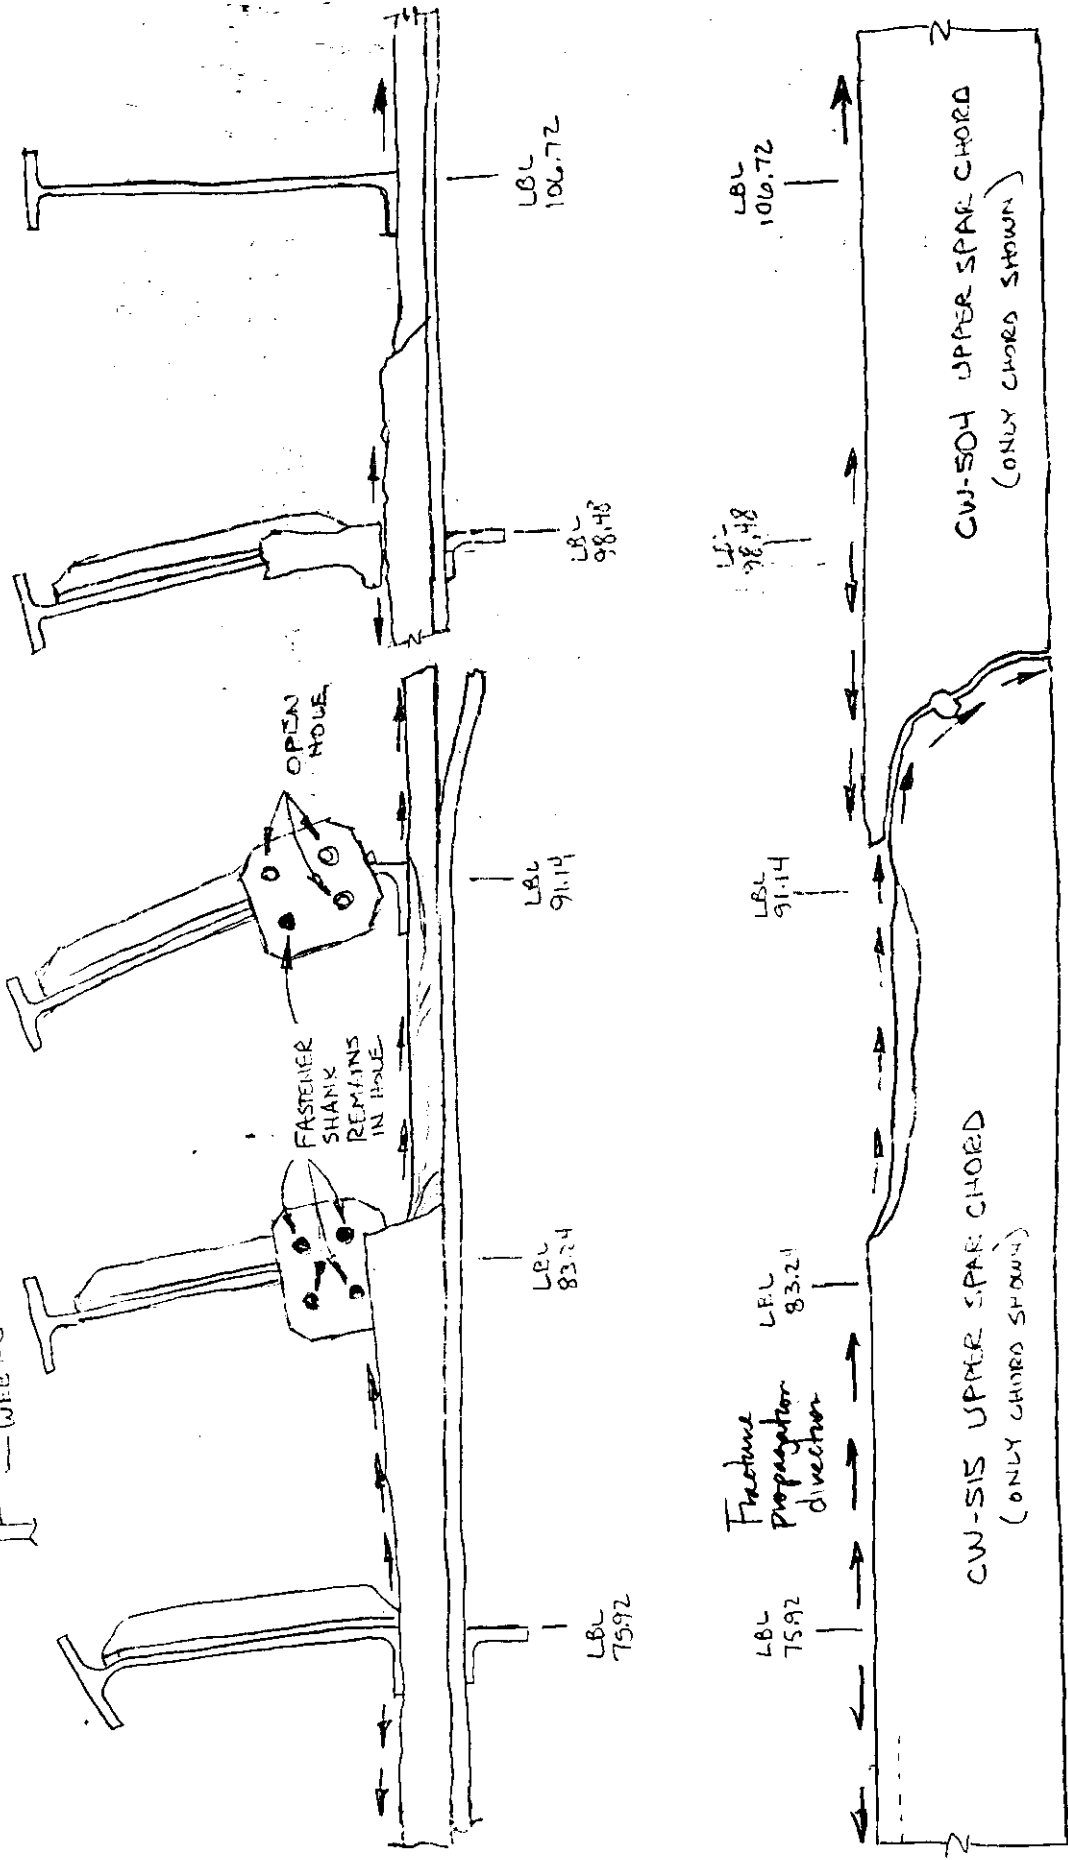
VIEW LOOKING AFT

The stiffeners at LBL 75.82, 83.24 and 91.14 suffered severe impact damage and fractured at 18", 15" and 12" from the upper shear ties respectively. The aft flange and the stiffener web at the impact location was crushed forward. A 2.5" wide impact mark was observed on the aft flange of the stiffeners. The stiffener at LBL 98.48 remained attached to the front spar web and the aft flange suffered impact damage from 17" to 23" from the upper shear tie. The shear ties are missing from the stiffeners at the bottom.
