FRONT SPAR - L.H. SIDE

VIEW LOOKING AFT AT LEFT CENTER SECTION FRONT SPAR

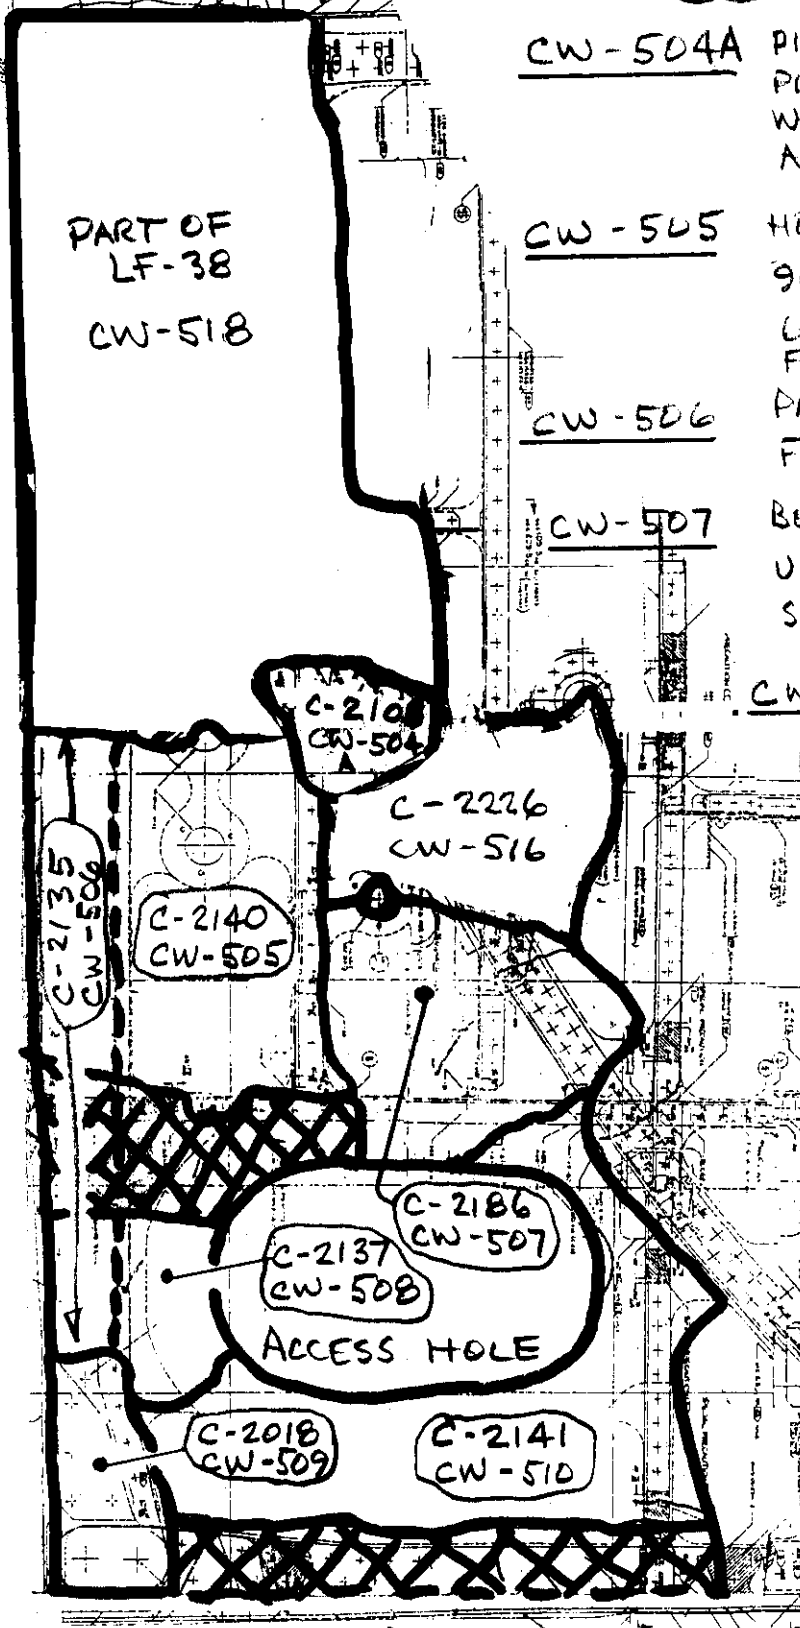
- CW-504A PIECE OF WEB ATTACHED TO PIECE OF LBL114 STIFFENER WITH INTERCOSTAL. I/C BENT, AND WAS BURNED.
- CW-505 HEAVY WEB BENT FORWARD 90° ALONG VERTICAL LINE 6" FROM OUTBD SIDE, GROOVES FROM BOLTS RUBBING. AFT SIDE.
- CW-506 PART OF TERMINAL FTG, TORN, FLAT.
- CW-507 BOTTOM 4" DEFORMED FWD 90°. UPR OUTBD DEFORMED 45° AFT. SCRAPE MARKS
- CW-508 PIECE DEFORMED AND HAS SCRAPE MARKS. 180° FROM ORIGINAL ORIENT.
- CW-509 LWR PART OF TERMINAL FITTING.
- CW-510 LWR PART OF WEB WITH ACCESS HOLE. ROLLED 180° FWD AND ~~IN~~ ^{OUT} FLAT ALONG RING CHORD.
- CW-511 PART OF OUTBD, LWR WING F.S. WEB. CAME OFF OF TERM. FTG. 14" HIGH, 12" INBD-OUTBD, AFT 6" BENT ^{AFT} 90° TO F.S. PLANE.

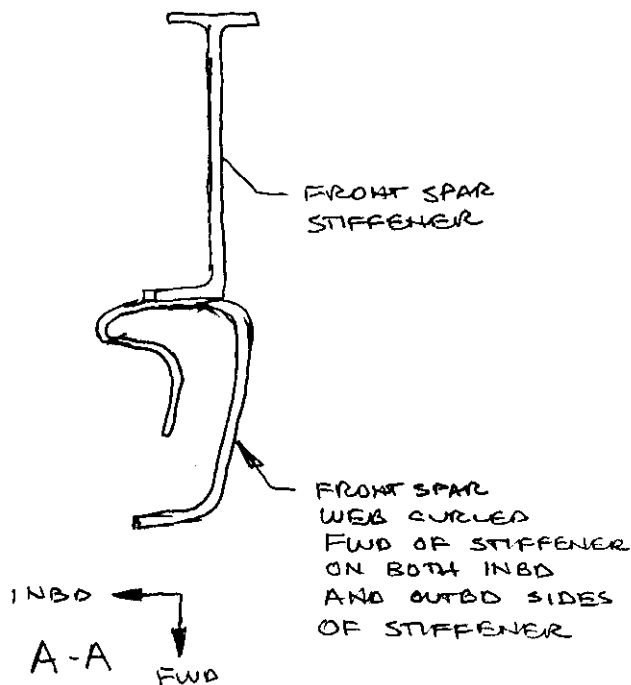
AFT SIDE OF CW-504 AT INTERFACE WITH CW-515 SHOWS SAME EVIDENCE OF BEING STRUCK BY SWB #3 AS OTHER FRONT SPAR SECTIONS. STIFFENERS ARE BUCKLED AND DISTORTED AT UPPER END COMMON TO CW-504.

SIGNIFICANT EVIDENCE OF FWD APPLIED FORCE TO LWR WEB AROUND ACCESS HOLE CAUSING WEB TO FRACTURE AND TOTALLY CURL AROUND ON ITSELF AT SEGMENTS CWS10, CWS08, AND CWS07. RADIUS OF CURVATURE OF APPROX 7"

NO EVIDENCE OF ANY BURNING OR SOOT EXCEPT ON INTERCOSTAL ATTACHED TO STIFFENER WHICH SHOWS BURNING AND SOOT.
