SPANWISE BEAM # 3

CW-603

# SPANWISE BEAM N° 3

DEBRIS FIELD # 3

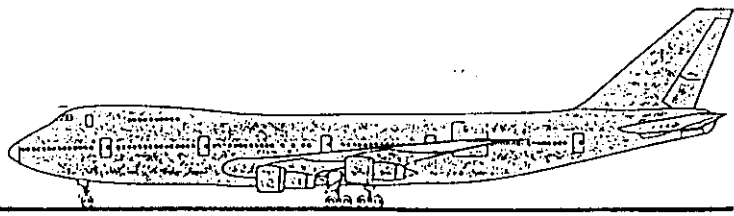
FRACTURED THROUGH SEALED PRODUCTION  
ACCESS HATCH. FOUR STIFFENERS WIDE  
EACH SIDE OF VERTICAL WEB FRACTURE.  
FIRST STIFFENER LEFT OF WEB FRACTURE  
IS SEPARATED FULL LENGTH IN STIFFENER WEB.

SOOT DEPOSITS ALONG ~~FR~~ FRACTURE  
LEFT AND RIGHT OF VERTICAL SPLIT; ~~FR~~ LEFT  
OF BBL Ø
