SPANWISE BEAM # 3

CW-604
A-475
RED

This section is from LBL 17.27 to LBL 75.90 and contains seven stiffeners.

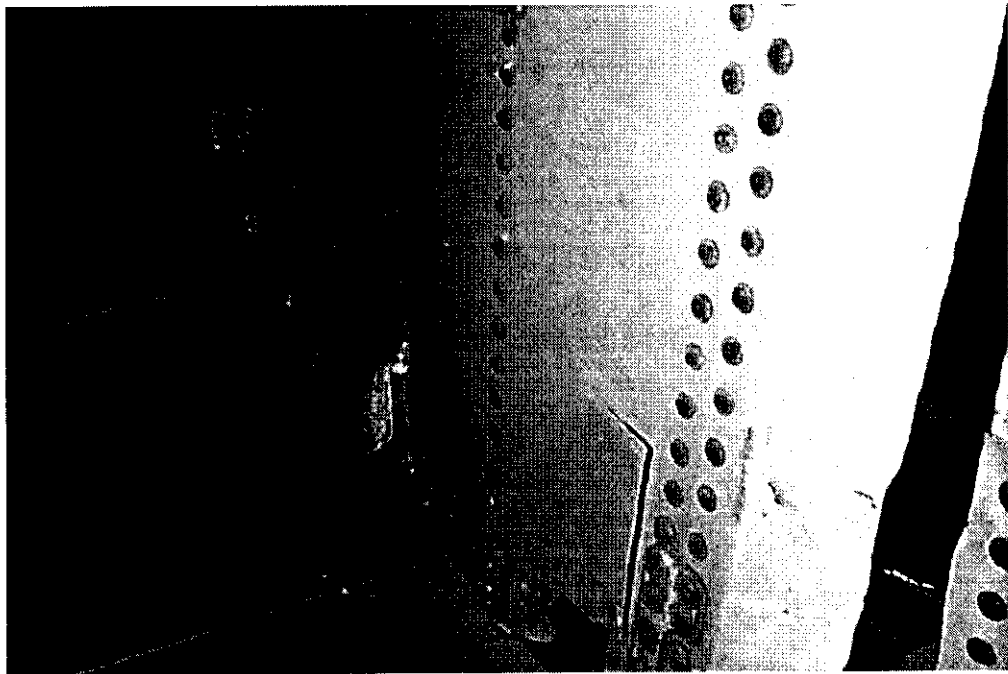
Only the lower shear ties remain attached to the stiffeners. The web is torn above the access door in a jagged form and bent aft at various tear locations. The rivets pitch is 1.5".
