**NATIONAL TRANSPORTATION SAFETY BOARD  
WASHINGTON, D.C.**

**STRUCTURES/SYSTEMS GROUP CHAIRMAN'S  
FACTUAL REPORT**

STRUCTURES/SYSTEMS GROUP CHAIRMAN'S FACTUAL REPORT

DCA-96-MA-068

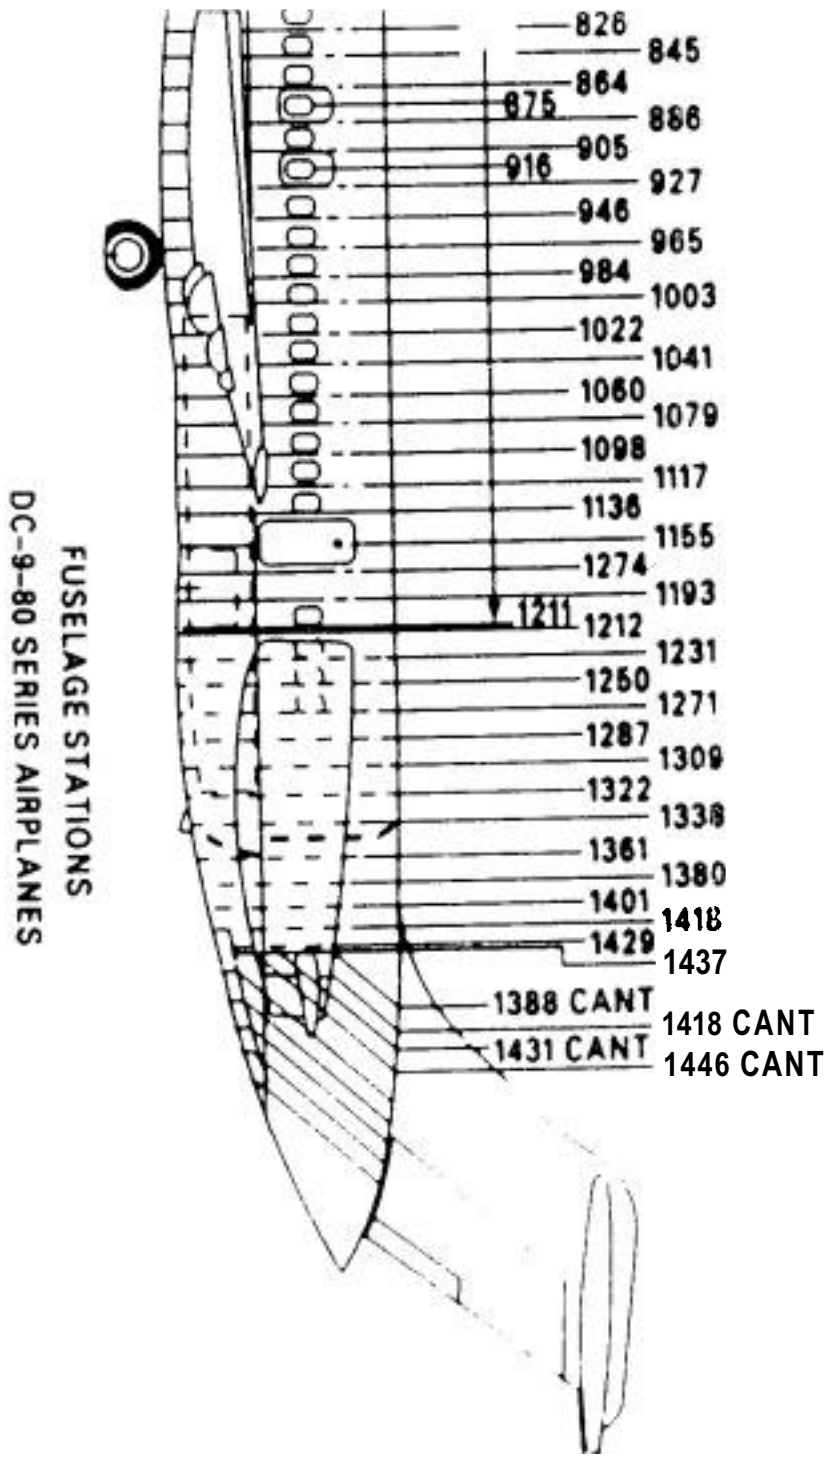
Figure 4. Fuselage Station and Longeron Identifications

The primary **area** of damage to the left fuselage **skin** consisted of several large holes/tears between fuselage stations (**FS**) 1250 to FS 1282' and from the top of the window belt to longeron (L) -2. (Identification of fuselage stations and longerons is contained in figure 4). Also documented was a 5"x2" **skin** puncture **near** FS 1295 between L-8 and L-9, a 114" puncture near FS 1310 just above L-17, and a 118" puncture near FS 1315 between L-16 and L-17. A total of 16 holes, punctures, or **tears** were documented on the left fuselage **skin**.
