NATIONAL TRANSPORTATION SAFETY BOARD

STRUCTURES GROUP FACTUAL REPORT

A. ACCIDENT DCA09MA021

Location: Denver, Colorado
Date: December 20, 2008
Time: 1818 Mountain Standard Time (MST)
Aircraft: Continental Airlines Flight 1404, Boeing 737-524, N18611

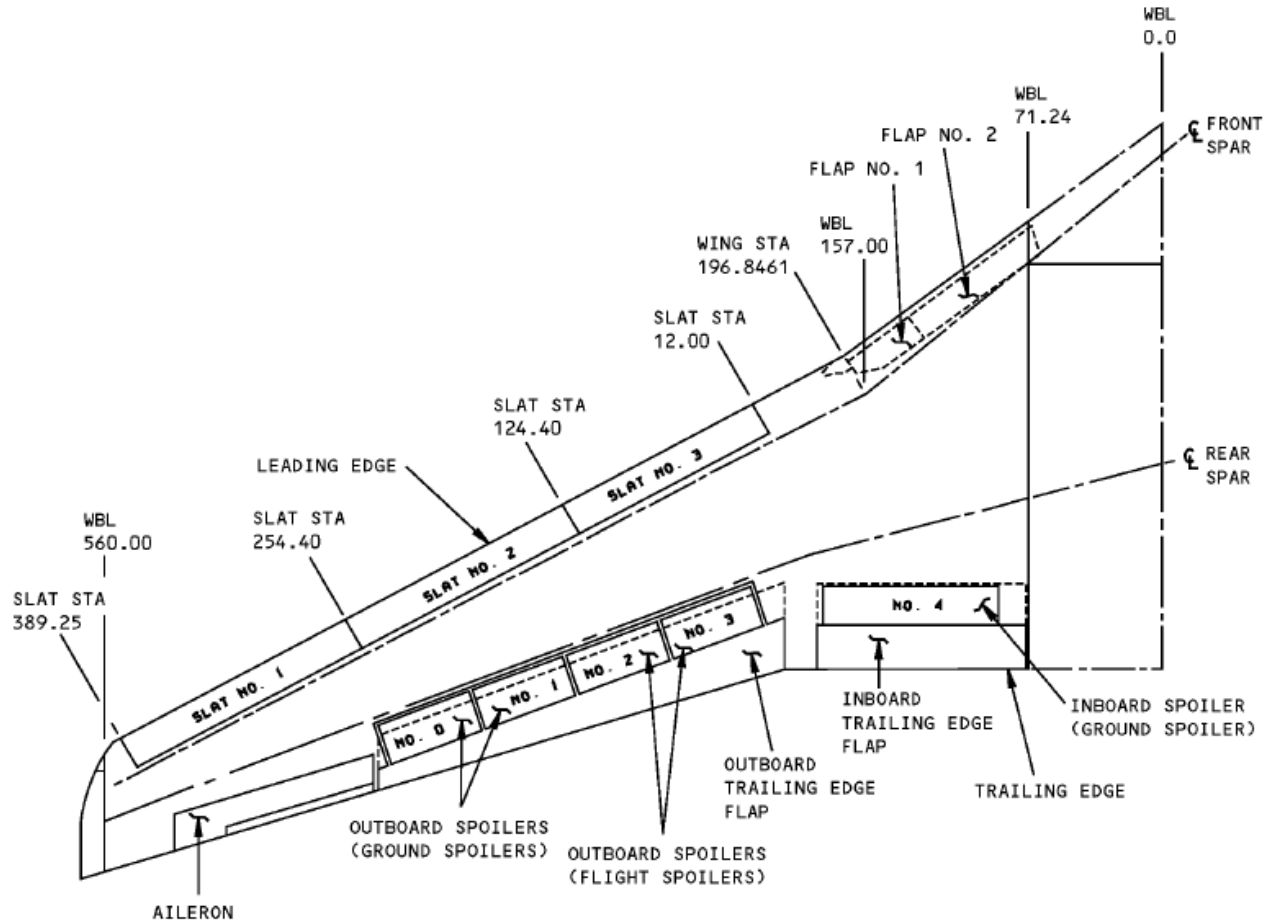
Figure 8 – Boeing 737-500 Wing Diagram (without winglets)

The left wing was intact and attached to the fuselage. The trailing edge flaps, leading edge slats, leading edge Krueger flaps, 5 spoilers, aileron and winglet remained attached to the left wing. The center and inboard leading edge slats and both Krueger flaps exhibited crushing, denting, and buckling damage and deformation in the area around where the engine was installed. The inboard trailing edge flap and inboard ground spoiler were bent and

The right wing was intact and attached to the fuselage. The right wing was deformed downward about 20° between the pylon and fuselage. The outboard trailing edge flaps, leading edge slats, 3 outboard spoilers, aileron, and winglet remained attached to the right wing. The Krueger flaps, upper wing skin inboard of the pylon, inboard flaps, and 2 inboard spoilers were consumed by fire. The inboard half of the outboard trailing edge flaps and the lower wing skin inboard of the pylon exhibited moderate to heavy fire damage. The engine and pylon remained attached to the wing with moderate buckling and tearing damage.

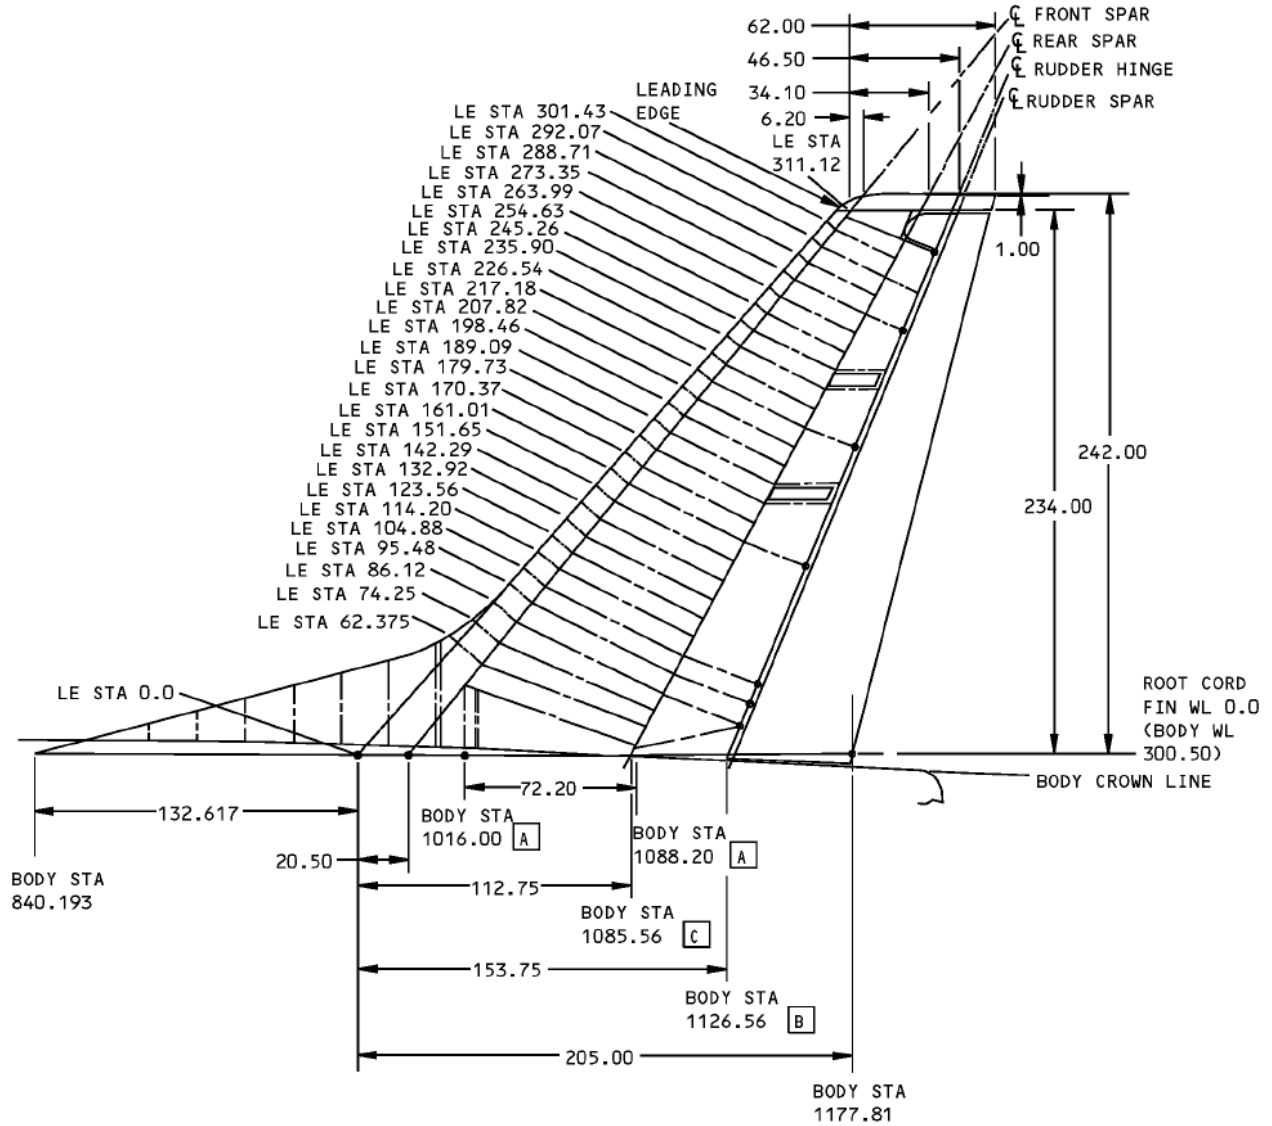
Figure 10 – Boeing 737-500 Vertical Stabilizer Station Diagram

The empennage was intact and exhibited little damage. The right side of the vertical stabilizer exhibited light fire damage and charring while the left side was essentially normal. The left horizontal stabilizer was undamaged. The right horizontal stabilizer exhibited tearing and crushing damage between stations 203 and 221 that penetrated about 27 inches aft of the leading edge.

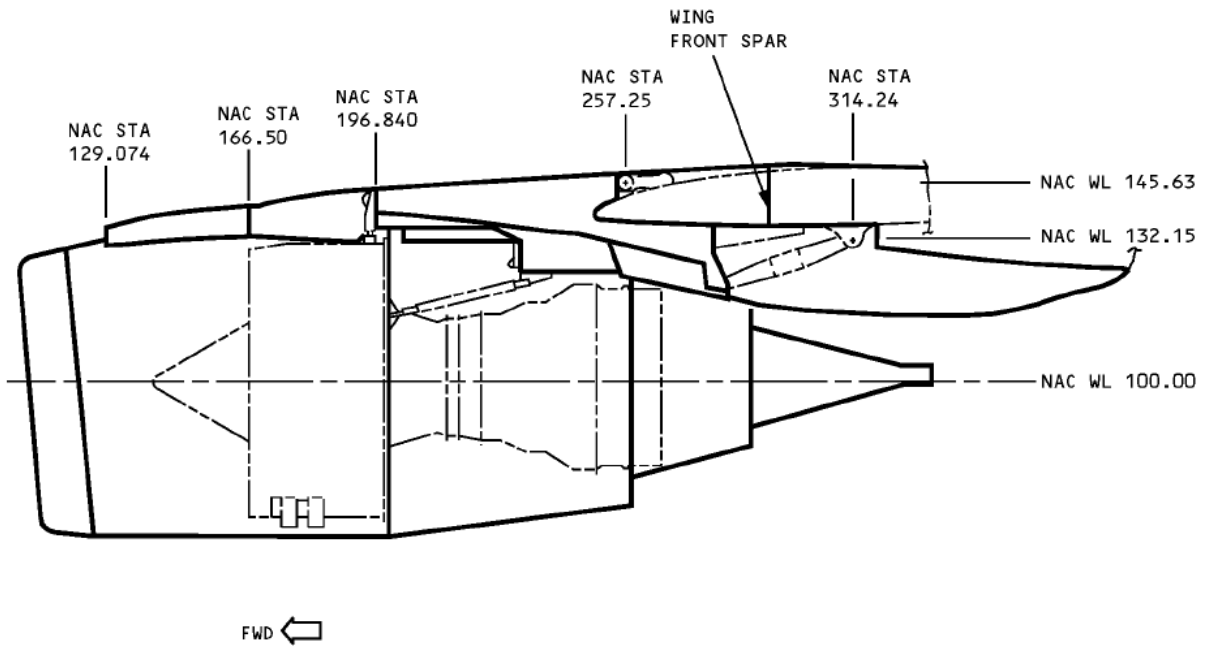
Figure 11 – Boeing 737-500 Nacelle Diagram

buckled aft of the area where the left MLG is normally installed. The left engine pylon area was crushed, buckled, and torn in the vicinity of nacelle station (NAC STA) 196.840. The section of the pylon above approximately NAC waterline (WL) 132.15 remained attached to the lower surface of the wing. The left wing forward spar at the pylon attachment location exhibited very little damage. The front spar clevis fitting, inboard lobe, which holds the fuse pin to the upper link assembly, was sheared off.
