FUSELAGE

Red Zone Fuselage Pieces: Fracture Directions / Deformations

Internal Overpressure Indication and Fracture Direction Survey

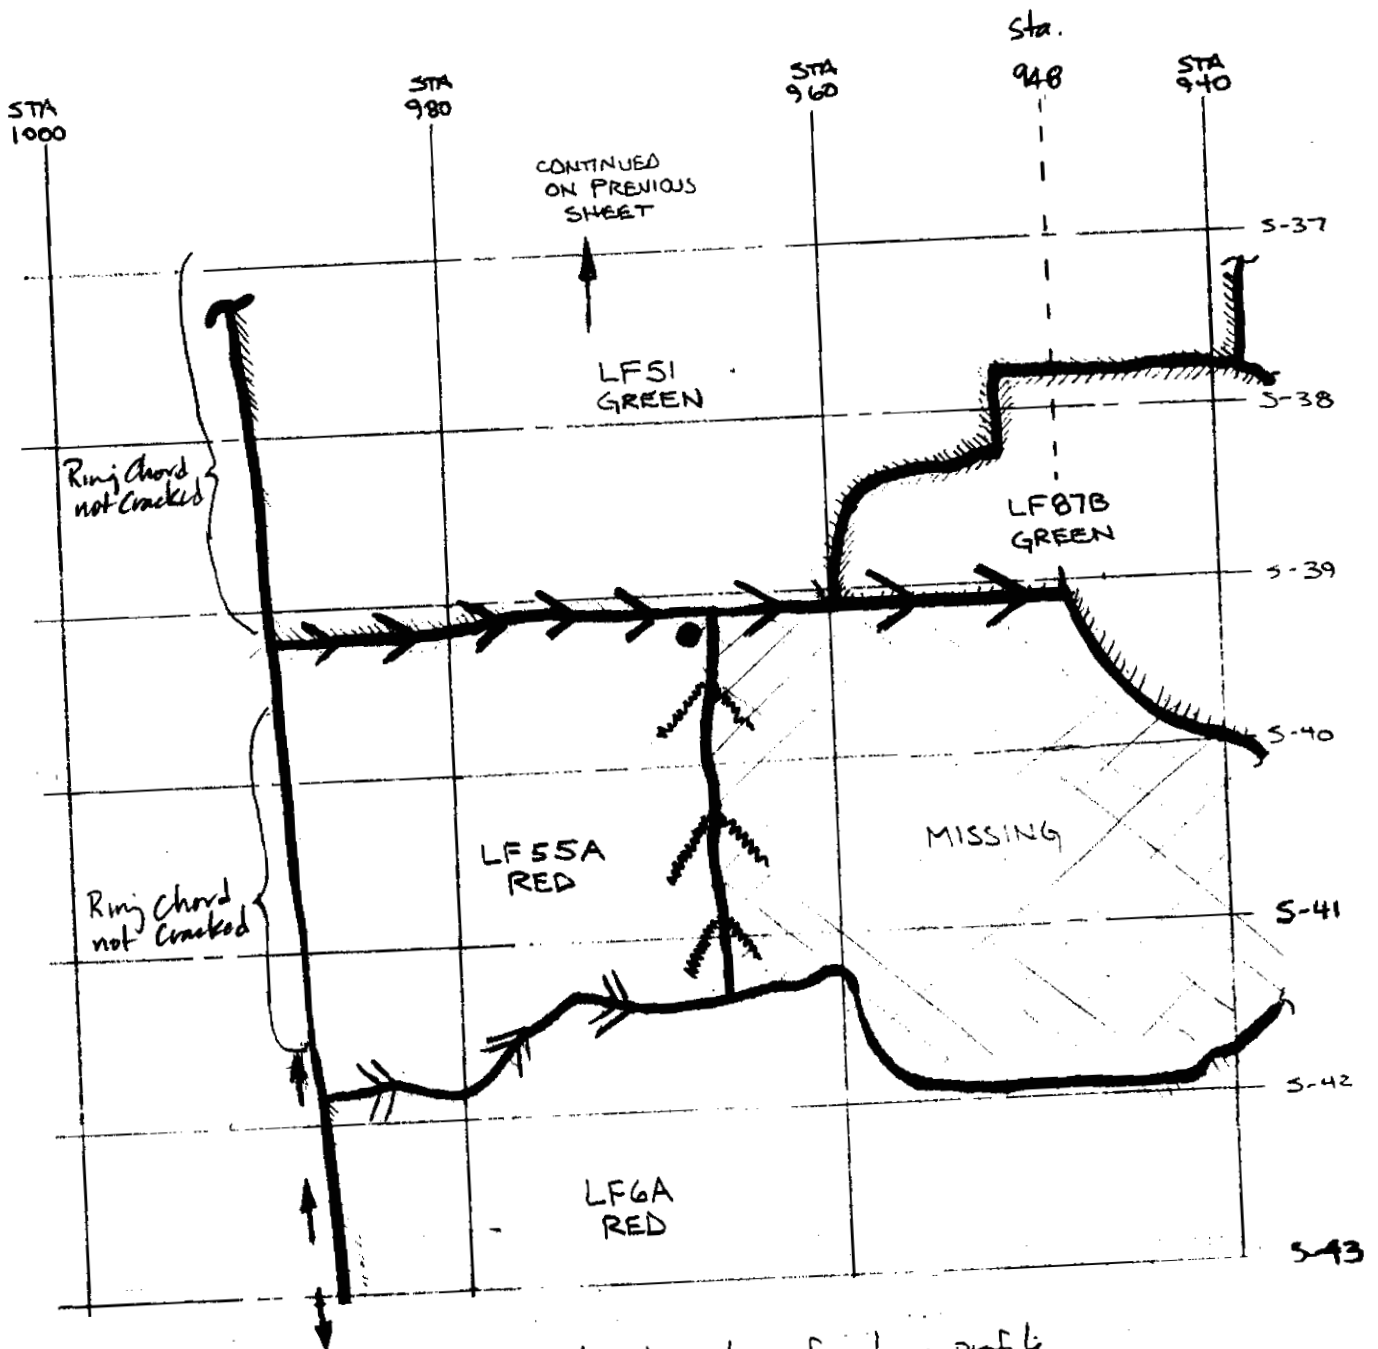
- Fracture propagation direction based on fracture profile through a number of fastener holes.
- Fracture direction documented by J. Widely & G. Fleis.
- Fracture direction based on extension of fracture path confirmed as above and peeling deformation observed. Final separation point being the end of the curl in the peeled area.
- End of curl in a peeled area
- ➔ Fracture direction in ring chord based on macroscopic fracture features ("chevrons").

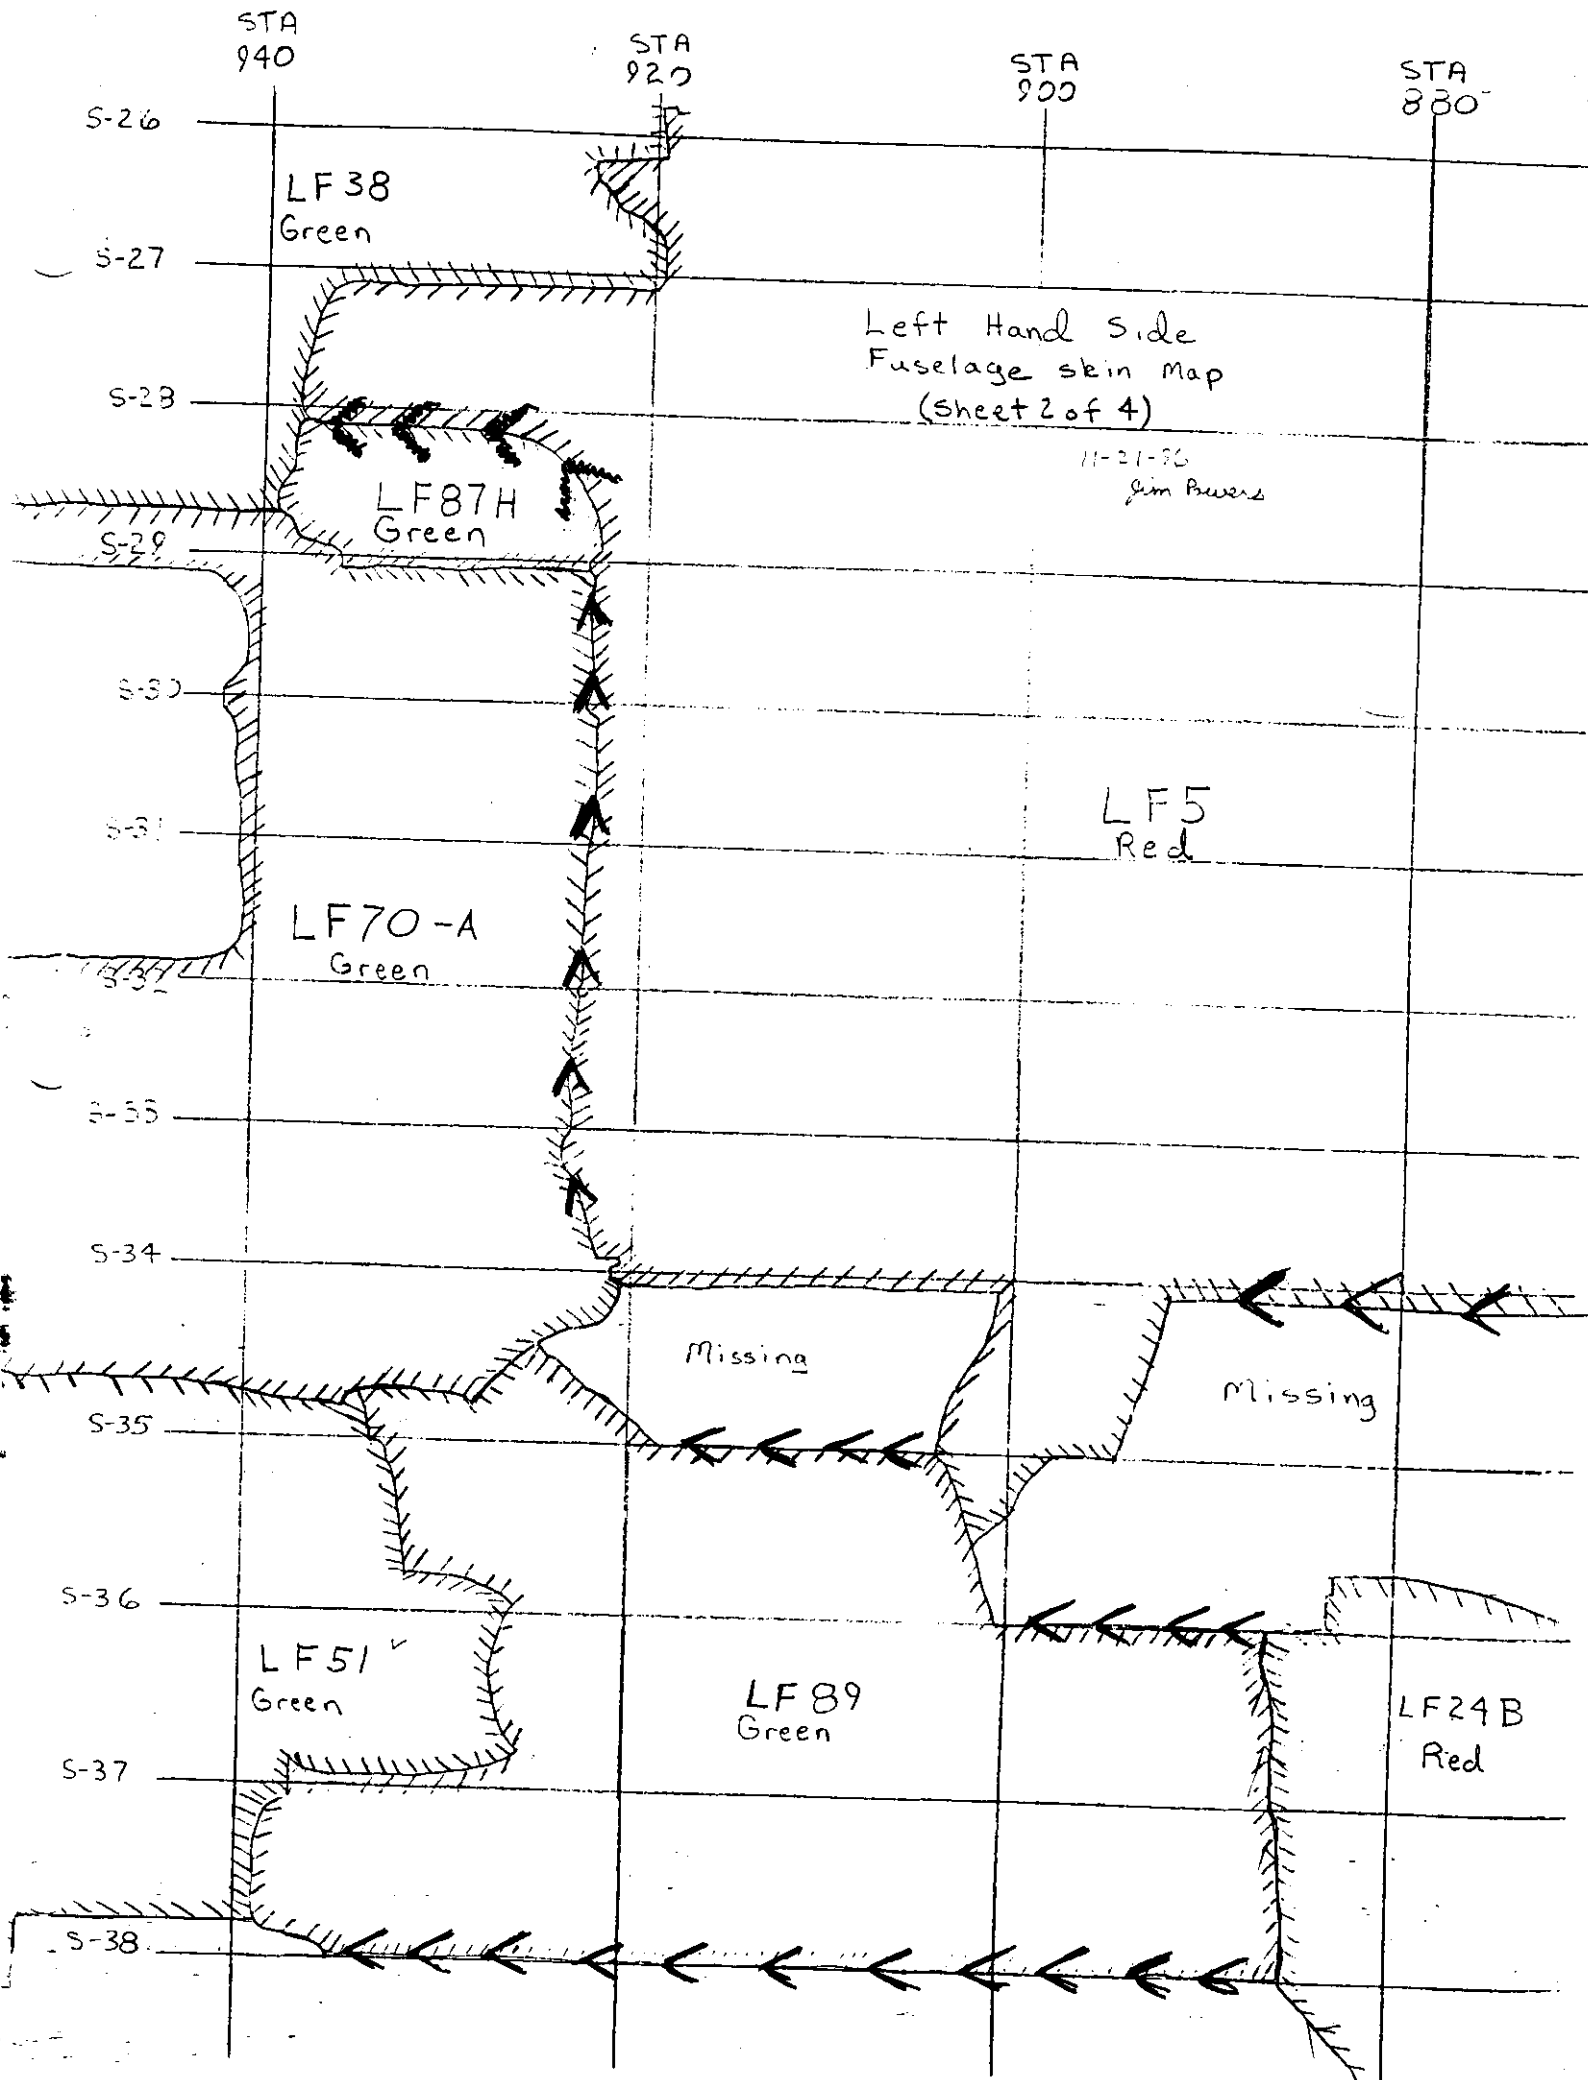
Fracture Direction Documentation - Red Zone (Supplement)

The following sketches are intended to supplement the original fracture direction maps generated by Jim Wildey and George Fleis on 9/28/96. The maps contain fuselage pieces recovered since the original documentation as well as a more accurate description of their size and location. Many of the directions were previously documented but are included because they were re-confirmed.

Two additional areas of net area tension through the longitudinal fastener line were observed along S-37R from Station 850-900 and along S-44R from Station 830-840. Unlike the previously documented areas containing net area tension, the fracture directions leading to and departing from these newly identified areas of net area tension were the same.

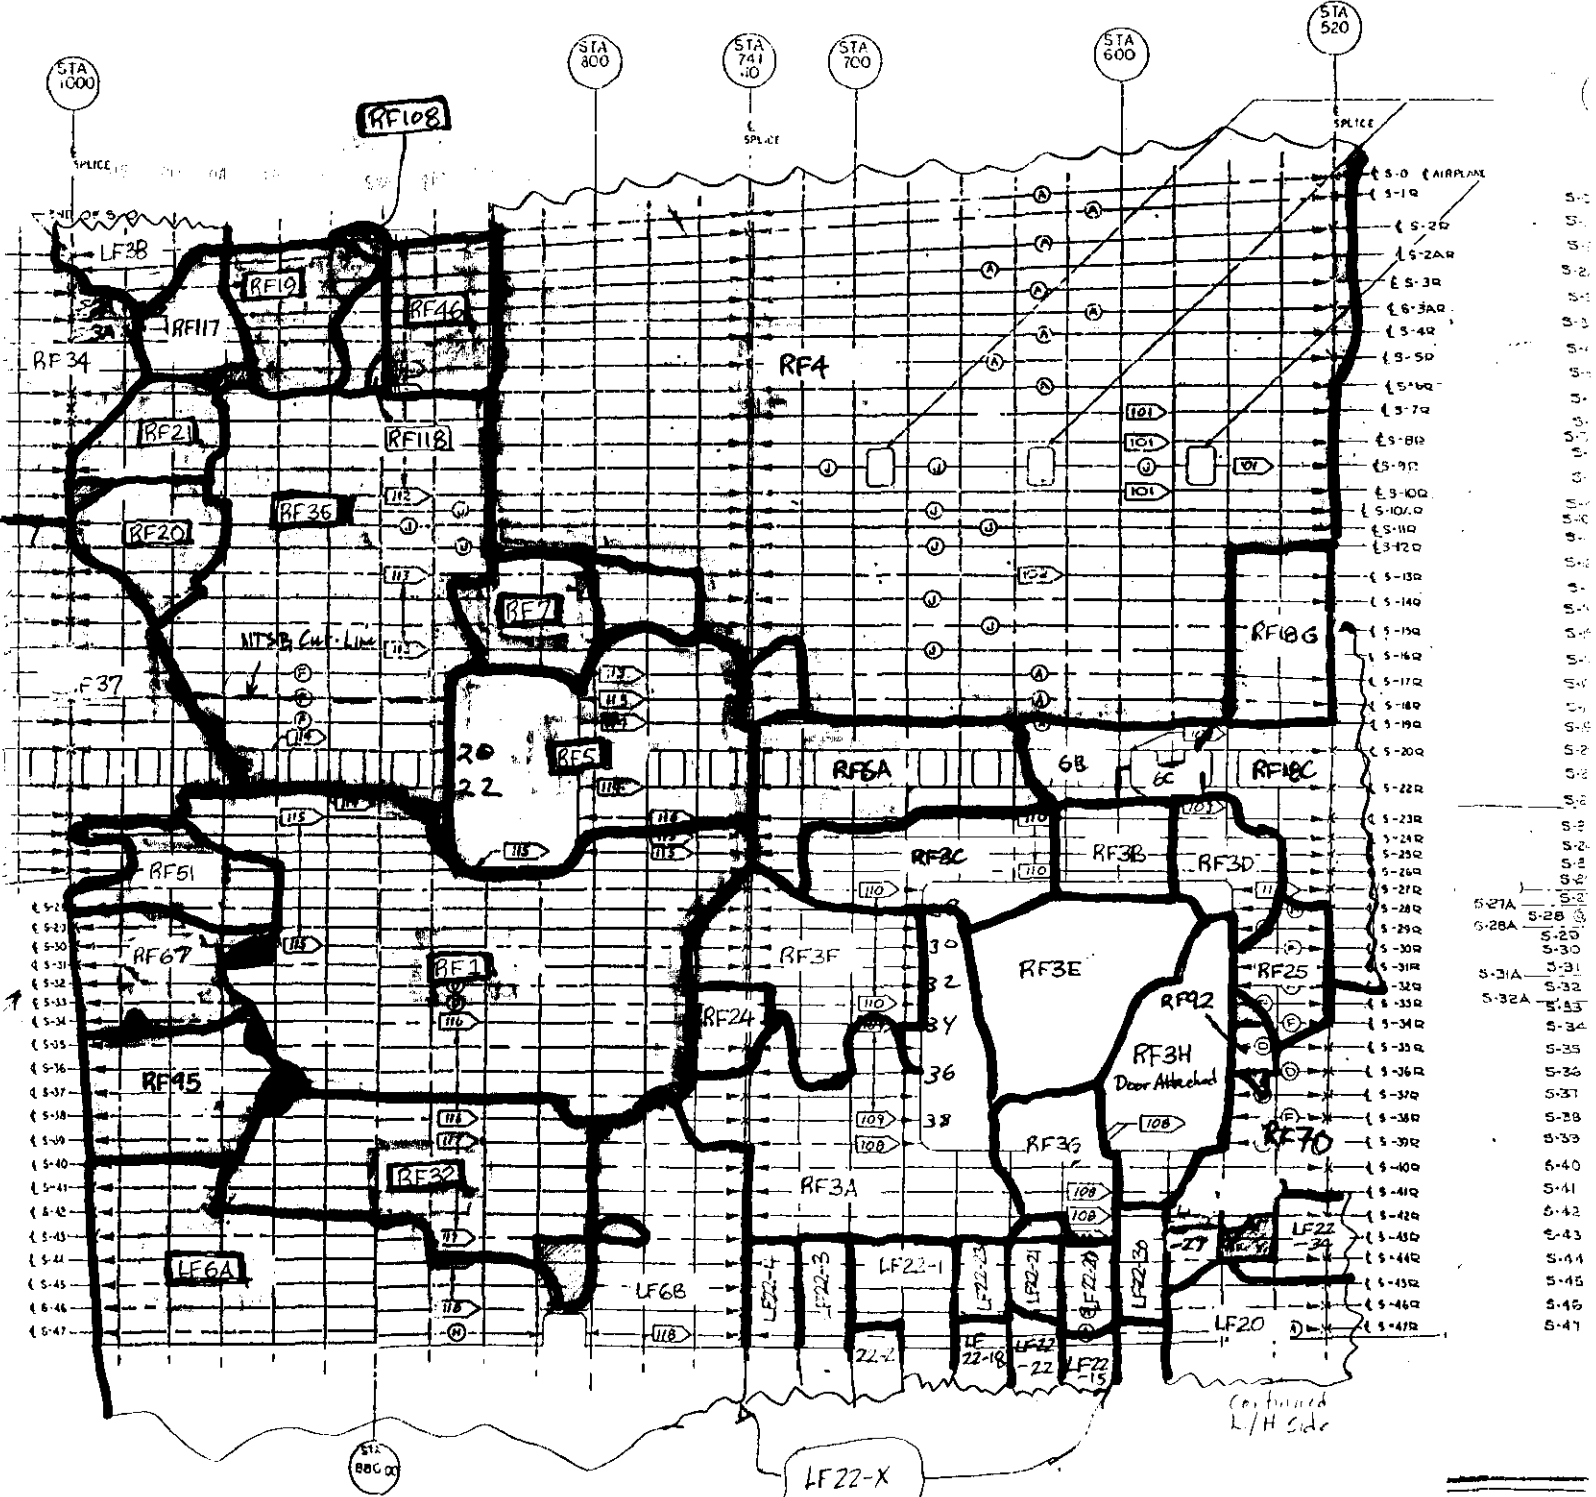
SECTION 42 - STA. 520-1000 (R/H Side)

The attached airplane fuselage maps give a running log of the pieces analyzed and to what extent. A high lighted line around the perimeter of the piece means the fracture surfaces have been examined with no evidence of any pre-existing slow growth cracks found. A completely high lighted orange section means that both general observations and all fracture surfaces were examined. A orange high lighted box around the ID implies that general observations were only made.

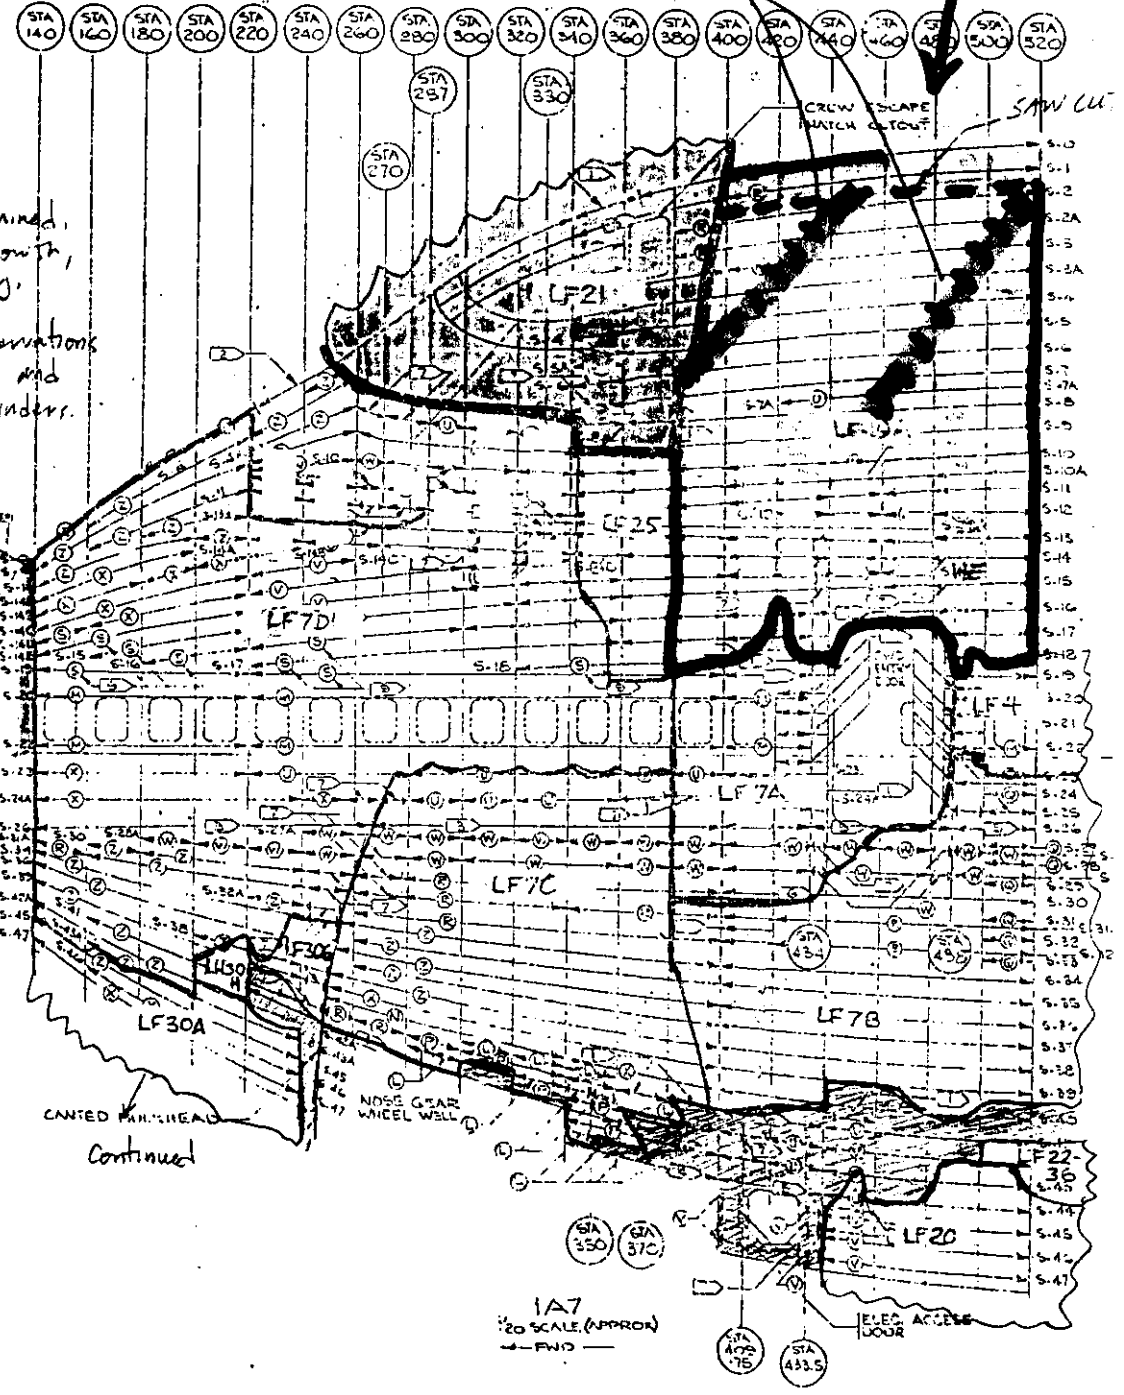
Fracture Surface Examined,
No evidence of slow growth,
ductile separation only.

General fracture observations
made to noted section and
documented in ring binders.
