LOG# LF1

JEKAS FIELD

FUSELAGE SEGMENT LH.

LEFT HAND
SKIN PANEL
← FWD

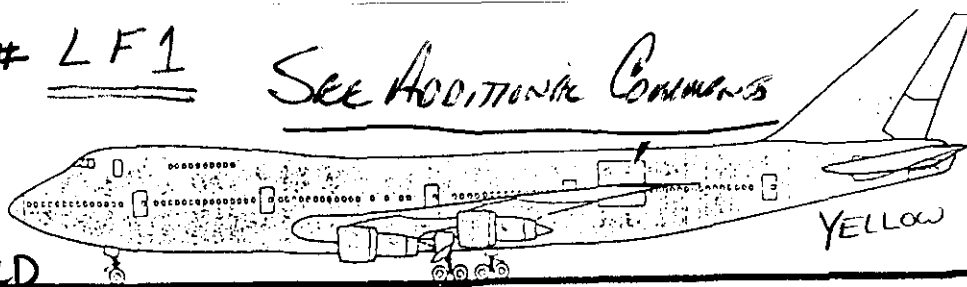
① ~~THE~~ THE FWD SECTION OF SKIN LOCATED @ FUSELAGE STATION 580 HAS FRACTURED IN A STRAIGHT LINE OVER THE 580 FORMER SHEAR TIES FROM THE STRINGER 23L DOWN TO STRINGER 38. THE STRINGERS ALSO WERE SEVERED AT THE SAME STATION.

³⁹ THE SKIN BT STRINGER 38 TO 39 ~~AT~~ STATION A ~~PORTION~~ OF 580 TO 600, HAS BEEN RIPPED AWAY. WITH AN ~~INDICATION OF~~ ~~THE~~ ~~MATERIAL~~ ~~BEING~~

③ THE SKIN IS SEVERED ALONG THE STRINGER 39 FROM STATION 600 BACK TO STATION 660. THIS BREAK IN THE SKIN HAS ROUGH TORN ~~MATERIAL~~ EDGES. THEY ARE THREE HOLES ^{TORN} ~~TEARS~~ VERTICAL OVER FORMER STA 620, STA, 640, STA 660. THE TEARS ~~ARE APPROX~~ RUN VERTICAL ^{FROM} TO STRINGER ³⁹ TO STRINGER 37, AND ~~ABOUT~~ VERY IN WIDTH FROM 6" TO 3". THE ROUGH EDGES AROUND THE HOLE TURN OB.

④ AT STATION 670, THE SKIN IS ROUGH
~~FROM~~ ^{TORN} FROM STRINGER 38 VERTICAL TO STRINGER
~~30 SKIN LAP. HAVE THE FOLLOWING.~~

THE PORTION OF SKIN FROM 670 AFT TO STA 720
AS SEEN ~~IN~~ ^{IT} ITEM 4 HAS BEEN ~~TOOK~~ ^{TORN} AWAY.

THIS SECTION ~~IS~~ ^{RUNS FROM} STRINGER 39 TO STRINGER ~~32~~ 34

⑤ THE AFT SECTION SKIN IS ROUGH ~~TOOK~~ ^{TORN} FROM
STATION 780, VERTICAL TO STATION 800.
SEE ITEM 5,
