LOG # LF10 <sup>101</sup>  
 TARGET # Bevs  
 REVI  
 COORD: LAT 40 39 71  
 LONG 72 37 27

# Aft Pressure Bulkhead Structure

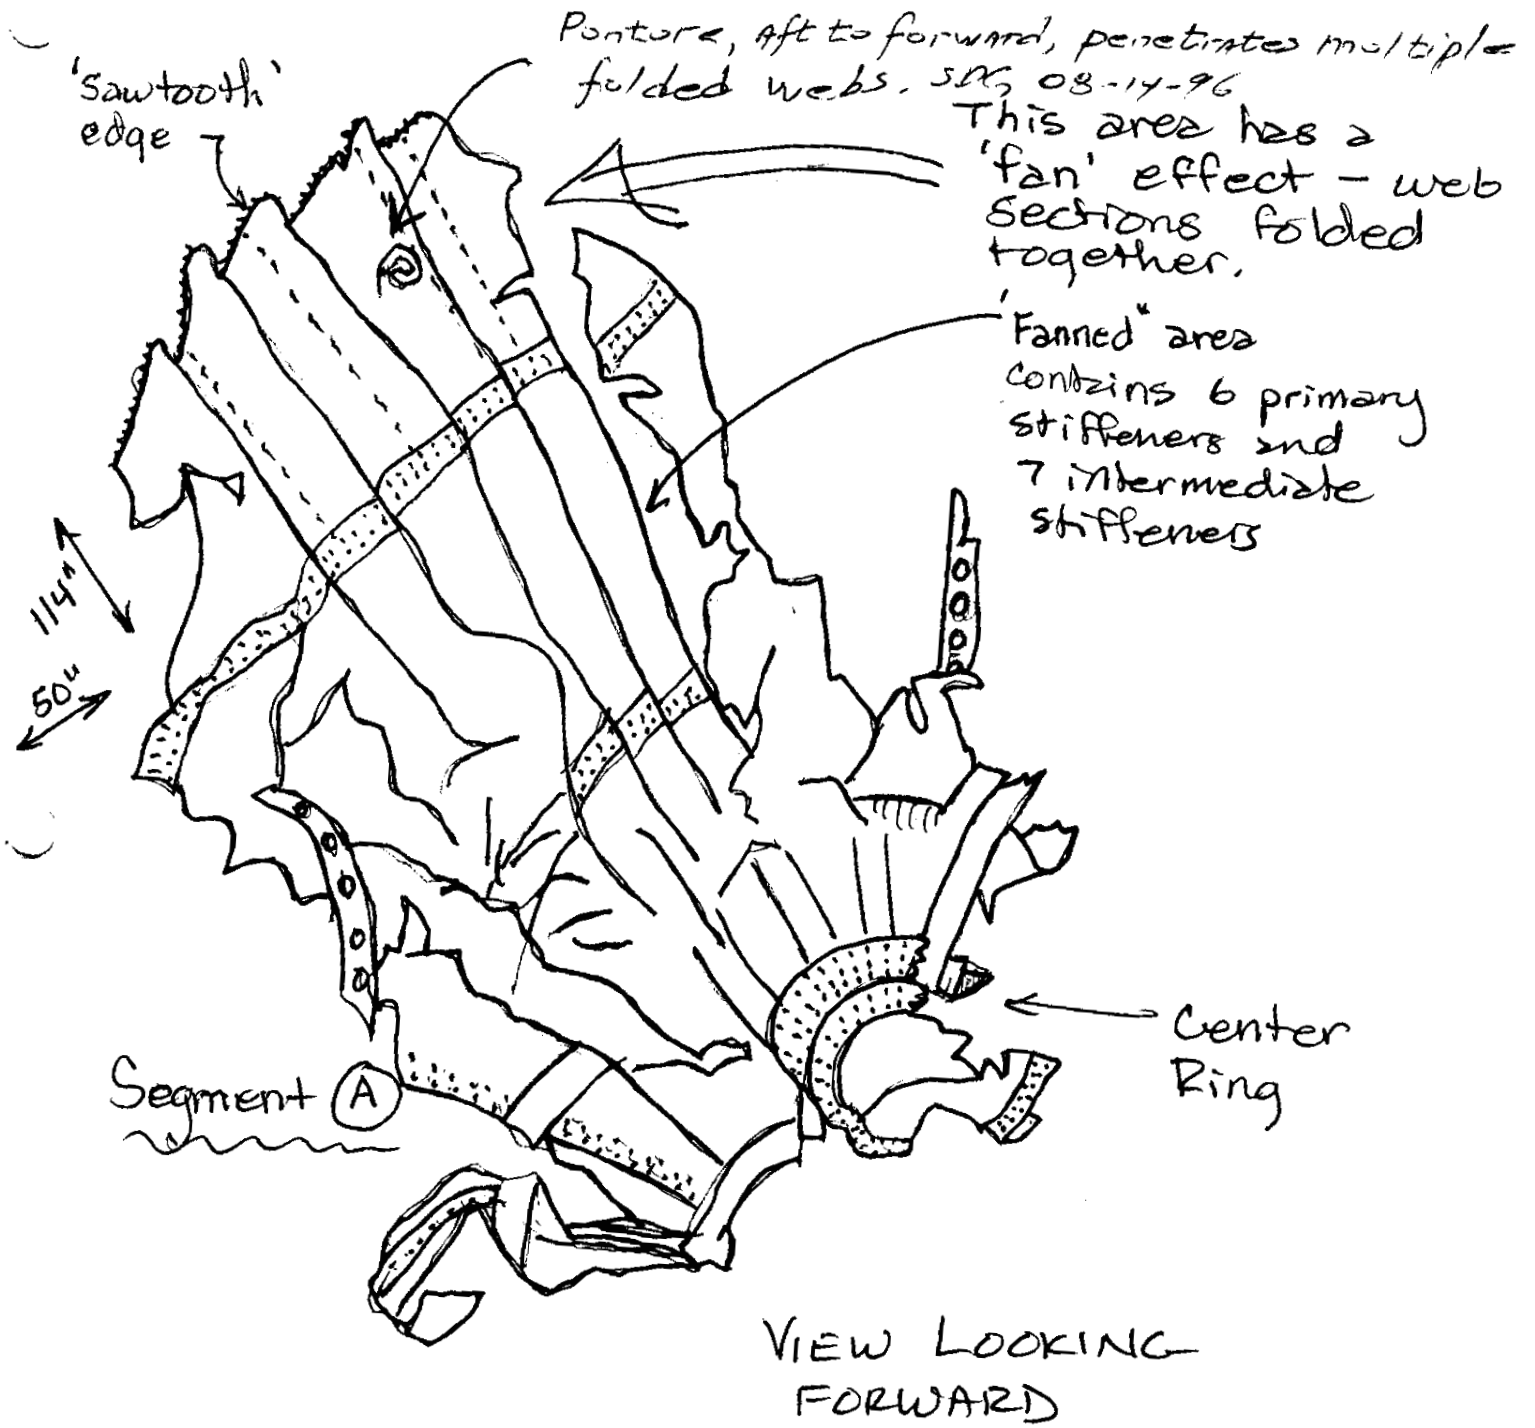
Portion of Aft Pressure Bulkhead as shown on next sheet. Minimal deformation to central portion of segment. Small puncture area (going aft) on RHS segment. Static failure along fastener row attaching to periphery of web. No signs of fire damage.

Additional portions, (A) and (B), cover most of the remaining LHS portion of the Bulkhead. Part labeled (C) was attached by wires to part (B) but does not appear to be bulkhead structure. See sheet 6 for locations of

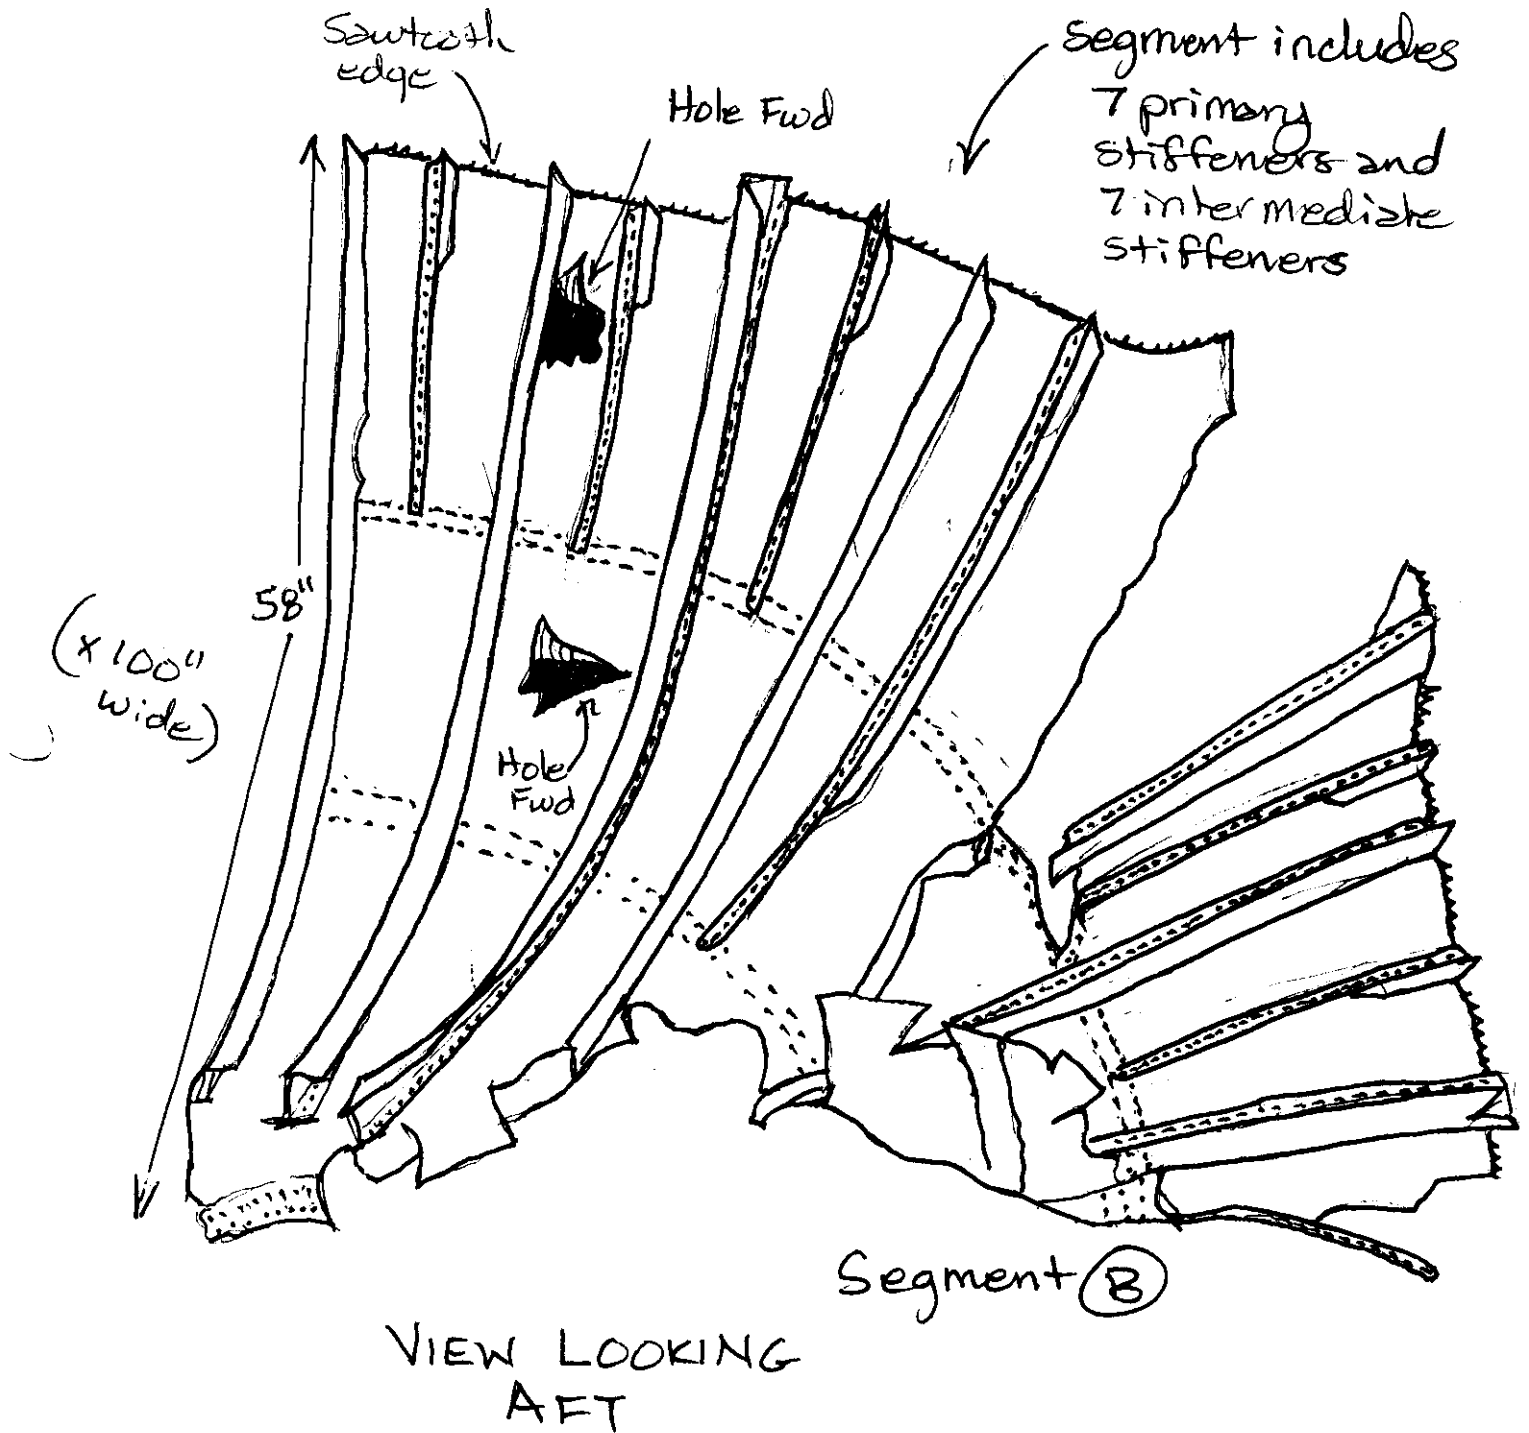
# Aft Pressure Bulkhead Structure

This Structure Attached to  
Aft Pressure Bulkhead Structure

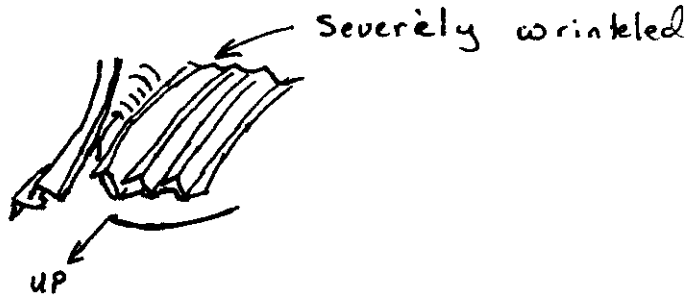
Additional portion (G) size shown on  
sheet 6. Segment folded (stiffeners closed  
on each other) similar to portion (E).  
No soot.
