LOG # LF122
 TAC# TARGET # DZ106
 COORD: LAT _____
 LONG _____

MAIN DECK FLOOR BEAM

LBL 98.5B FROM STA 1298 TO STA 1325

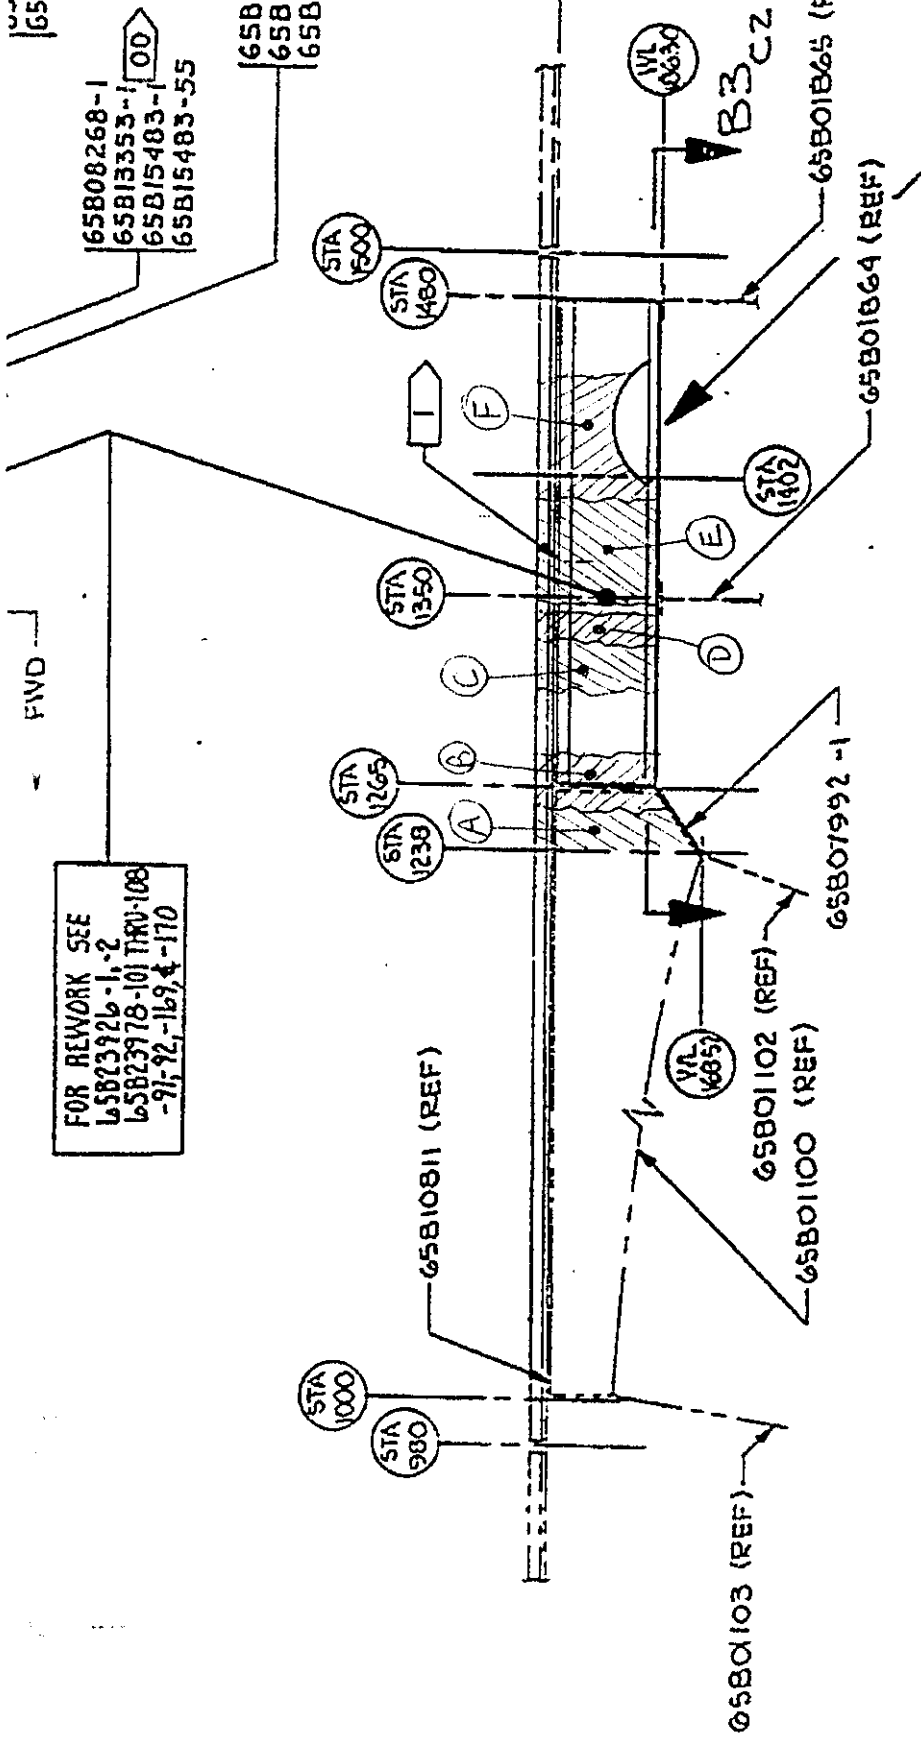
LBL 98.58
 FLRBM

- * INDICATION OF SOOTING ON THE INBOARD SIDE OF THE FLOOR BEAM WEB FROM THE CIRCULAR CUTOUT FORWARD TO THE EDGE OF THE WEB. NOT SHOWN ON SKETCH
- * THE FLOOR BEAM WEB FRACTURED ABOVE THE LOWER CHORD VERTICAL LEG.
- * APPROXIMATELY 6.0 INCHES OF THE SEAT TRACK FAILED AT THE RADIUS, AS SHOWN ON SKETCH
- * A DARK TAR LIKE SUBSTANCE COATS THE LOWER SURFACE OF THE SEAT TRACK HORIZONTAL FLANGE AND APPEARS TO HAVE RUN DOWN THE FLOOR BEAM WEB. LOCATED ON BOTH SIDES OF THE FLOOR BEAM.
- * NO INDICATION OF ANY PENETRATIONS.
