LOG # LF 123

LBL 48.58 LONGITUDINAL FLOOR BEAM  
STA 1321 TO STA 1341

DEBRIS FIELD GREEN

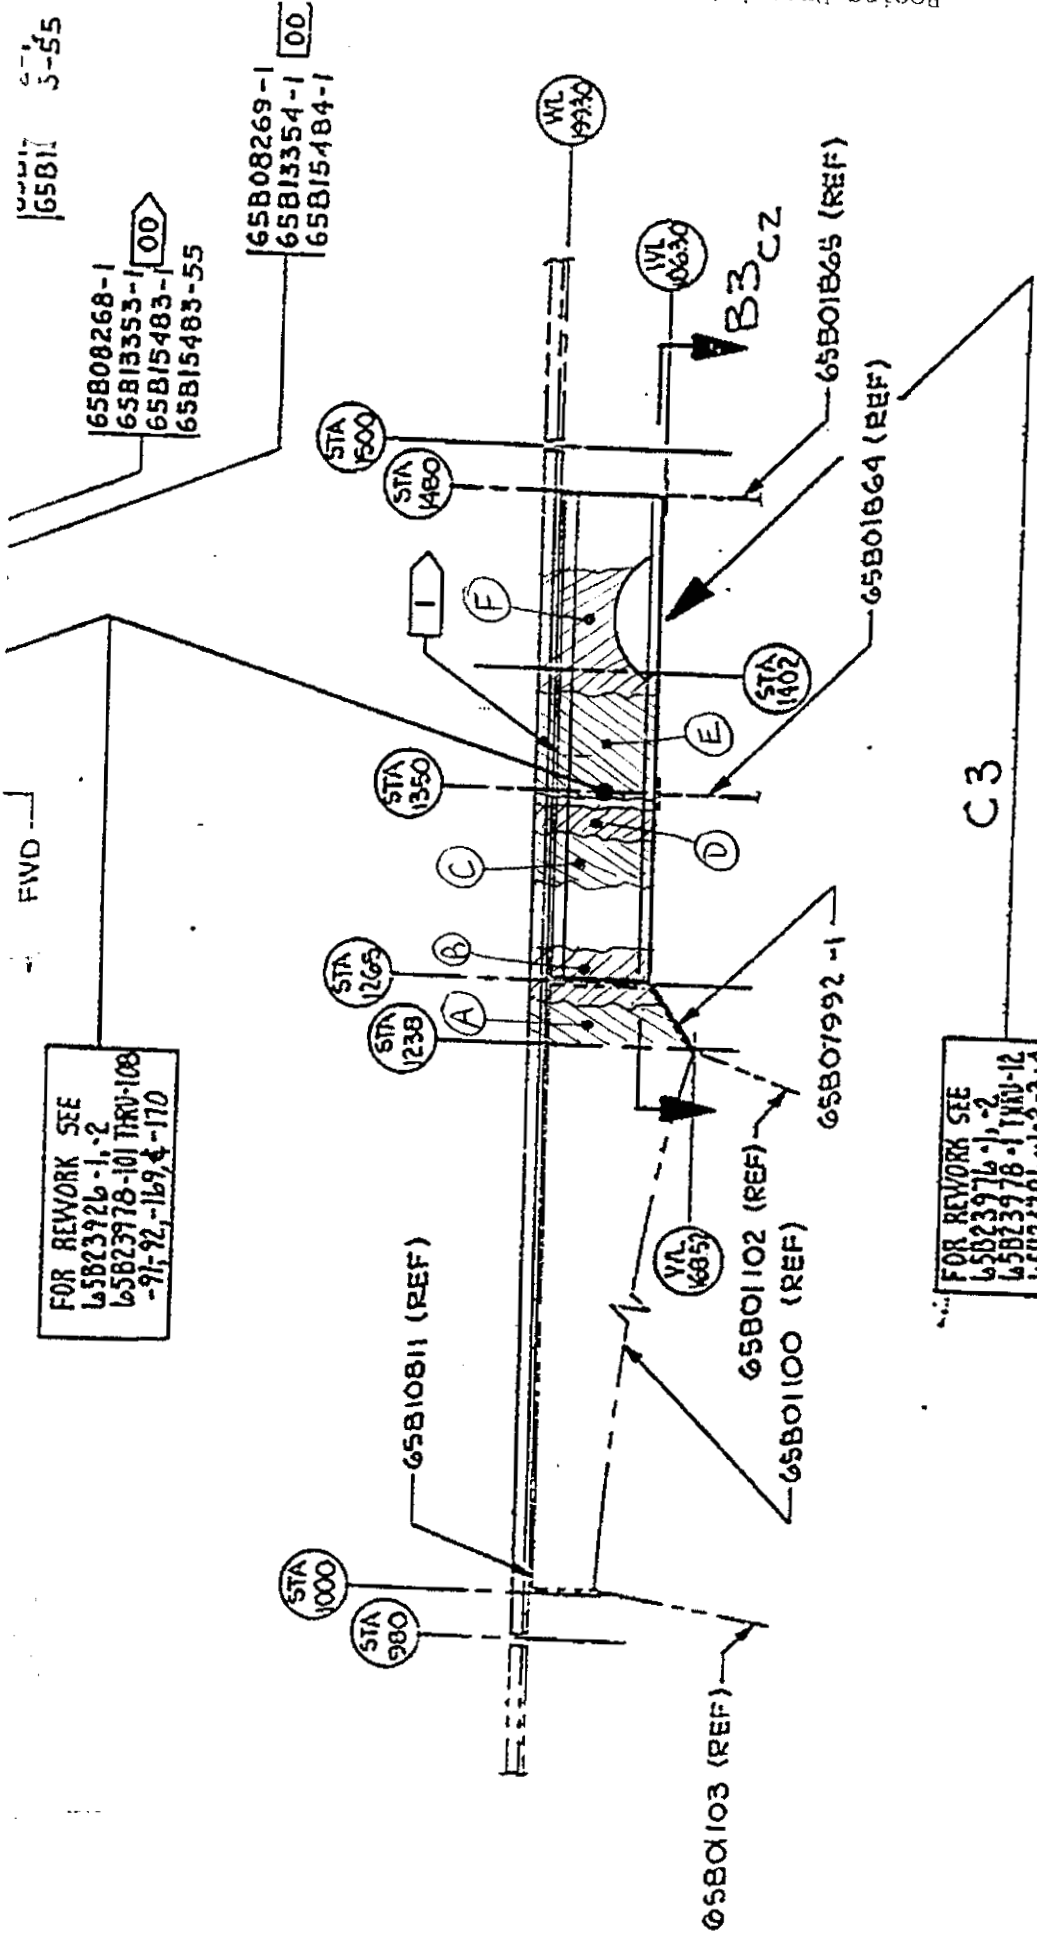
LBL 98.58  
 FLRBM

- \* INDICATION OF POSSIBLE LIGHT SCOTING ON OUTBOARD SURFACE OF F/B WEB
- \* BOTH THE UPPER AND LOWER CHORDS FRACTURED AT THE RADIUS OF THE HORIZONTAL FLANGE. THE VERTICAL FLANGE REMAINED W/ WEB.
- \* THERE IS A TAR LIKE SUBSTANCE WHICH HAS RUN DOWN THE UPPER SURFACE OF THE FLOOR BEAM WEB ON THE OUTBOARD SIDE. NOT SHOWN ON SKETCH.
- \* NO INDICATION OF PENETRATIONS IN WEB.
