LOG # LT 144
 TAG # Z 2981
 COORD: LAT _____
 LONG _____

DEBRIS FIELD GREEN

LBL 98.58 LONGITUDINAL FLOOR BEAM FROM STA 1346 TO STA 1400.

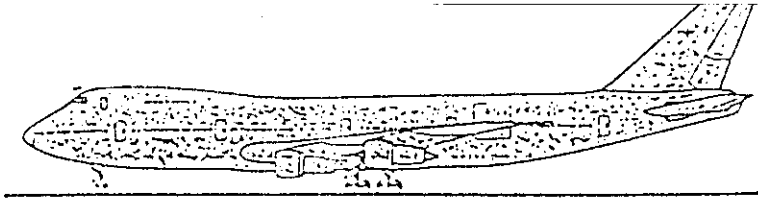
- * THE UPPER CHORD (SEAT TRACK) EXTENDS FROM STA 1350 TO 1400 A WITH SECTION OF PASSENGER SEAT THAT REMAINED ATTACHED FROM STA 1366 TO STA 1383.
- * THE LOWER CHORD SEPERATED AT THE RADIUS WITH THE HORIZONTAL FLANGE MISSING EXCEPT FROM STA 1346 TO STA 1360. TWO SMALL PIECES OF THE STA 1350 BULKHEAD UPPER CHORD REMAINED ATTACHED TO THE LOWER CHORD HORIZONTAL FLANGE.

- * THE WEB FRACTURED FROM THE FWD EDGE AT STA 1346 TO JUST AFT OF THE BATHTUB FITTING AT STA 1350, JUST ABOVE THE LOWER CHORD VERTICAL FLANGE.
- * THE LOWER CHORD SECTION WITH THE HORIZONTAL FLANGE STILL ATTACHED IS TWISTED APPROXIMATELY 110° TO 160° IN THE AXIS OF THE FLOOR BEAM.

- * THE FLOOR BEAM WEB HAS A JAGGED TEAR EXTENDING FROM THE LOWER CHORD AT STA 1390, UP ABOUT 3.5 INCHES THEN BACK DOWN TO THE LOWER CHORD AND AFT TO THE END OF THE FLOOR BEAM SECTION AT STA 1400.

- * THERE ARE NO INDICATIONS OF PENETRATIONS.
- * THERE ARE INDICATIONS OF POSSIBLE LIGHT SOOTING ON BOTH INBOARD AND OUTBOARD SIDES.
- * THE VERTICAL STIFFENER UPSTANDING LEGS ARE MISSING AT STA 1372 AND STA 1394
