LOG # LF26 ^{SDG} ^{RTS 10-7-96}

DEBRIS FIELD #1 Green
(Far)

LHS Aft Body Skin, S-8L → 24L, STA 2285 → 2360.

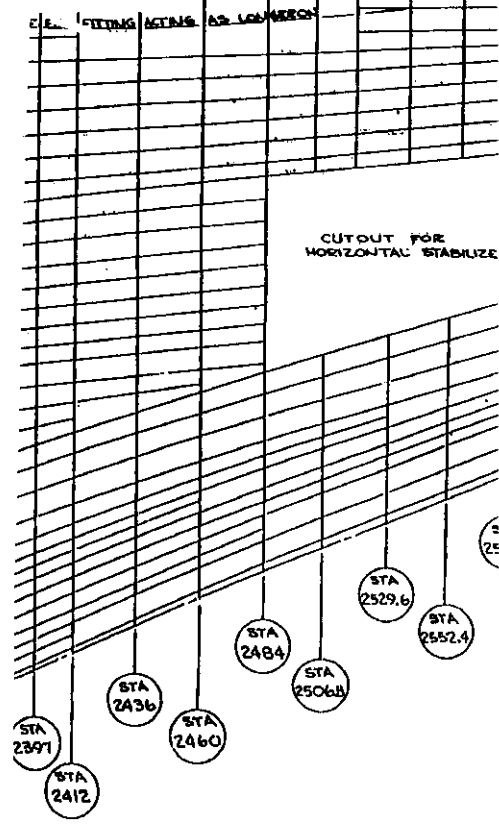
DEVELOPED VIEW LEFT SIDE 1/20 SCALE

Body skin panel section includes Y ring at STA 2360 and several small portions of empennage structure as shown on next page. Upper fracture surface of Y ring is shown below. Fails through Y ring fastener holes at/near stringer attach.
