LOG # LF127

TARGET # C2455

DEBRIS FIELD GREEN

PRESSURE DECK FLOORBEAM, LBL 75.92  
STA 1439 TO 1466

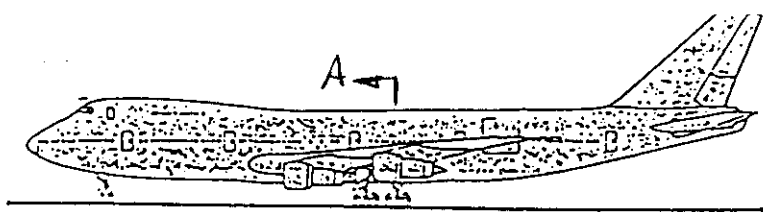
FLOORBEAM UPPER CHORD  
REMNANT, UPPER SEAT TRACK  
CROWN PORTION MISSING,

STIFFENER ON  
INBOARD SIDE  
ALSO

AFT WEB  
OVERLAPS FWD WEB

OUTSTANDING FLANGE  
BENT AFTWARD,  
WITNESS MARK  
INDICATIONS

FLOORBEAM LOWER CHORD  
REMNANT, LOWER FLANGES  
FOR ATTACHMENT TO THE  
PRESSURE DECK BROKEN  
OFF.

WEB  
CRACKED

WITNESS  
MARK  
INDICATIONS  
ON INBOARD  
SIDE OF WEB.

STA 1460 VERTICAL  
STIFFENER, LOWER  
END PADS BROKEN  
OFF. (STIFFENER  
PROVIDES BACK UP FOR  
MLG TRUNNION SUPPORT  
FITTING UPPER OBLIQUE  
TIE RODS RUNNING FROM  
STA 1480 TO STA 1460)

NO APPARENT SOOTING  
OF EITHER INBOARD OR  
OUTBOARD SURFACE.
