LBL 33.99 LONGITUDINAL FLOOR BEAM
FROM STA 1273 TO 1303.5

LOG # LF 132
TARGET # D 2111
COORD: LAT _____
LONG _____

DEBRIS FIELD WHITE

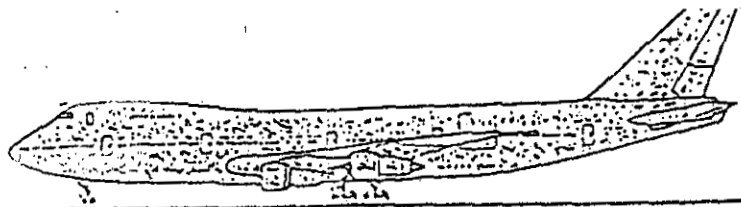
- * NO INDICATION OF ANY PENETRATIONS IN WEB.
- * INDICATION OF POSSIBLE LIGHT SOOTING AND OR DIRT ACCUMULATION ON BOTH THE INBOARD AND OUTBOARD SIDES.
- * SEALANT AROUND THE EDGE OF THE WEB CIRCULAR CUTOUT SHOWS INDICATION OF SOOT AND OR LIGHT CHARING ON THE OUTBOARD SIDE ONLY.
- * THE WEB LOWER EDGE FAILED ALONG THE FASTENER LINE COMMON TO THE LOWER CHORD EXCEPT AT THE STA 1283.5 STIFFENER WHERE A SMALL SECTION OF THE LOWER CHORD VERTICAL FLANGE REMAINED ATTACHED.

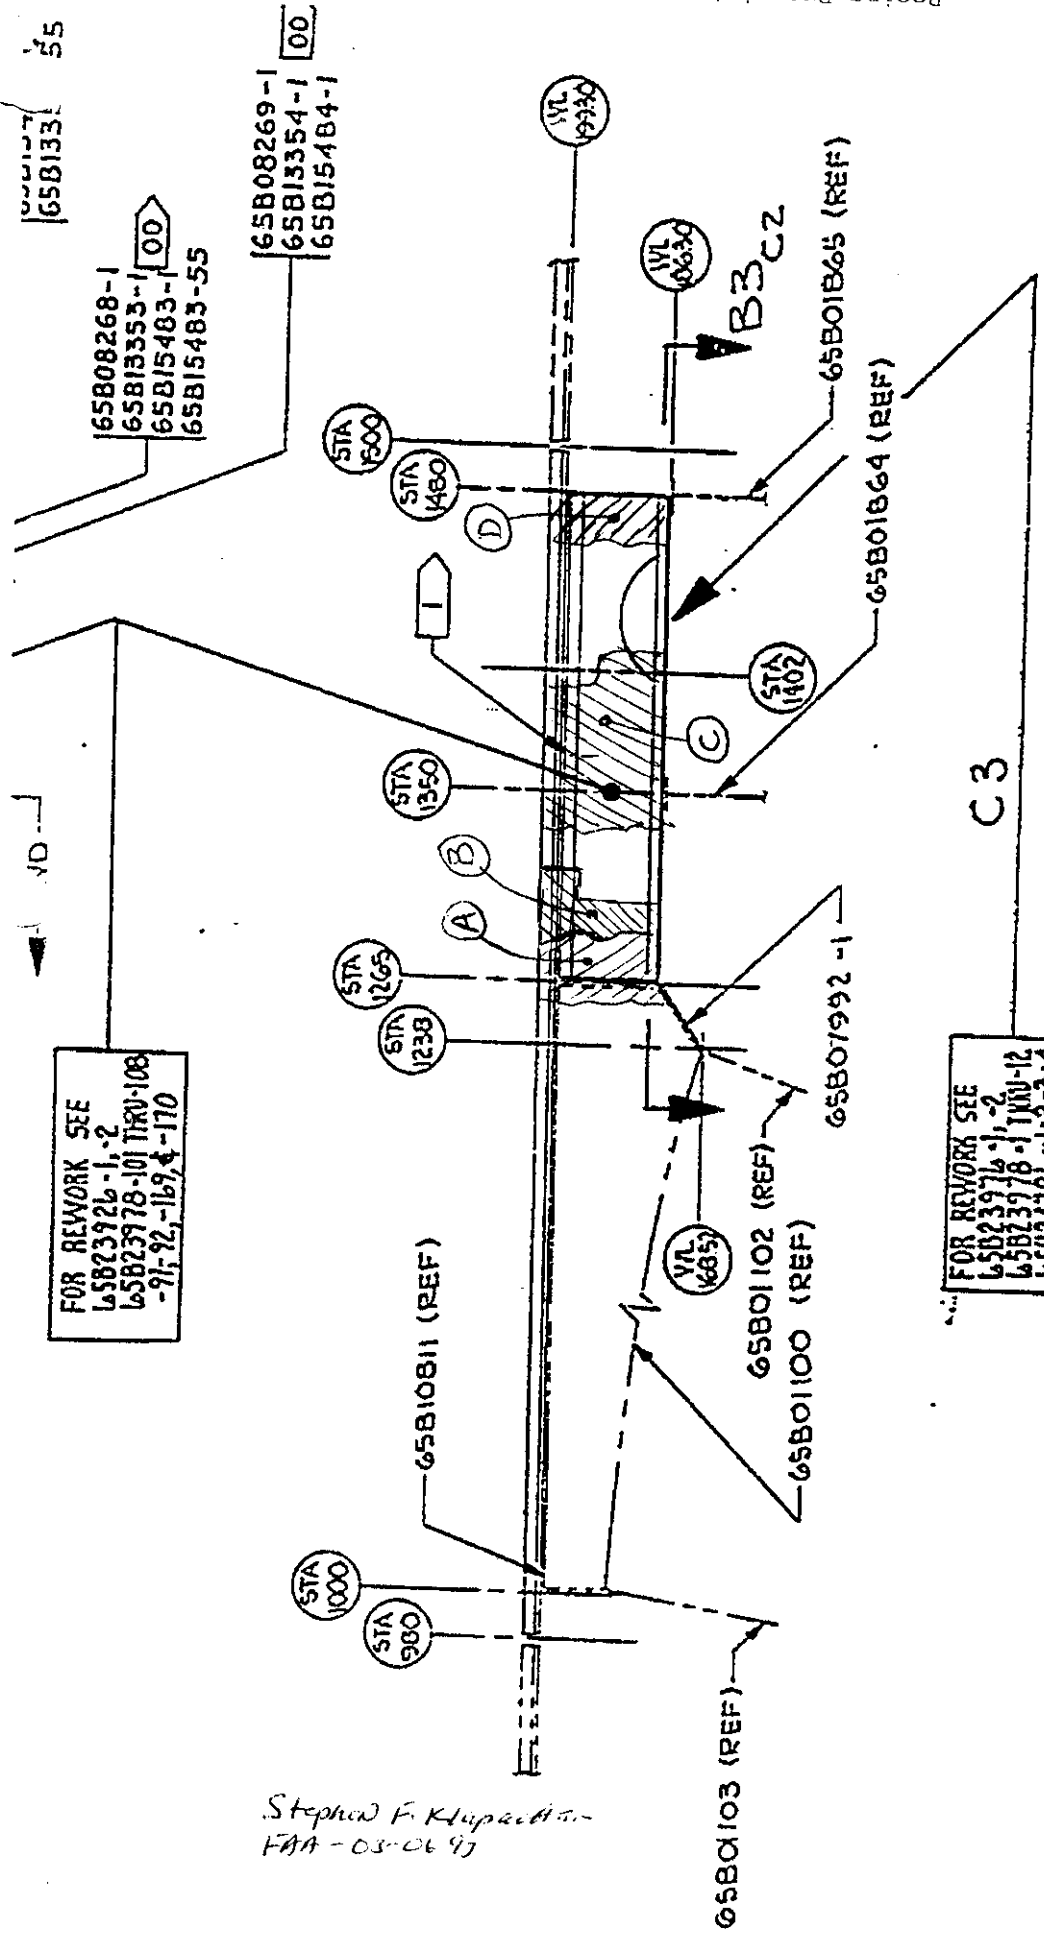
LBL 33,99
 FURBIM

ITEM	LOG #
A	LF 131
B	LF 132
C	LF 133
D	LF 134
