KEEL BEAM BOX
SEE SKETCH ON
NEXT PAGE

LOG # LF-14 Rev A ^{SDG} ^{RTS 10-1-96} ^{RHS}

Rev A added extra segments
depth of structure
now have Parts A, B, C & D
Added Pages 1a, 9-12
Revised Pages 1, 5, 6

LF 14 Rev A
ROAD MAP

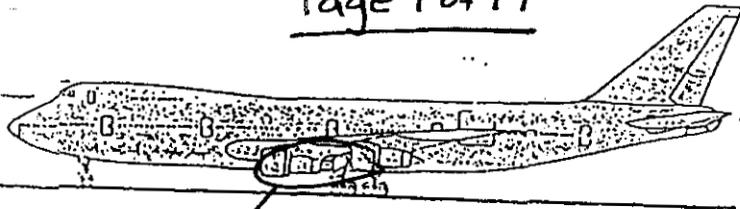
DEBRIS FIELD SEE BELOW

PART	DEBRIS FIELD
PART A	RED TAG # 1001 A-2048
B	GREEN C 061
C	↓ → WHITE D2133 Kurtz 2/28/97
D	ASSOCIATED WITH GREEN TAG # C-109 <div style="border: 1px solid black; padding: 5px; display: inline-block;">C-2440</div>
