LOG # 1071045 SD's  
LF-16 REV A  
 TARGET # \_\_\_\_\_  
 COORD: LAT \_\_\_\_\_  
 LONG \_\_\_\_\_

DEBRIS FIELD GREEN \*

RELATED TO CWZ

LF-16

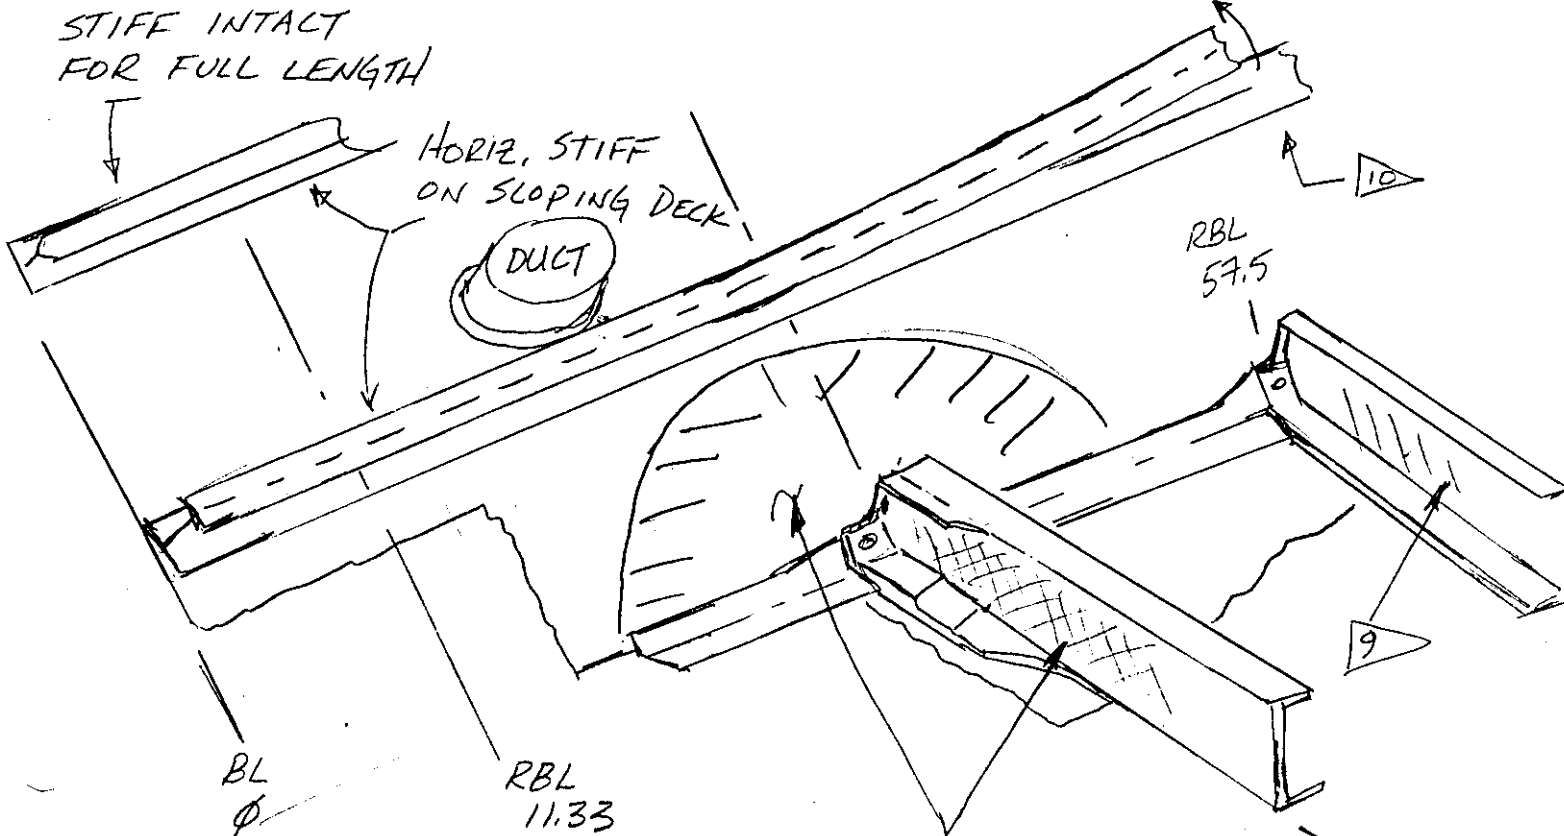
LF-16 PART A (RHS)

VIEW LOOKING UP @ SLOPING DECK

HEAVILY SOOTED  
PAINT PEELING  
OFF STIFFENER  
(BEFORE CUT)

*Left*  
DIRTY/SOOTED

9 THIS SIDE OF STIFF DIRTY/SOOTED NOT NEAR AS BAD AS BL 33 STIFF, OUTB'D SIDE OF STIFF CLEANER, BUT STILL SHOWS SIGN OF SOOT. THE STIFF AT BL 75 IS ABOUT THE SAME AS BL 57.5 STIFF

10 HORIZONTAL STIFF SEVERED @ RBL 70,

UP, ALSO BROKEN AT EXTRU. RADIUS FROM RBL 33 => 70
