LOG # LF 17  
TARGET # C-109  
COORD: LAT \_\_\_\_\_  
LONG \_\_\_\_\_

DEBRIS FIELD GREEN

LOG# LF-17  
TAG: C-109 (GREEN)

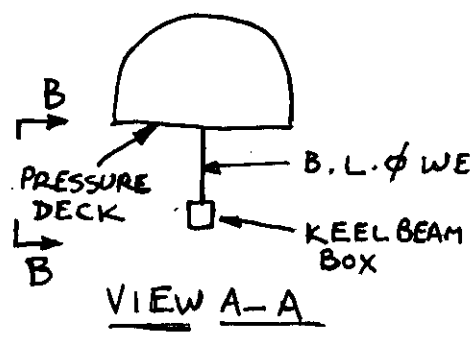
STRUCTURE IS PART OF THE B.L.  $\phi$  KEEL BEAM CENTER WEB EXTENDING FROM STA 1241 (REAR SPAR OF WING BOX) AFT TO STA  $\sim$ 1330, AND FROM THE PRESSURE DECK AT W.L. 186.3 DOWN TO W.L. 116 (TOP OF KEEL BEAM BOX). PARTS OF THE KEEL BOX UPPER SURFACE REMAIN ATTACHED, AS WELL, INCLUDING A PORTION OF THE BOX UPPER WEB, BOX VERTICAL WEB (LEFT SIDE, FROM STA  $\sim$ 1255 TO STA  $\sim$ 1277) WITH THE MAIN LANDING GEAR DOOR ACTUATOR SUPPORT FTG (LHS) AT STA 1265, WITH A PORTION OF ITS BACK-UP INTERCOSTAL AND FITTINGS. A PIECE OF ACTUATOR SUPPORT ARM REMAINS ATTACHED TO THE SUPPORT FITTING. REMNANTS OF KEEL BOX UPPER FORGINGS REMAIN ATTACHED IMMEDIATELY BELOW THE BOX UPPER WEB AT STATIONS  $\sim$ 1287,  $\sim$ 1301,  $\sim$ 1307,  $\sim$ 1319 AND  $\sim$ 1329. A PORTION OF THE KEEL BOX UPPER CHORD, LBL 9.0, REMAINS FROM  $\sim$ STA 1235 TO  $\sim$ 1277. FROM STA  $\sim$ 1235 TO STA  $\sim$ 1255, ON THE ~~KEEL~~ KEEL BOX SLOPING UPPER SURFACE, REMAIN THE TWO KEEL BEAM ATTACHMENT BRACES (SEE SKETCH) AND THE B.L.  $\phi$  LWR CHORD.

THE B.L.  $\phi$  WEB ASSEMBLY IS BENT AS SHOWN IN THE SKETCH ALONG A LINE RUNNING FROM STA  $\sim$ 1283 AT THE TOP (W.L. 186.3) TO STA  $\sim$ 1281 AT THE BOTTOM (W.L. 116). THE BEND IS APPROXIMATELY 110°, WITH THE AFT PART OF THE WEB ASSY BENT OUTBOARD TO THE LEFT.

A PIECE OF TOILET DRAIN TUBE REMAINS ATTACHED TO THE WEB ASSY AT STA 1265, W.L.  $\sim$ 174, BY A DUCT CLAMP. THE DUCT REMNANT IS ABOUT EIGHT FEET LONG AND IS ATTACHED TO THE RIGHT HAND SIDE.

A LENGTH OF APU PNEUMATIC DUCT REMAINS ATTACHED TO THE WEB ASSY ON THE LEFTHAND SIDE AT STA 1265, W.L.  $\sim$ 146. ITS LENGTH IS ABOUT EIGHT FEET AND THE DUCT IS CRUSHED AND ALMOST BROKEN IN TWO AT ABOUT THREE FEET FROM ONE END.

A CONSIDERABLE AMOUNT OF HYDRAULIC TUBING REMAINS ATTACHED TO THE WEB ASSY, THE MAJORITY OF IT BEING LOCATED ON THE RIGHT HAND SIDE OF THE WEB. IN ADDITION, THE AIRPLANE'S LATERAL CONTROL MECHANISMS REMAIN ENTANGLED WITH THE B.L.  $\phi$  WEB ASSY, HELD BY CONTROL CABLES, <sup>LINKAGE</sup> AND HYDRAULIC TUBING WHICH'S PASSES THROUGH THE WEB AT VARIOUS ~~PENETRATION~~ PROVISIONS LOCATIONS.
