LOG # LF-20 ⁵⁰⁶ _{275 10-7-96}

DEBRIS FIELD #2

Aft 41 and Fwd 42 Belly Skins

STA 440 → 580, S-42L → 37R

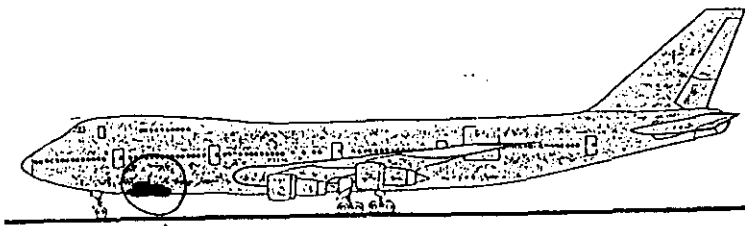
Aft 41 and FWD 42 BELLY SKINS

Skin panel very deformed.

stringers are still attached and

somewhat flattened against the skin.

No frame segments remain attached. Most edges on

segment are bent downward. The lav service panel between STA 540/560 is still in place. The panel outer skin is pushed upward into the service panel.

Large portion of cargo container (R1) recovered in same load. No evidence of burn damage.
