LOG # LF 126
 TAG TARGET # Z 3205
 COORD: LAT _____
 LONG _____

LBL 75.92 LONGITUDINAL FLOOR BEAM
 FROM STA 1290 TO STA 1318

DEBRIS FIELD GREEN

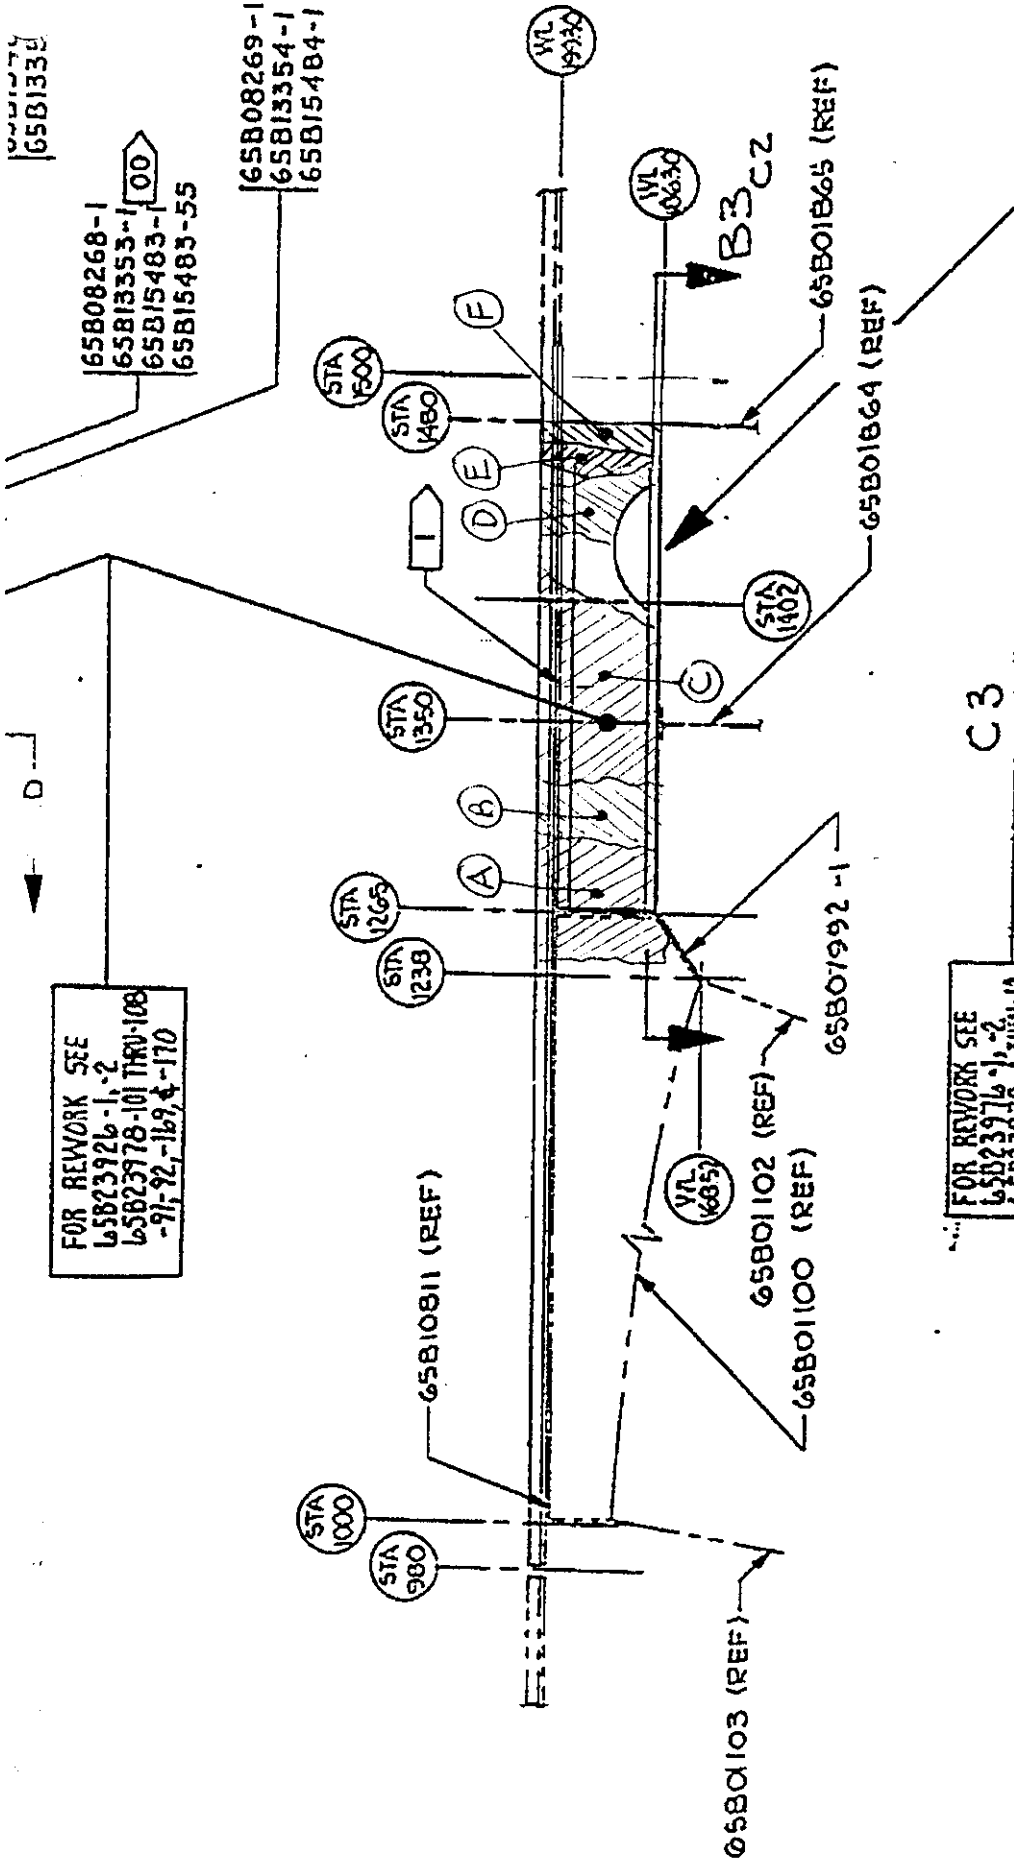
LBL 75.92
 FLRBM

- * THERE ARE INDICATIONS OF MEDIUM TO HEAVY SOOTING ON BOTH INBOARD AND OUTBOARD SIDES.
- * LOWER CHORD HORIZONTAL FLANGE IS MISSING
- * LOWER CHORD VERTICAL FLANGE PULLED OUT OF WEB AND SEPERATED FROM REMAINING LOWER CHORD FROM STA 1290 TO STA 1305.
- * THERE ARE NO INDICATION OF PENETRATIONS IN WEB.
- * THERE IS A TAR LIKE SUBSTANCE ON THE LOWER SURFACE OF THE REMAINING UPPER CHORD HORIZONTAL FLANGE AND THE UPPER EDGE OF THE WEB ON THE OUTBOARD SIDE ONLY.
- * THERE ARE DARK SPLATER MARKS ON THE OUTBOARD WEB SECTION FORWARD OF STA 1290
- * THE FORWARD SIDE OF THE VERTICAL STIFFENERS HAVE A THICK BLACK SUBSTANCE FROM THE UPPER CHORD TO THE LOWER CHORD.
