LOG # LF27

DEBRIS FIELD

LOG # LF27G

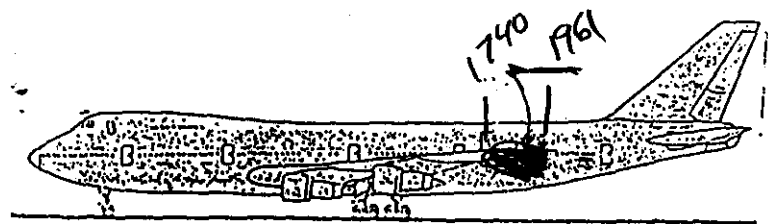
SECTION LF27A MEASURES APPROX $5\frac{1}{2}' \times 3\frac{1}{2}'$ AND ENCOMPASSES FRAMES 1740 THRU 1800 AND STRINGERS S30L THRU S34L. ALL FRAMES MISSING AND ALL STRINGERS FRACTURED, ALSO S33L + S34L MISSING. FUSELAGE SKIN IS IRREGULAR IN SHAPE AND ALL EDGES SHEARED AND TORN AT RIVET HOLES. NO EVIDENCE OF FIRE/SMOKE DAMAGE.

SECTION LF27B MEASURES $5' \times 5'$ AND ENCOMPASSES FRAMES 1760 THRU 1800, AND STRINGER LOCATION S25L THRU S31L. ALL FRAMES MISSING, AND ALL STRINGERS FRACTURED, ALSO STRINGERS S25L, S26L, & S27L MISSING. FUSELAGE SKIN IS IRREGULAR IN SHAPE AND ALL EDGES SHEARED AND TORN. THIS SECTION MATCHES UP TO LF3 AND LF27A NO EVIDENCE OF FIRE/SMOKE DAMAGE.

SECTION LF27C MEASURES APPROX $3\frac{1}{2}' \times 3\frac{1}{2}'$ AND ENCOMPASSES FRAMES STA 1820 THRU 1840, AND STRINGER LOCATIONS S27L THRU S31L. ALL FRAMES MISSING, STRINGERS S29 + 30 FRACTURED AND PULLED FROM FUSELAGE SKIN/RIVETS, ALL OTHERS MISSING. FUSELAGE SKIN IS IRREGULAR IN SHAPE AND ALL EDGES ARE EITHER SHEARED OR TORN. THIS SECTION MATCHES UP TO LF27B, LF3 AND LF27D NO EVIDENCE OF FIRE OR SMOKE DAMAGE.

SECTION LF27D MEASURES APPROX $12' \times 6\frac{1}{2}'$
AND ENCOMPASSES FRAMES 1840 THRU 1940 AND STRINGER
LOCATIONS S22L THRU S30L. ALL FRAMES ARE MISSING
SO ARE STRINGERS S22L, S24L, S25L, S26L, S29L & S30L.
REMAINING STRINGERS S23L AND S27L ARE FRACTURED.
FUSELAGE SKIN IS BENT AND EDGES ARE SHEARED, TORN & IRREGULAR.
TWO PARTIAL WINDOW OPENINGS ABOVE AND BETWEEN
FRAMES 1840 TO 1860 AND 1860 TO 1880. THIS
SECTION MATCHES UP WITH LF3 AND LF27E.
NO EVIDENCE OF FIRE OR SMOKE DAMAGE.

SECTION LF27E MEASURES APPROX $2' \times 1\frac{1}{2}'$
AND ENCOMPASSES FRAME STATIONS 1820 + 1840, AND STRINGERS
S31L THRU S34L. NO STRINGERS OR FRAMES ARE ATTACHED.
FUSELAGE SKIN IS JAGGERED AND TORN. THIS SECTION MATCHES
TO LF27C, LF27B, AND LF27A. NO EVIDENCE OF FIRE
OR SMOKE DAMAGE.

SECTION LF27F MEASURES APPROX $2\frac{1}{2}' \times 1\frac{1}{2}'$ AND
ENCOMPASSES FRAME STATIONS 1940 THRU 1960 AND STRINGERS
S24L THRU S29L. NO STRINGERS OR FRAMES ATTACHED.
FUSELAGE SKIN IS JAGGERED AND TORN. THIS SECTION MATCHES
TO LF27D, LF3 AND LF28A. NO EVIDENCE OF FIRE
OR SMOKE DAMAGE.

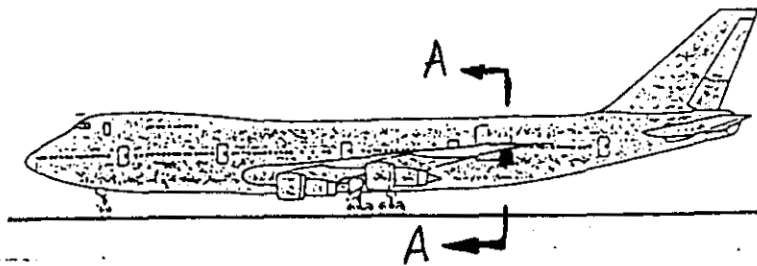
- 1) A STABILIZATION INTERCOSTAL REMAINS ATTACHED ALONG THE UPPER SIDE WALL OF STG 35L.
- 2) THERE IS LIGHT SOOTING / DIRT ALONG THE INBOARD SURFACE OF THE PANEL.
- 3) FRACTURE SURFACES APPEAR TO BE ~~BE~~ DUCTILE FAILURES.
