LOG # LF-3

DEBRIS FIELD #1

FUSELAGE SKIN AND STRINGERS
STA 1720 - 2018, STR 27L-3R

LF-3 FUSELAGE SKIN

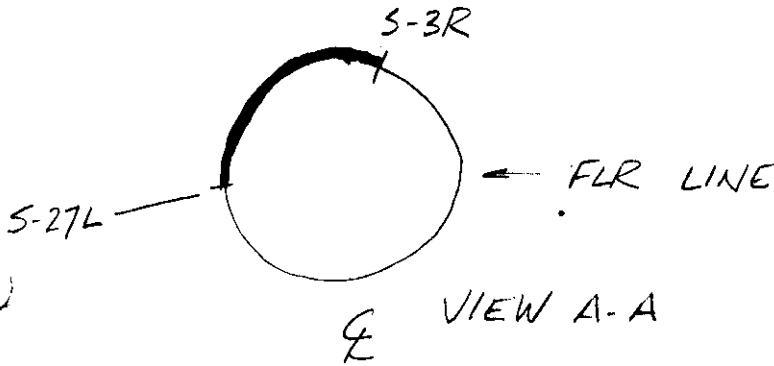
UNIT COMPRISED OF SKINS PLUS STRINGERS
WITH A FEW FRAMES ATTACHED - SEE NOTES

PANEL IS CLEAN AND FREE OF SOOT/ASH

SKIN IS FREE OF SHEAR WRINKLES

UNIT HAS 15 WINDOWS, ONE HAS GLASS

A crease runs diagonally up and aft beginning at FS 1880, stringer 18L. The crease turns more upward at FS 1940, stringer 15L. This location has a ^{12"} skin tear that crosses the crease line and has been displaced by the crease. The crease continues from this location to FS 2000, S-13L. The fracture sites at S 18L, 16L, 15L, 14L and 13L lie at or very near this crease.
