LOG # LF36 ^{SOS}
TARGET #
COORD: LAT
LONG

STA 980 Lower Frame Segment

LF36

LF 36
SUPPLEMENTAL
PAGE

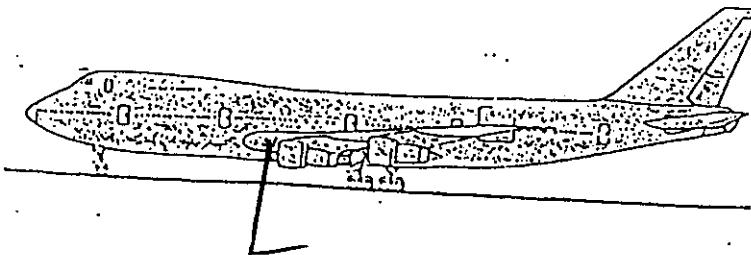
This is the first frame segment forward of the front Spar Bulkhead. Frame retains original contour. All skin attach flanges are broken free. The failsafe angle is bent at three location, however there are no other signs of impact damage. There is no evidence of fire damage or sooting.
