LOG # LF38

LHS Upper Fuselage skin from STA 900 to STA 1350, S-412 to S-29L.

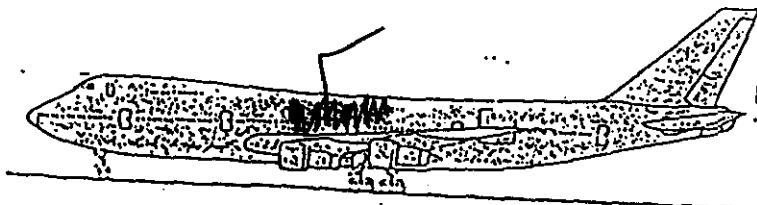
Major portions of frames remain attached to the skin from STA 1000 forward. Between 1000 and 1140, only the segments near the window belt remain attached. The STA 1241 frame is attached below S-14. The Door 3L forward edge frame is intact for upper stops #6 through #9. The sill structure remains attached.

The two window panes centered at STA 950 and STA 970 remain in place. Both the inside and outside surfaces are smooth and show no obvious signs of heat damage. There is no obvious heat damage to remaining portions of Wing to Body fairing between STA 920 and 1000 at the lower edge of the segment.

The panel itself does not show any obvious signs of fire damage or sooting.
