LOG # LF39
 TARGET # _____
 COORD: LAT _____
 LONG _____

DEBRIS FIELD # 1 green
 (far)

Green Tag # C860 LF39A

LHS Skin Panel, STA 1319 to STA 1440,
 S-5L to S-23L.

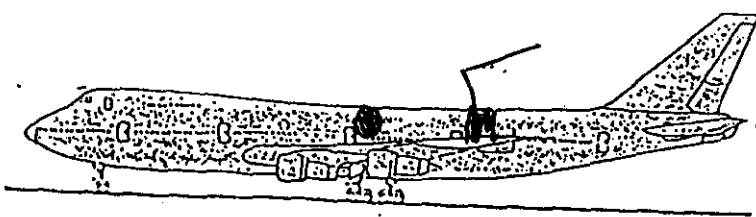
This skin panel segment includes the aft upper portion of the Door 3L cutout. All stringers and door sill structure is intact and in place. The aft Door edge frame is intact with stops #2 through #9 in place.

There is moderate sooting on the panel internal surface. This part mates with a panel aft labelled as LF2. Panel LF2 has no sooting on the interior surface. Both this panel and LF2 exhibit what appears to be light sooting on the external surface. The two windows aft of STA 1350 are still in place and both internal & external surfaces are smooth. Moderately heavy sooting on window internal surface and light sooting on external surface. There appears to be some heat damage to velcro stripping on edge frame I/c. (plastic stripping is somewhat melted & curled). Interior face of attendant assist handle appears to be lightly melted.
