GREEN C101

LOG # LF 41 RB

TARGET # 2

DEBRIS FIELD 7

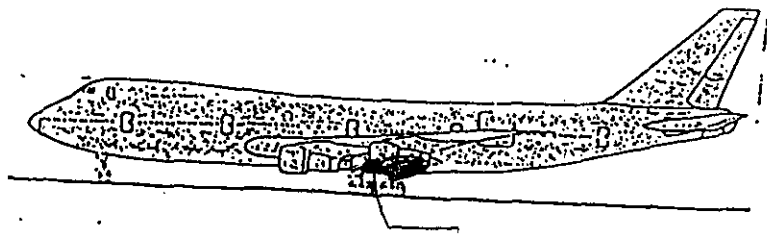
This section of fuselage measures approx 12' x 4' and encompasses station locations 1480 to 1620, and stringer location S51R, E, S51L (S50L KEEL CHORD) S49L, S48L, S47L, S46L

- a) PORTION OF S46L FRACTURED FROM STA 1620 TO 1560. REMAINING PORTION OF STRINGER (WITH FUSELAGE SKIN) MISSING FROM STA 1560 TO 1480
- b) PORTION OF S47L FRACTURED FROM STA 1620 TO 1560. REMAINING PORTION OF STRINGER (WITH FUSELAGE SKIN) MISSING FROM STA 1560 TO 1480
- c) PORTION OF S48L FRACTURED FROM STA 1620 1580 (FUSELAGE SKIN MISSING FWD STA 1560 - DOWN TO S49L.

d) S49L MISSING STA 1620 thru 1600. REMAINDER OF STRINGER TO STA 1480 FRACTURED AND CRACKED THROUGH AT STA 1540

e) S50L FRACTURED AT STA 1620 TO 1600, REMAINDER OF STRINGER MISSING

f) S51L NOT SECURED FROM STA 1620 TO 1560 (RIVETS PULLED) AND REMAINDER OF STRINGER MISSING TO STA 1480.

g) KEEL CHORD FRACTURED AT STA 1540 AND REMAINING SECTION MISSING TO STA 1480.

h) Support casting AT STA 1480 FRACTURED.

FUSELAGE SKIN JAGGERED, EDGES BENT INWARD AND OUTWARD AT VARIOUS LOCATIONS. ENTIRE SKIN PANEL BENT 90° INWARD AT STA 1540.

SOME EVIDENCE OF SMOKE/SOOT RESIDUE.

CENTER OF PANEL BAYS BULGE INWARD B.H.
