LOG # LF42 ^{1/23}
 TARGET # 2
 COORD: LAT 7
 LONG 11
 DEBRIS FIELD 1

LF 42A

DEBRIS FIELD #1

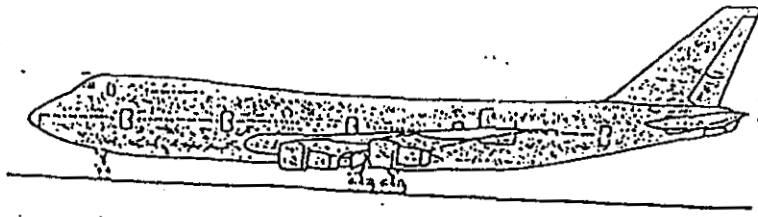
This section of fuselage measures approx 9' x 2' and encompasses station location 1800 thru 1900, and stringer locations S50L, S51L, (⊕) S51R and S50R. NO FRAMES ATTACHED TO STRUCTURE, WHICH IS TWISTED AND CURLED OVER.

- a) STRINGER S50R MISSING
- b) " S51R TWISTED AND FRACTURED AT STA 1860, REMAINING SECTION FROM STA 1820 TO 1800 MISSING
- c) STRINGER S51L TWISTED AND FRACTURED AT STA 1860
- d) " S50L " " " " " 1860

SPIN PUNCTURES OUTWARD	between	S51R + S51L,	STA	1900 - 1880
" PUNCTURES/TEARS	"	S51R + S51L,	STA	1880 - 1860
"	"	S51R + S51L	"	1860 - 1820
"	"	S51R + S51L	"	1820 - 1800

NO EVIDENCE OF FIRE OR SMOKE DAMAGE

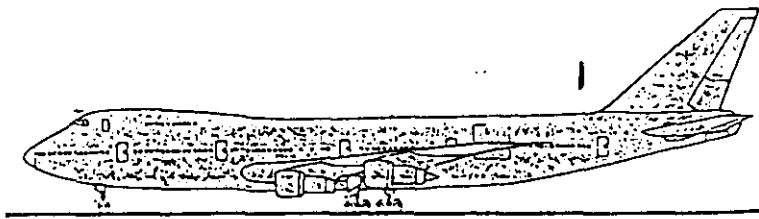
LOG # LF42G

- 1) FRAME SHEAR TIE PORTIONS (LEG AGAINST SKIN PANEL) REMAIN ATTACHED AT STA 1940, STG 5-50R TO 5-51R, AND AT STA 1960, STR 49R TO 50R AND STR 50R TO 51R.
- 2) OUTBOARD SURFACE OF THE SKIN PANEL APPEARS TO BE MODERATELY SOOTED.
- 3) FRACTURE SURFACES APPEAR TO BE DUCTILE FAILURE.

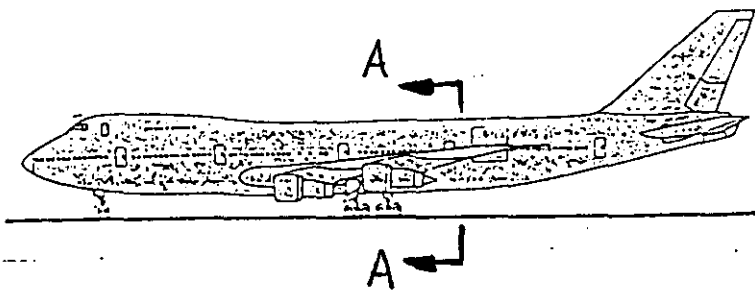
LOG # LF42H

- 1) REGION INCLUDES THE INTERSECTION OF TWO SKIN SPLICES. THE CIRCUMFERENTIAL SPLICE AT STA 1741.10 IS REPRESENTED FROM STG. 45L TO 48L. THE LONGITUDINAL SPLICE AT STG 46L IS REPRESENTED FROM STA 1720 TO 1750.
- 2) THE SKIN IS OF HEAVY GAGE, ~0.160 TO 0.180 INCH, HOWEVER IT APPEARS THAT SOMETHING OF MASS EXITING THE AIRPLANE THRU IT CENTERED AT ABOUT STA 1730, STG 48L. TAKEN AS A WHOLE, WITH PANEL, LOG # LF53, IN THIS VICINITY, THE SKINS BEND OUTBOARD NOTICEABLE WITH A CENTRALIZED PORTION ATTACHED TO LF42H BENT OUTBOARD SIGNIFICANTLY.
- 3) AN EXTERNAL SKIN REPAIR APPEARS TO EXIST IN THE REGION STA ~1722 TO ~1734, STG 45 1/4 L TO 46L.

- 1) STG 45L REMAINS ATTACHED FROM STA ~1723 TO STA 1740
- 2) STG 46L REMAINS ATTACHED FROM STA ~1721 TO STA ~~1732~~ ~1752
- 3) STG 47L IS MISSING
- 4) STG 48L REMAINS ATTACHED FROM STA ~1732 TO STA ~1740
- 5) STRINGER CLIPS ARE PRESENT AT STA 1740 FOR STRINGERS 45L AND 46L.
- 6) STRINGER SPLICE FITTINGS (OR A PORTION OF ONE) EXIST AT STA 1740 FOR STRINGERS 45L, 46L AND 48L.

- 1) A SMALL PORTION OF THE STA 1740 FRAME REMAINS ATTACHED AT STG 46L.
- 2) THERE IS NO APPARENT SOOTING.
- 3) FRACTURE FACES APPEAR TO BE DUCTILE FAILURE.
