# LF45D

LOG # LF67 D,E

DEBRIS FIELD GREEN

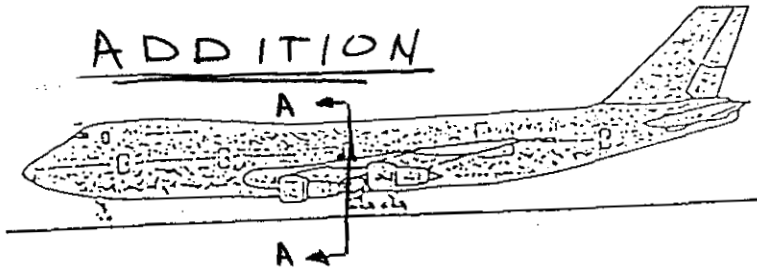
LF67D is a piece of fuselage outer skin, disbonded from its underlying doubler, at the lower forward corner of the main entry door 3L cutout. This skin was covered by the steel corner doubler, that is part of LF67A. This part mates to LF67A. The exterior is pock-marked and both sides are scored. THIS SECTION IS SLIGHTLY BOWED INWARD.

LF67E is a piece of fuselage skin above the overwing longeron between Sta 1328 to 1340.

It is along the fastener lines at Sta 1328 and 1340. This part mates to LF67A, LF71A, and LF179A. THIS PART IS FOLDED 180°
