LF-5

65B00005 3

LOG # LF 5 RTS 10  
509  
 TARGET # LLS-46 (5)  
 COORD: LAT 40-38-42  
 LONG 72 39 07  
 DEBRIS FIELD # 3  
 Pg 115 (near field)

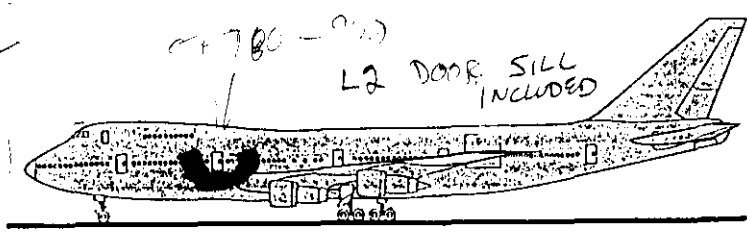
STARTING AT STA 780 (FRAME MISSING) AND LOCATION S37L (STRINGER MISSING - RIVET HOLES ONLY). 18" ALONG S37L FUSELAGE SKIN TEARS DIAGONALLY UP AND AFT TO THE POINT WHICH IS STA 800 AND S36L, PROCEEDS 13" AFT ALONG THE S36L, THEN TEAR PROCEEDS VERTICALLY UP TO S34L. TEAR PROCEEDS AFT ON S34L TO 7 1/2" FWD OF STA 900. TEAR CONTINUES DIAGONAL DOWNWARD 4" BELOW S35L @ STA 900, AND THEN PROCEEDS VERTICAL UPWARD ON A LINE 2" AFT OF STATION 900 TO S33L. TEAR CONTINUES <sup>AFT</sup> ALONG S34L (WHICH IS CRUSHED AND BUBBLED, <sup>AS</sup> SKIN) 3 1/2" AFT OF STA 920 (STA 930 FRAME MISSING). TEAR MOVES VERTICALLY UP TO S30L @ STA 920, TEAR CONTINUES DIAGONALLY AFT TO S28L AND PROCEEDS <sup>(RTS)</sup> ANOTHER 11" AND TURNS VERTICAL FOR 8", THEN TEAR PROCEEDS FWD + HORIZONTALLY TO STA 920, AND CONTINUES VERTICALLY ALONG STA 920 TO S26L. TEAR PROCEEDS DIAGONALLY UPWARD TO A POINT 7" ABOVE S22L @ STA. 853. ~~RTS~~ (3) RTS
