LOG # LFS2

TAG # C611

SKIN & STRINGERS, STA 2020 TO 2160, S45L TO S45R

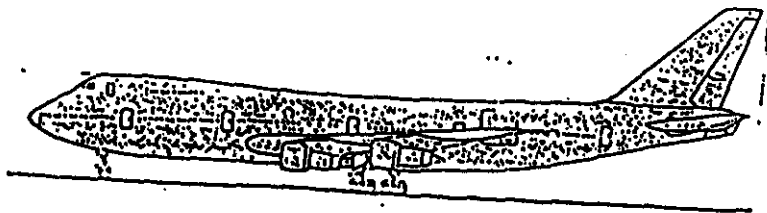
- RED PAINT IS VERY DARK BTWN S46L & S51R (NOT SOOT OR FIRE APPEARANCE)
- MULTIPLE OUTWARD PUNCTURES AND TEARS WITH MOST COILINGS AFT AND ORIGIN IS WITHIN 1" OF FRAME/SKIN INTERSECTIONS
- 1 COIL OUTWARD AND AFT RUNS FROM STA. 2060 TO 2080, BTWN S51L & S51R,  $\approx 4"$  DIA  $1\frac{1}{2}$  COILS
- BENT  $\approx 90$  OUTWARD @ STA 2060 BTWN S51L AND S46L
- ABOVE S46L @ EACH TEAR, SKIN ROLLED AFT AND OUTWARD  $90^{\circ}$ - $120^{\circ}$
- STRINGERS ARE CRUSHED AT EACH FRAME AND MOST FRACTURED INTO 20" SEGMENTS
- SKIN DIMPLED INWARD  $\frac{1}{2}$ " TO 1" BETWEEN STRINGERS (CORRUGATED METAL APPEARANCE)
