LOG # LF64 RTS
10-10-96
 TARGET # GREEN
 COORD: LAT _____
 LONG _____
 DEBRIS FIELD Z 2520

SKIN SEGMENT, STA 990 TO 1000,
 STG 32L TO 34L

SEGMENT IS JUST FORWARD OF THE
 WING CENTER SECTION ON LEFT SIDE
 OF AIRPLANE.

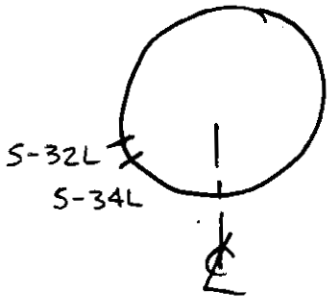
LOG # LF 64
GREEN

REFER FIRE AND EXPLOSION GROUP NOTES FOR FIRE DAMAGE

FRACTURE SURFACES APPEAR TO BE DUCTILE FAILURE.

NOTE: NO SOOT OR FIRE DAMAGE APPARENT.
CJH:JAM
10-13-96
