LOG # LF65 ^{RTS} 10-10-96

BODY FRAME STA 1080 STUB BEAM
ON LEFT SIDE OF AIRPLANE,
LBL 98.58 TO SIDE OF BODY,
W.L. 190 TO 200

STA 1080 FRAME STUB BEAM, LEFT HAND SIDE

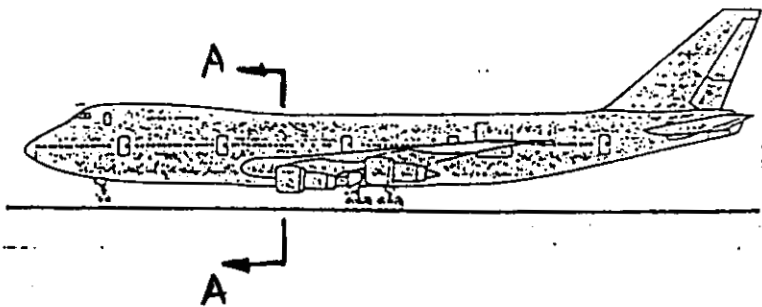
VIEW A-A

REFER FIRE AND EXPLOSION GROUP NOTES FOR FIRE DAMAGE

- 3] STRINGER TO SKIN HI-LOKS STILL INTACT IN STRINGER. HI-LOKS DO NOT APPEAR TO BE DAMAGED, SKIN FAILED FROM NET AREA TENSION.
- 1] FAIRING ATTACHMENT PROVISIONS
- 2] STRINGER TO FRAME CLIP TORQUED RESULTING IN STRINGER COCKED TO APPROXIMATELY 10° TO ORIGINAL ATTACHMENT LINE.
