LOG # LF7 Rev A <sup>1014RTS</sup> SR

DEBRIS FIELD Yellow (#2)

LHS skin Assemblies from Debris field #2. Panels in vicinity of Door #1L and NW. See next sheet for location of three panels labeled (A), (B), & (C).

2728 Boeing TWA  
7/29/96

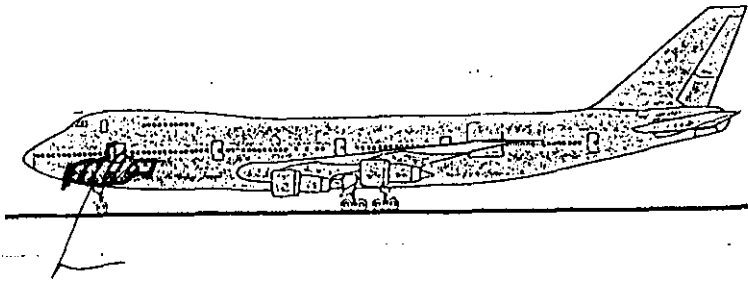
Panel (A): TAG # B134 (yellow)

STA 434 edge frame in good condition from S-18 down to end @ S-30.

STA 400, 420 frames mostly intact.

Panel (B): TAG # B170 (Yellow)

Lwr aft door corner intact. Most of failure is along lwr row of S-23 lap splice.

Section is still close to original curvature with 75% of frame structure intact.

Panel (C): TAG # B176 (Yellow)

This panel looks very clean. The STA 280, 300, and 320 frame are mostly intact. At STA 340, the lower 4 bays of the cheek frame remain with only lwrmost bay still fastened. STA 360, 380 are almost completely gone except for a few bays in vicinity of S-34 lap. A small portion of the torque box remains between STA 340-360 (vertical web and approx 6" of horizontal web).

No signs of fire damage

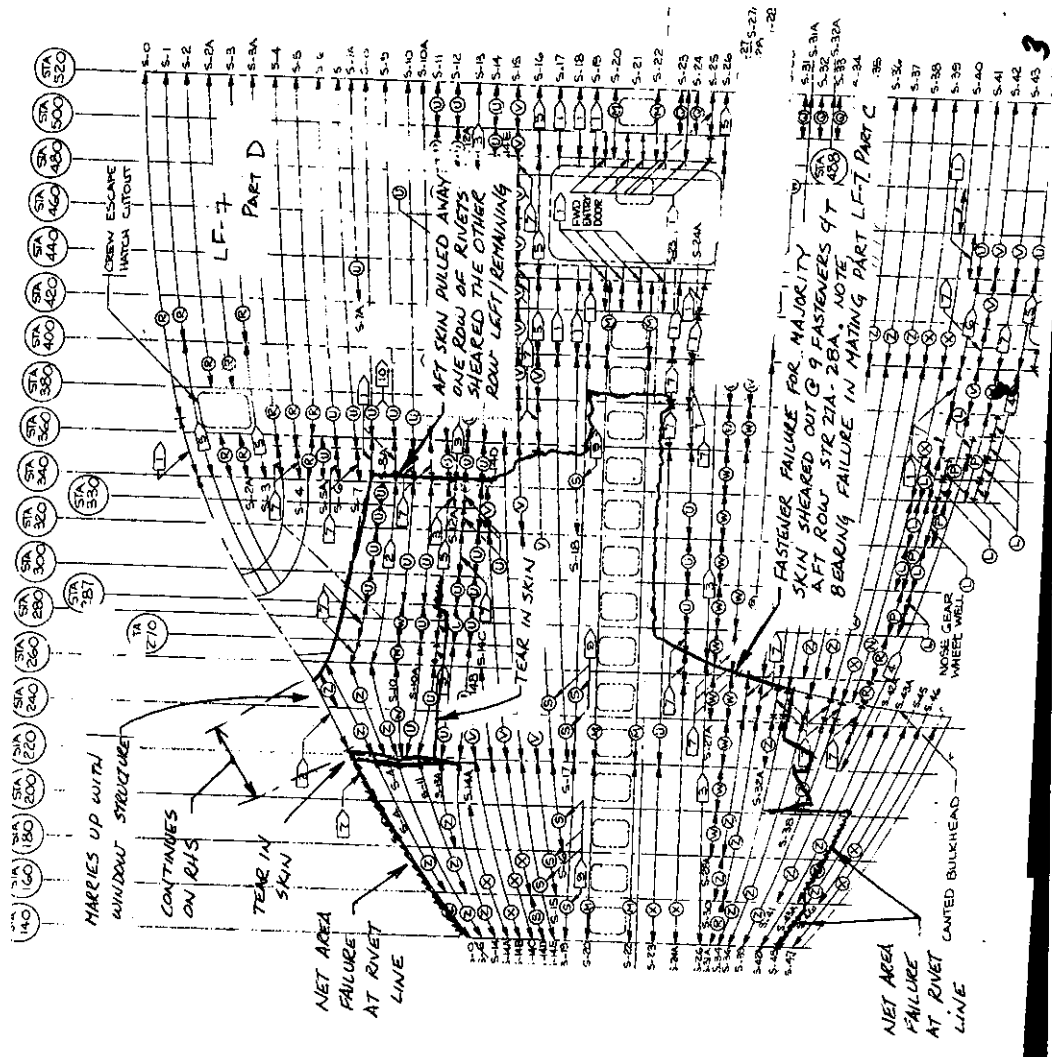
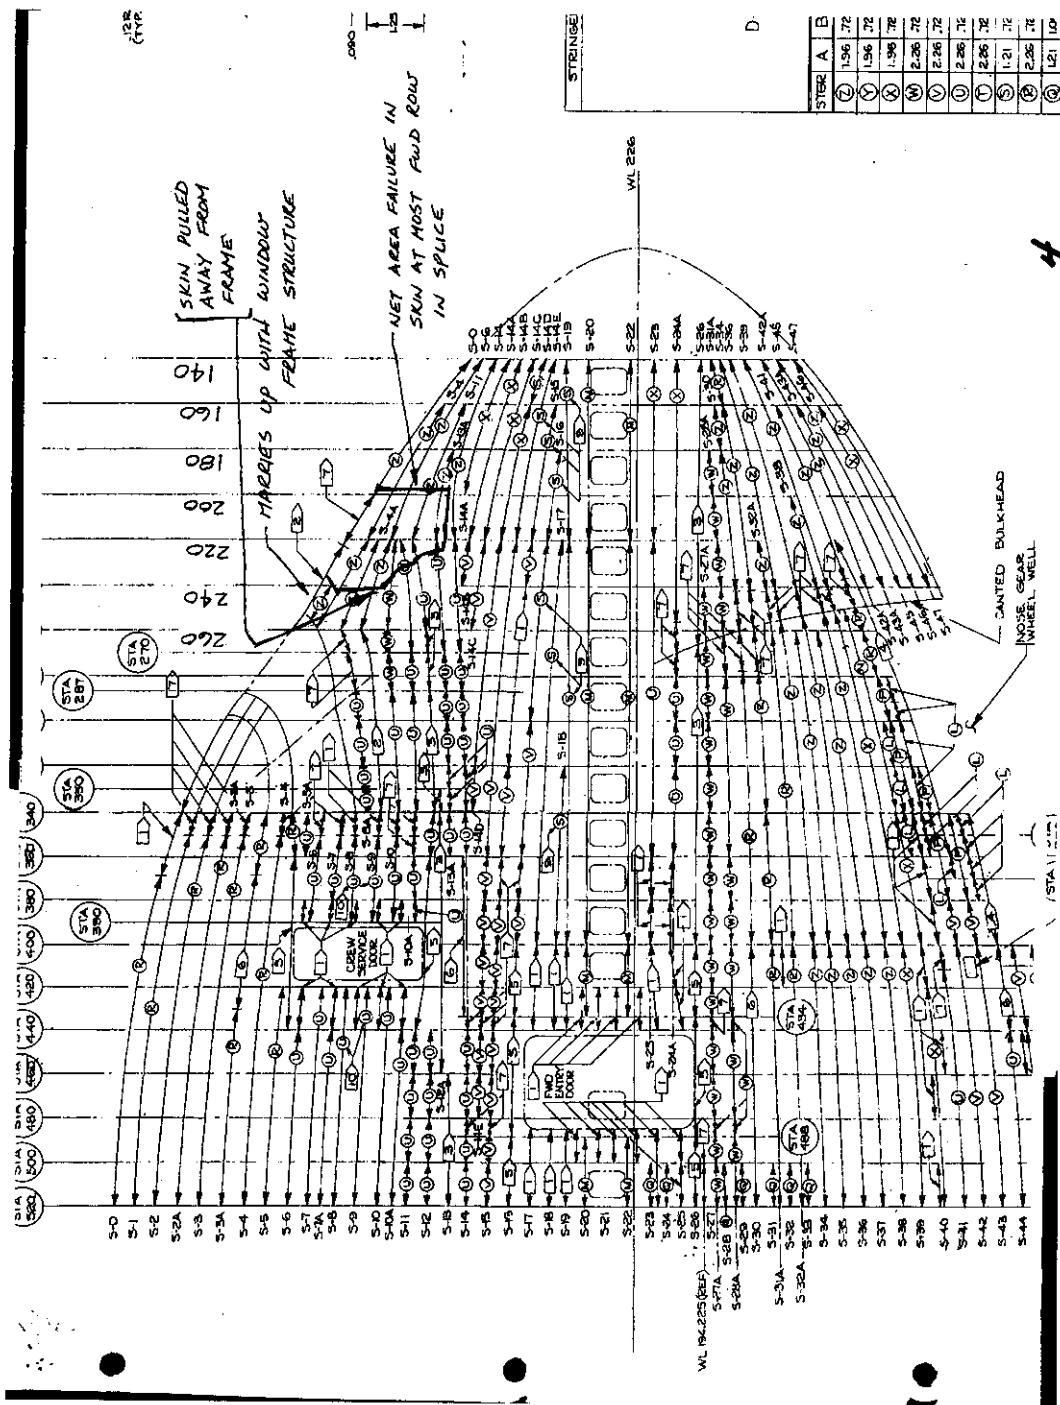
LHS Skin Assemblies

- A Fwd Door Surround and Door 1L
- B Lwr Aft Door corner surround into section 42.
- C Lwr 41 from N/W to window belt.

All items from Yellow Zone
