LOG # LF 89

SKIN PANEL

STA 885 TO STA 938, S'35L TO S'38L

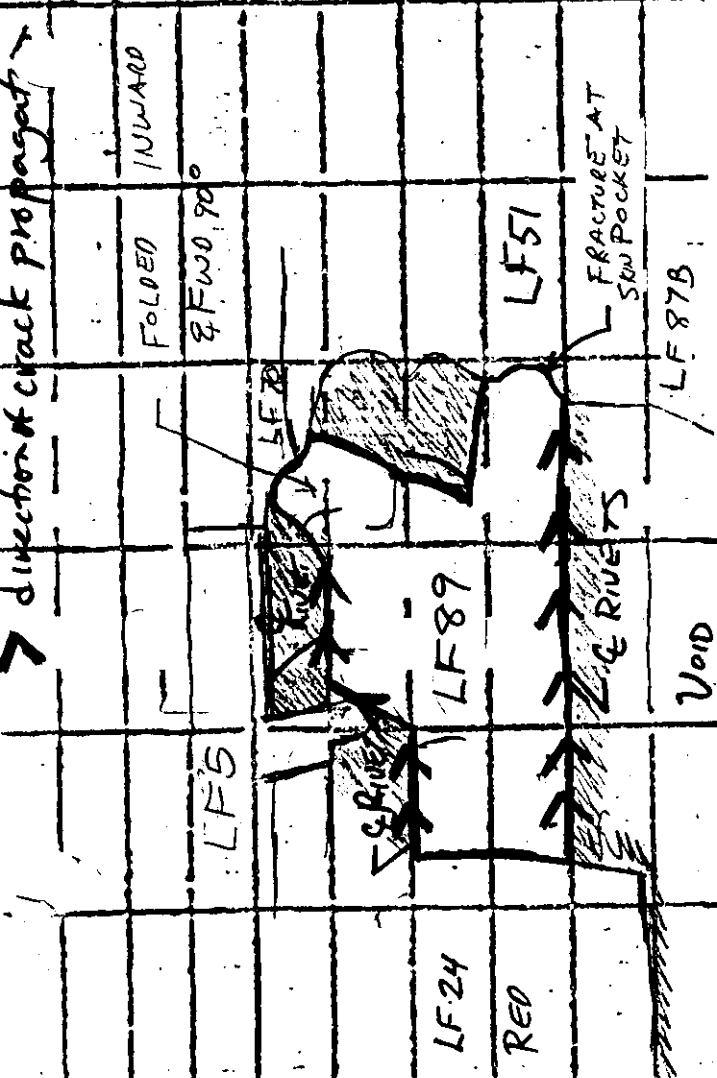
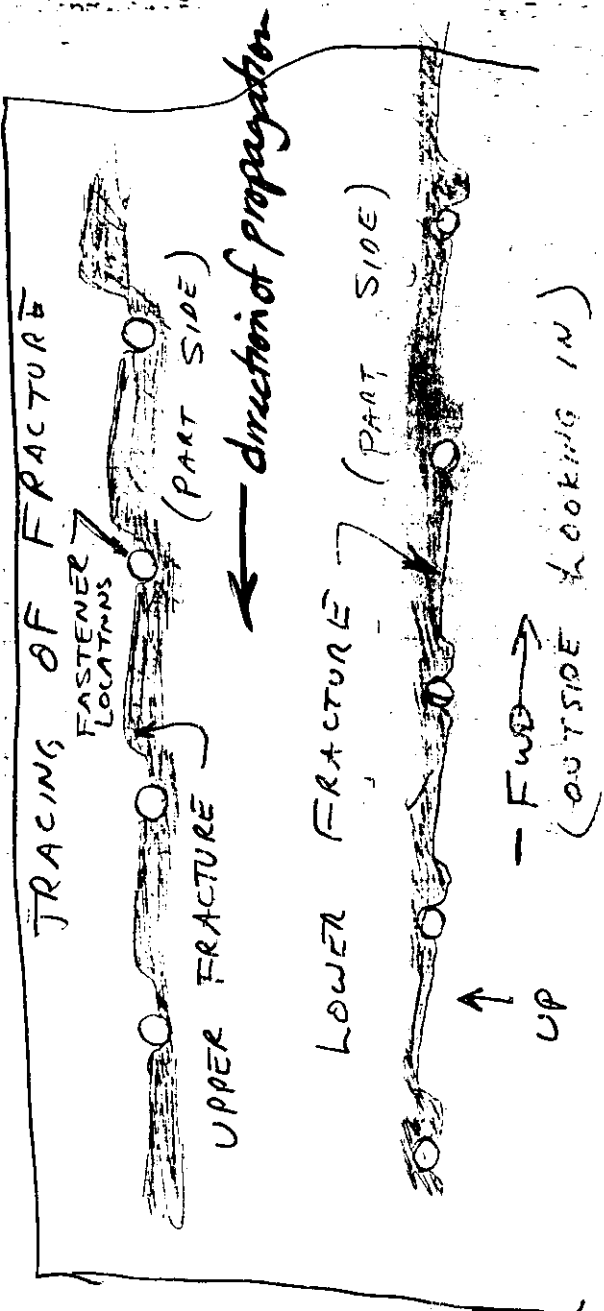
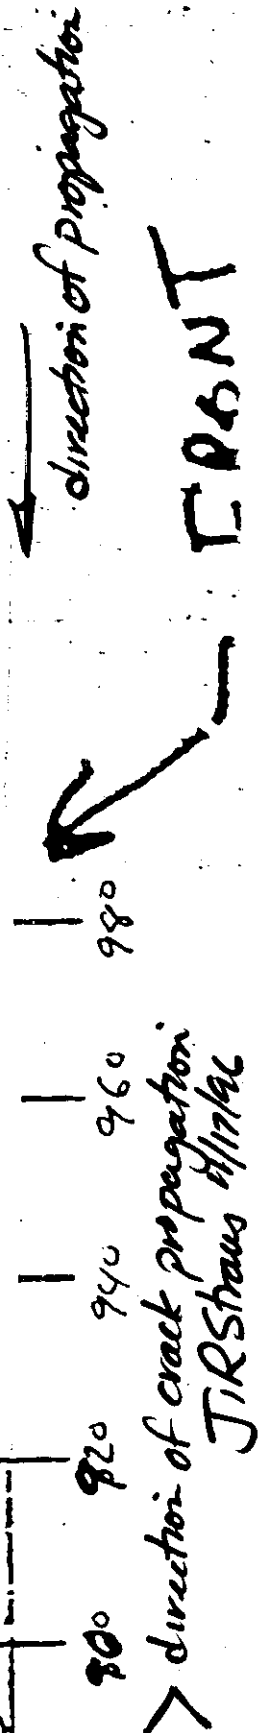
LF 89

> direction of crack propagation

- Φ 8.31L
- Φ 8.32L
- Φ 8.33L
- Φ 8.34L LAP
- Φ 8.35L
- Φ 8.36L
- Φ 8.37L
- Φ 8.38L
- Φ 8.39L LAP
