LOG # LF 96

SKIN STA 780 TO STA 800

LEFT STR 37 TO S-40L

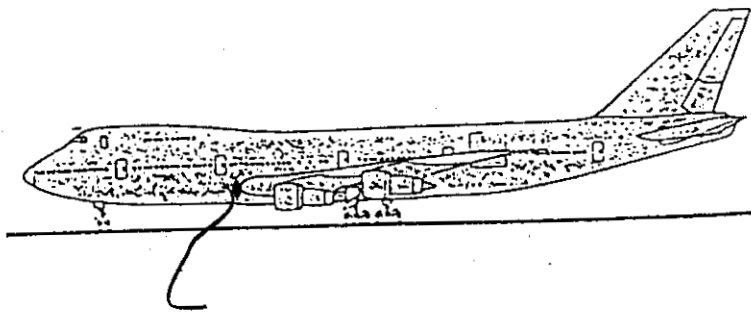
SMALL PORTION OF FUSELAGE SKIN
FROM LHS LOWER LOBE. NO FRAMES
OR STRINGERS REMAIN ATTACHED AND
ALL STRINGER FASTENER HOLES ARE
OPEN. THIS SEGMENT MATCHES UP WITH
LF1 (FWD), LF5 (UP), LF24B (AFT) AND
LF22-6 (DOWN).

THERE IS NO EVIDENCE OF FIRE DAMAGE OR
SOOTING.
