NOSE GEAR DOORS L&G

NOSE LANDING GEAR DOOR

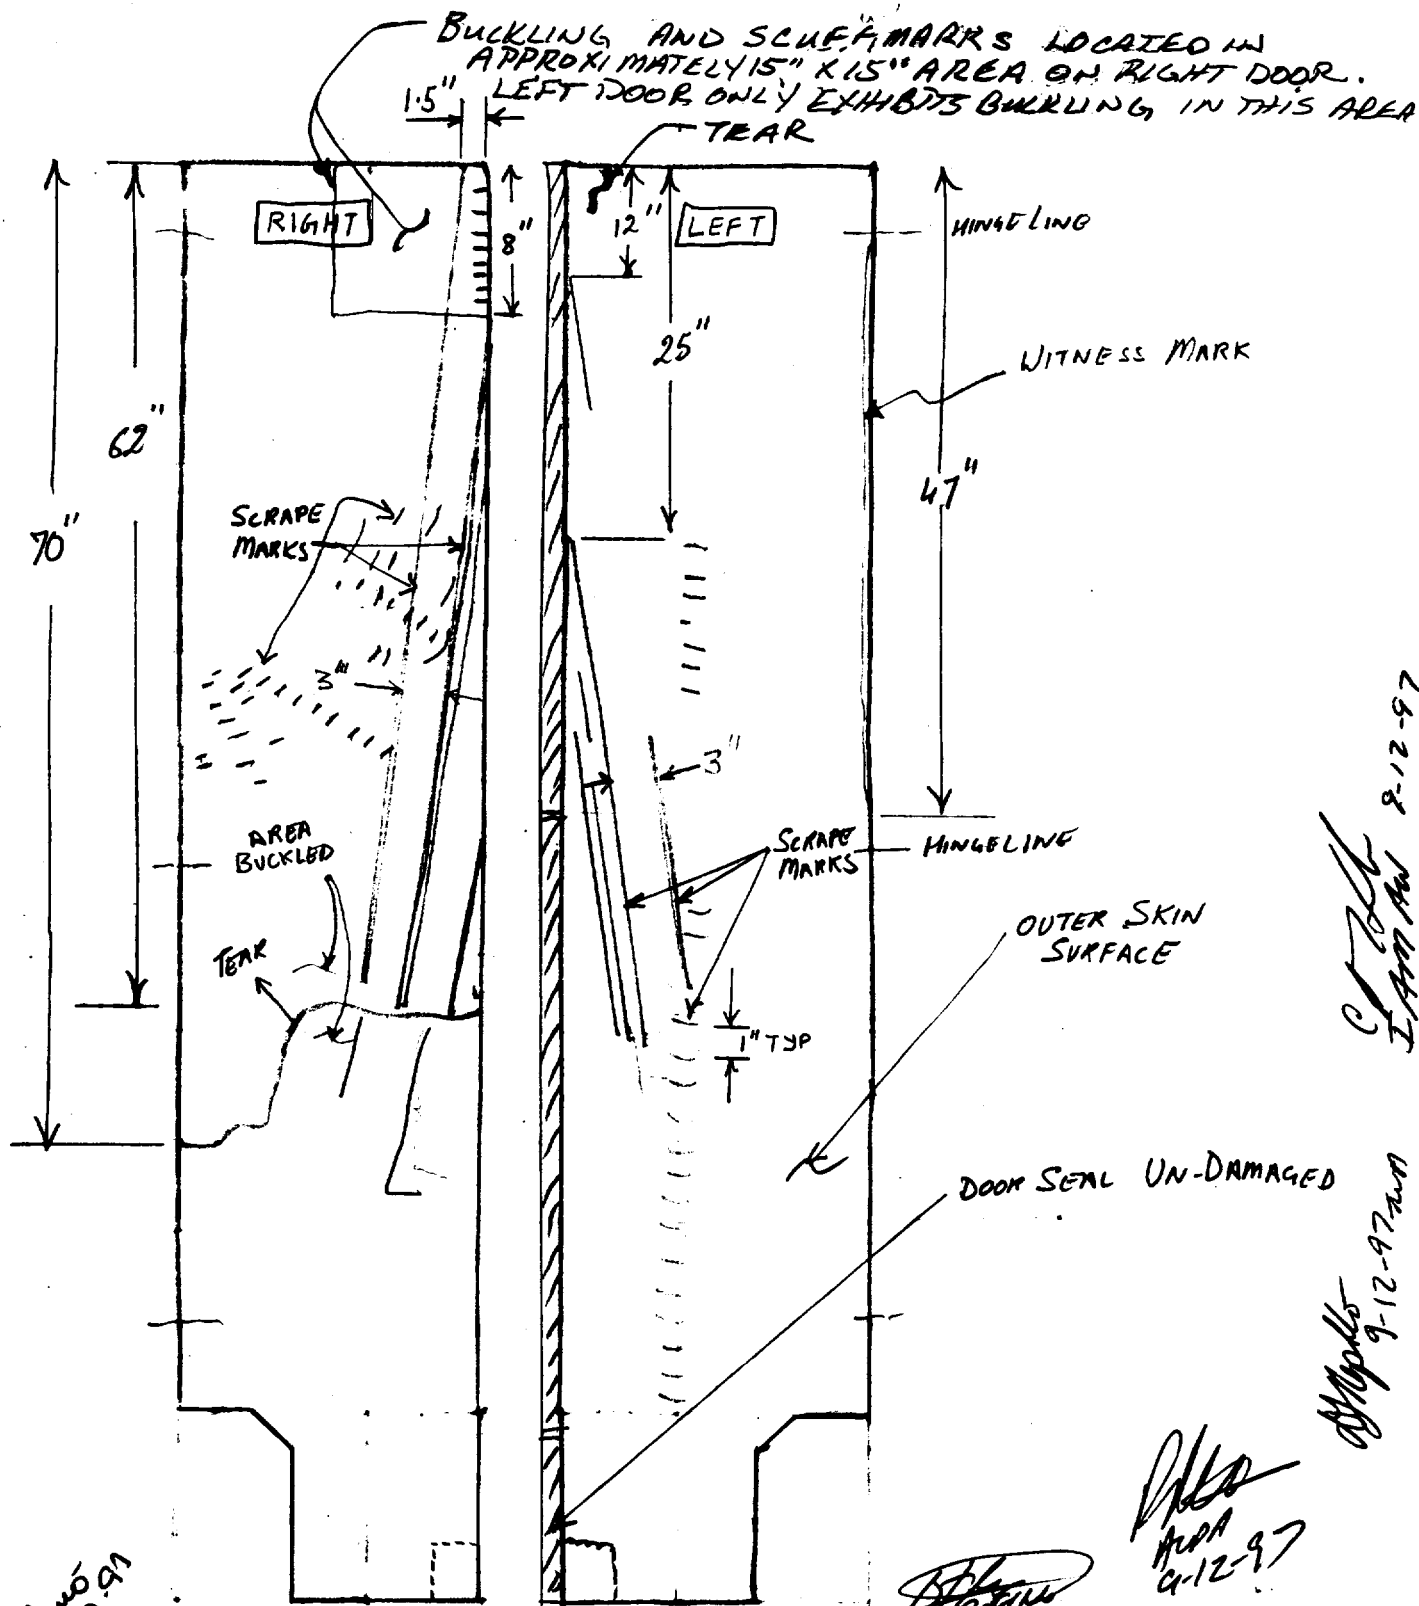
NLG FWD DOOR. (OUTER SURFACE)
VIEW LOOKING-UP

LUG AND CLEVIS SHOW MINOR EVIDENCE OF OVER ROTATION
 LUG AND CLEVIS REMAINED WITH AIRCRAFT (SP16)

LUG AND CLEVIS REMAINED WITH AIRCRAFT (SP19)
 LUG AND CLEVIS REMAINED WITH AIRCRAFT (BOOPS)

LUG SHOWS EXTENSIVE EVIDENCE OF OVER TRAVEL
 LUG REMAINED WITH AIRCRAFT (SP16)

DOOR STRUCTURE SEVERELY CRUSHED

LUG AND CLEVIS SEPARATED FROM DOOR AND AIRCRAFT
 NO EVIDENCE OF OVER TRAVEL

LUG AND CLEVIS REMAINED WITH DOOR
 CLEVIS SHOWS EVIDENCE OF OVER ROTATION
