LOG # 121

TARGET # 008

### #4 FLAP TRACK ASSY.

DEBRIS FIELD GREEN COOB

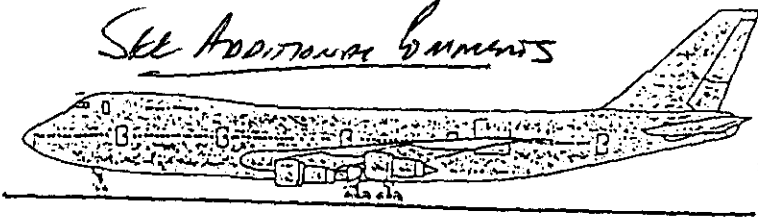
LEFT SIDE INBOARD FLAP TRACK AND CARRIAGE ASSY #4 FLAP POSITION. THE FRONT FLAP TRACK MOUNT SEPERATED FROM THE WING UNDER SIDE (MOUNT IS FRACTURED)

CARRIAGE IS MOSTLY INTACT WITH THE EXCEPTION OF THE CONNECTING RODS AND LINKAGE. WHICH ARE BROKEN AND OR FRACTURED.

THE MID FLAP. IS PARTIALLY CONNECTED AND THE UPPER SURFACE INBOARD SIDE IS DELAMINATED ~~AT~~ AT THE TRAILING EDGE OF THIS SECTION. THE FLAP IS SEVERED AT THE INBOARD & OUTBOARD LOCATIONS (EDGES) THIS ASSY MEASURES APPROX 16 FT. LONG WITH NO SIGNS OF SOOTING.

THE TRAILING EDGE FLAP IS STILL CONNECTED TO THE ~~THE~~ MID FLAP. BY THE FLAP CONNECTORS. THE TRAILING EDGE FLAP IS CONNECTED AT 2 POINTS AND HAS A BREAK-SEPERATION IN THE CENTER MAILING IT 2 PIECES
