LOG # LW-22

DEBRIS FIELD GREEN (C887)

Left Wing #3 Flap Track Assy

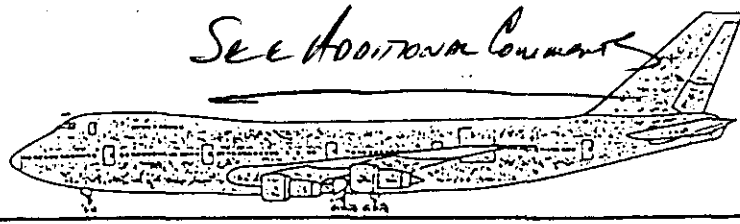
#3 Left Hand FLAP TRACK AND CARRIAGE ASSY. Fwd section has a approx. 2 foot piece missing. Mid section TOP has a section of SPAR ATTACHED (4 bolts) 3' FT Long 6" wing. Slightly curled. AFT section carriage assy is fractured AT FLAP MOUNT AREA. All mounts appear to be fractured. No burning or sooting indications

- 1) THERE ARE SOOTING INDICATIONS AT THE REAR SPAR ATTACH AREA - BOTH VERTICAL SIDES AND THE TOP.
