GREEN DEBRIS FIELD

TAG+ C 019

FBI = 8/9/96-37

R2 15 A SECTION OF THE UPPER RUDDER APPROX.

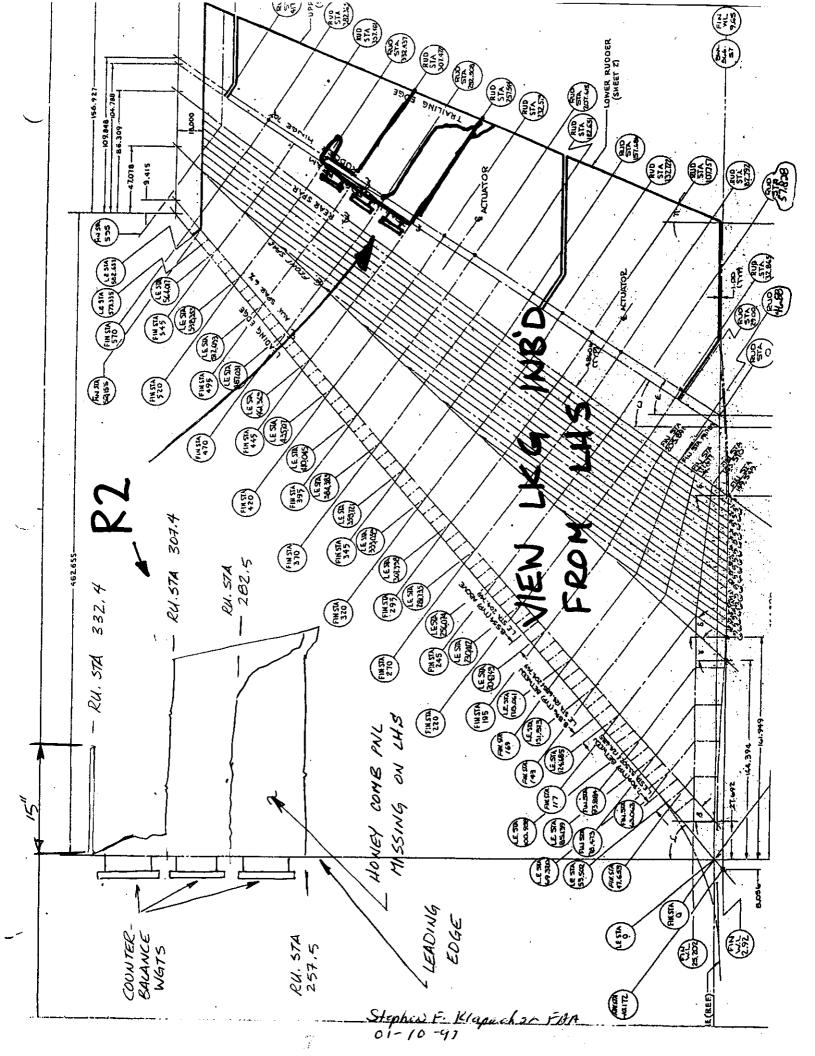
T' X 6'9" FROM RU. STA 257.5 TO 332.4

RUNNING FROM LEADING EDGE TO TRAILING EDGE.

THE LUS HONEY COMB SKIN PANEL IS MISSING

BETWEEN RU. STA 257 \$ 282. THE LEADING EDGE

BEAM HAS 3 SECTIONS OF COUNTER BALANCE WEIGHTS.

THE HINGE FITTING HAS NEGLIGIBLE DAHAGE, WITH BOLT

ATTACHED AT PINOT POINT. RIGHT SKIN PANEL OUTER

FACE SHEET IS MISSING FOR APPROXIMATELY 3" BY 24".

OUTER SKINS HAVE SOME MINOR PUNCTURES AND

SURFACE ABRASIONS. LEADING EDGE SEAL SHROUD

HAS IMPACT DAMAGE, THERE AKE NO OBVIOUS

SIGNS OF SOOT NOR FIRE DAMAGE, R2'S LEADING

EDGE MATES WITH RI AT RU. STA 332.
