TAG # C2246

LOG # RF-11

FRAME SEGMENT  
STA 1420, STR 5R - 9R

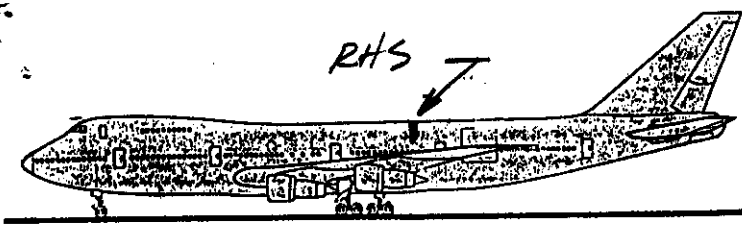
- STA 1620 FRAME SEGMENT, STR 5R-9R
- STR CLIPS SHOW SIGNS OF LATERAL DEFORMATION
- FASTENERS C/T SHEAR TIE AND SKIN PULLED THRU SHEAR TIE
- NO HEAVY SIGNS OF SOOTING, ONLY 'CLOTH ASH'
